## CITY OF SASKATOON

# Asbestos-Containing Building Materials Assessment Report - Trailer 702

**Report Number: 1667963**

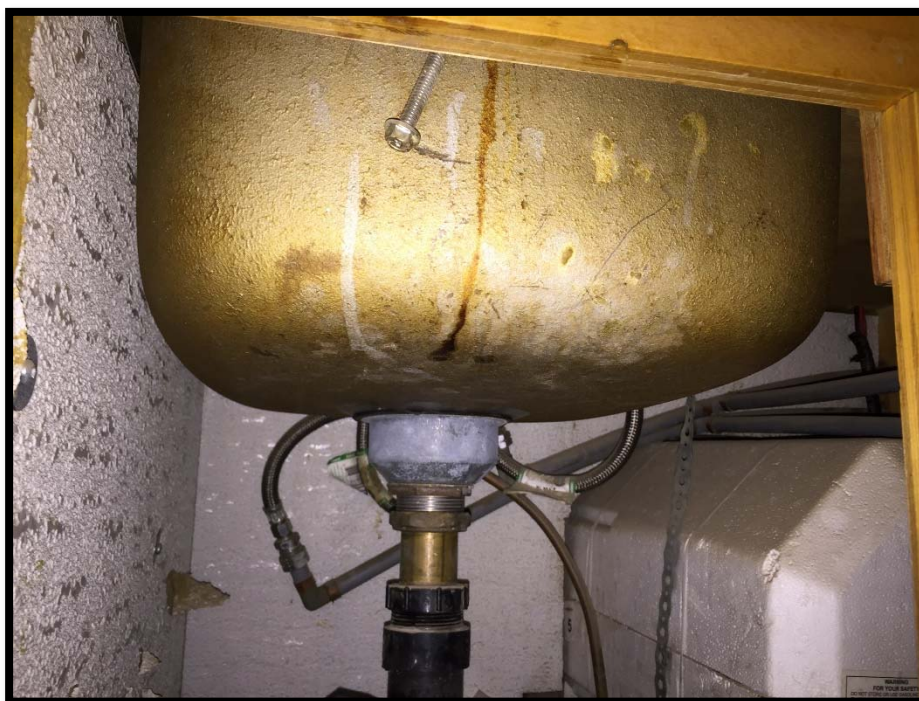
#### **Gold Sink Undercoat**

One (1) sample of gold sink undercoat was collected during the assessment. The sample collected was found to contain 2.2% Chrysotile asbestos. Asbestos-containing gold sink undercoat (see Photograph 1 in Appendix B) was observed in the following location:

- Room 100 (approximately 1 sink).

**Photograph 1: Asbestos-Containing Gold Sink Undercoat.**

If scheduled for impact, sinks with asbestos-containing gold undercoat should be abated following low-risk abatement work procedures as outlined in the *Saskatchewan Asbestos Abatement Manual* (2017). Alternatively, as the gold sink undercoat was observed in good condition, and with a priority rating of 5 (please see the room by room spreadsheet provided in Appendix C for a description of the priority ratings), it can be managed in place if not scheduled for impact.

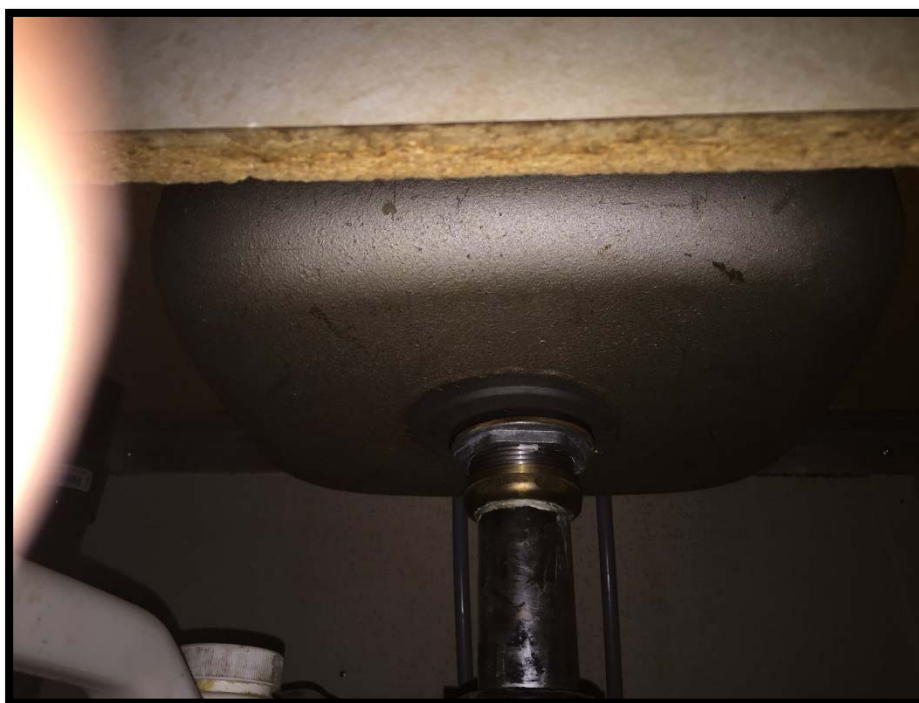
#### **Silver Sink Undercoat**

One (1) sample of silver sink undercoat was collected during the assessment. The sample collected was found to contain 2.1% Chrysotile asbestos. Asbestos-containing silver sink undercoat (see Photograph 2 in Appendix B) was observed in the following location:

- Room 101 (approximately 1 sink).

**Photograph 2: Asbestos-Containing Silver Sink Undercoat.**

If scheduled for impact, sinks with asbestos-containing silver undercoat should be abated following low-risk abatement work procedures as outlined in the *Saskatchewan Asbestos Abatement Manual* (2017). Alternatively, as the silver sink undercoat was observed in good condition, and with a priority rating of 5 (please see the room by room spreadsheet provided in Appendix C for a description of the priority ratings), it can be managed in place if not scheduled for impact.
