February 6, 2018

CITY OF SASKATOON

Asbestos-Containing Building Materials Assessment Report - Trailer 704

Report Number: 1667963

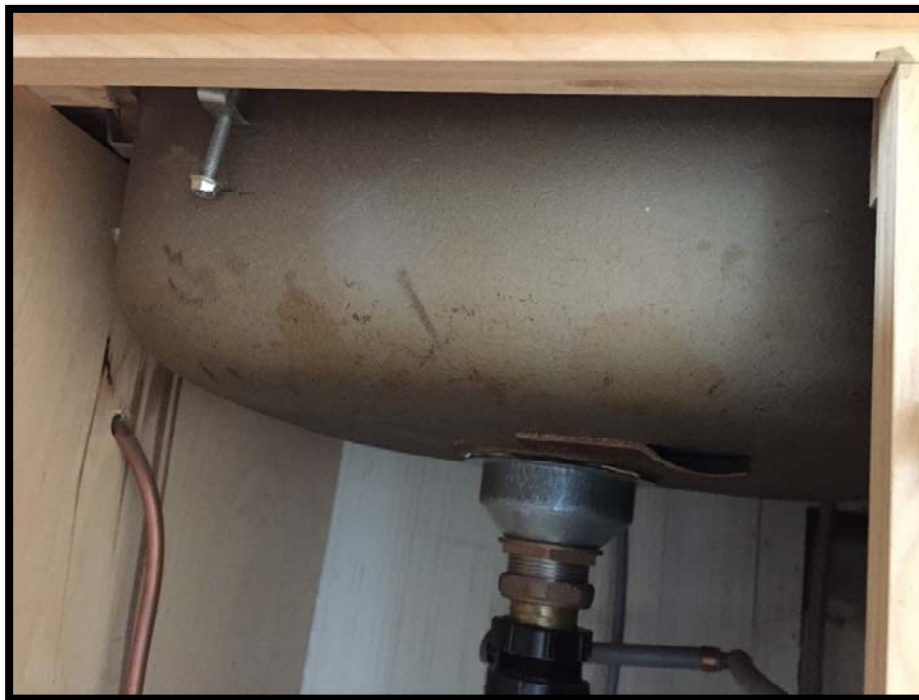
One (1) sample of gold sink undercoat was collected during the assessment. The sample collected was found to contain 3.7% Chrysotile asbestos. Asbestos-containing gold sink undercoat (see Photograph 1 in Appendix B) was observed in the following location:

- Room 100 (approximately 1 sink).

Photograph 1: Asbestos-Containing Gold Sink Undercoat.

If scheduled for impact, sinks with asbestos-containing gold undercoat should be abated following low-risk abatement work procedures as outlined in the *Saskatchewan Asbestos Abatement Manual* (2017). Alternatively, as the gold sink undercoat was observed in good condition, and with a priority rating of 5 (please see the room by room spreadsheet provided in Appendix C for a description of the priority ratings), it can be managed in place if not scheduled for impact.

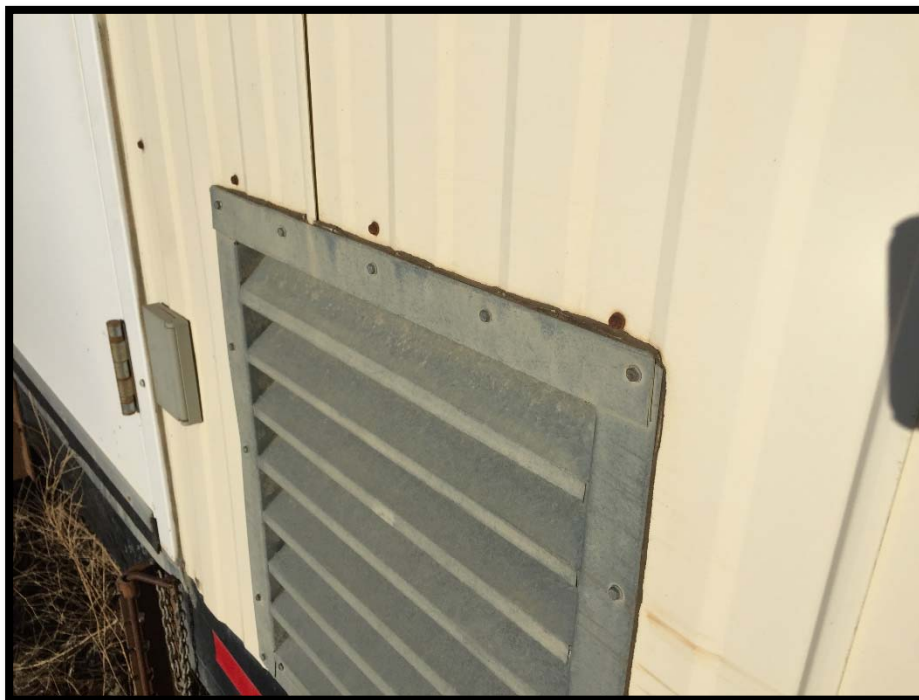
One (1) sample of black building caulking was collected during the assessment. The sample collected was found to contain 4.4% Chrysotile asbestos. Asbestos-containing black building caulking (see Photograph 2 in Appendix B) was observed in the following location:

- Exterior (approximately 65 linear feet).

Photograph 2: Asbestos-Containing Black Building Caulking.

If scheduled for impact, asbestos-containing black building caulking should be abated following low-risk abatement work procedures as outlined in the *Saskatchewan Asbestos Abatement Manual* (2017). Alternatively, as the black building caulking was observed in good condition, and with a priority rating of 5 (please see the room by room spreadsheet provided in Appendix C for a description of the priority ratings), it can be managed in place if not scheduled for impact.

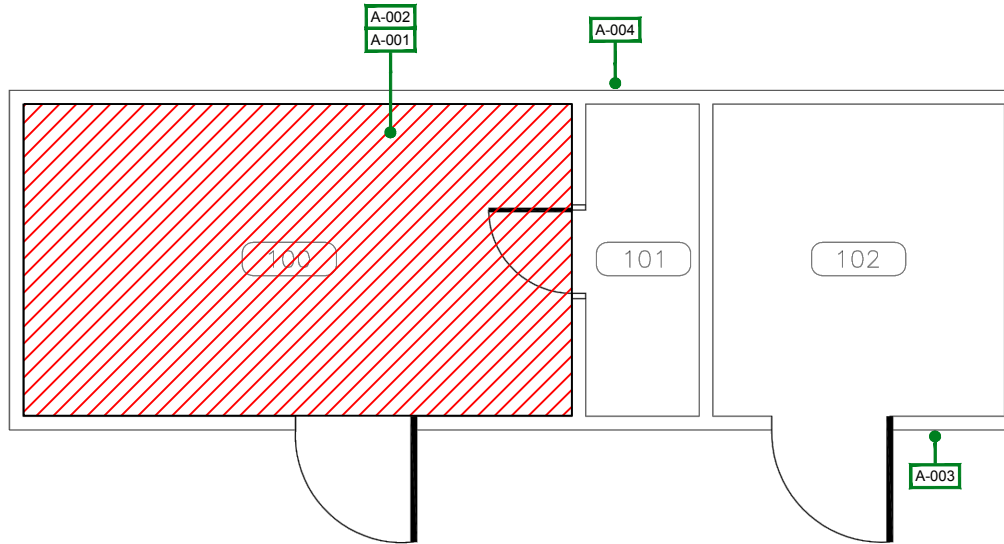
TITLE
MAIN FLOOR

1. ASBESTOS IS A CARCINOGEN. DO NOT BREATHE ASBESTOS DUST.
2. ASBESTOS-CONTAINING BLACK BUILDING CAULKING IS LOCATED ALONG THE EXTERIOR OF THE TRAILER.
