## CITY OF SASKATOON

# Asbestos-Containing Building Materials Assessment Report - Trailer 707

**Report Number: 1667963**

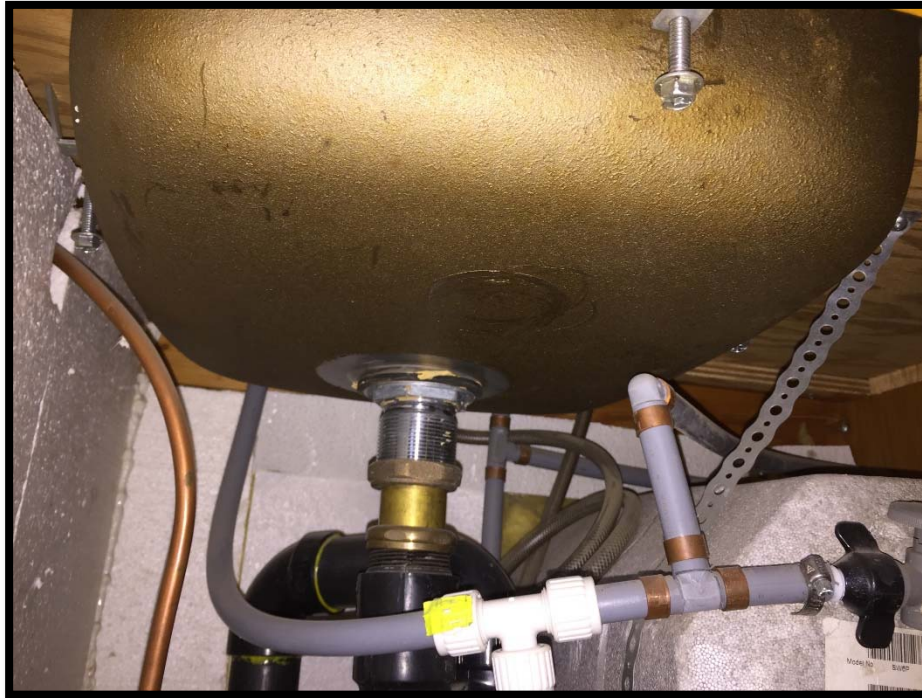
One (1) sample of gold sink undercoat was collected during the assessment. The sample collected was found to contain 2.6% Chrysotile asbestos. Asbestos-containing gold sink undercoat (see Photograph 1 in Appendix B) was observed in the following location:

- Room 100 (approximately 1 sink).

**Photograph 1: Asbestos-Containing Gold Sink Undercoat.**

If scheduled for impact, sinks with asbestos-containing gold undercoat should be abated following low-risk abatement work procedures as outlined in the *Saskatchewan Asbestos Abatement Manual* (2017). Alternatively, as the gold sink undercoat was observed in good condition, and with a priority rating of 5 (please see the room by room spreadsheet provided in Appendix C for a description of the priority ratings), it can be managed in place if not scheduled for impact.

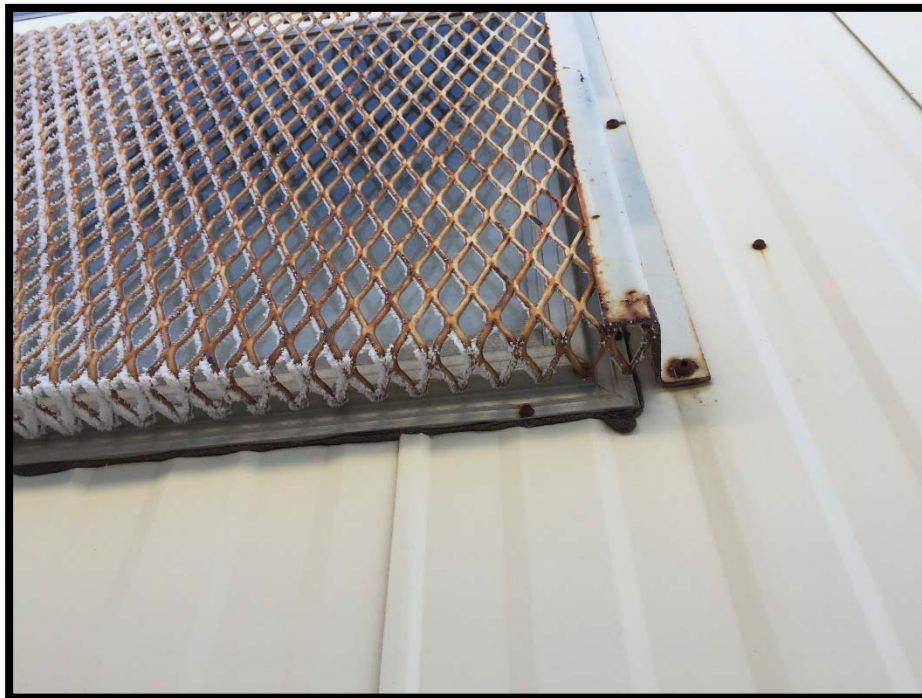
One (1) sample of black building caulking was collected during the assessment. The sample collected was found to contain 4.1% Chrysotile asbestos. Asbestos-containing black building caulking (see Photograph 2 in Appendix B) was observed in the following location:

- Exterior (approximately 50 linear feet).

**Photograph 2: Asbestos-Containing Black Building Caulking.**

If scheduled for impact, asbestos-containing black building caulking should be abated following low-risk abatement work procedures as outlined in the *Saskatchewan Asbestos Abatement Manual* (2017). Alternatively, as the black building caulking was observed in good condition, and with a priority rating of 5 (please see the room by room spreadsheet provided in Appendix C for a description of the priority ratings), it can be managed in place if not scheduled for impact.
