February 5, 2018

CITY OF SASKATOON

Asbestos-Containing Building Materials Assessment Report - Trailer 708

Report Number: 1667963

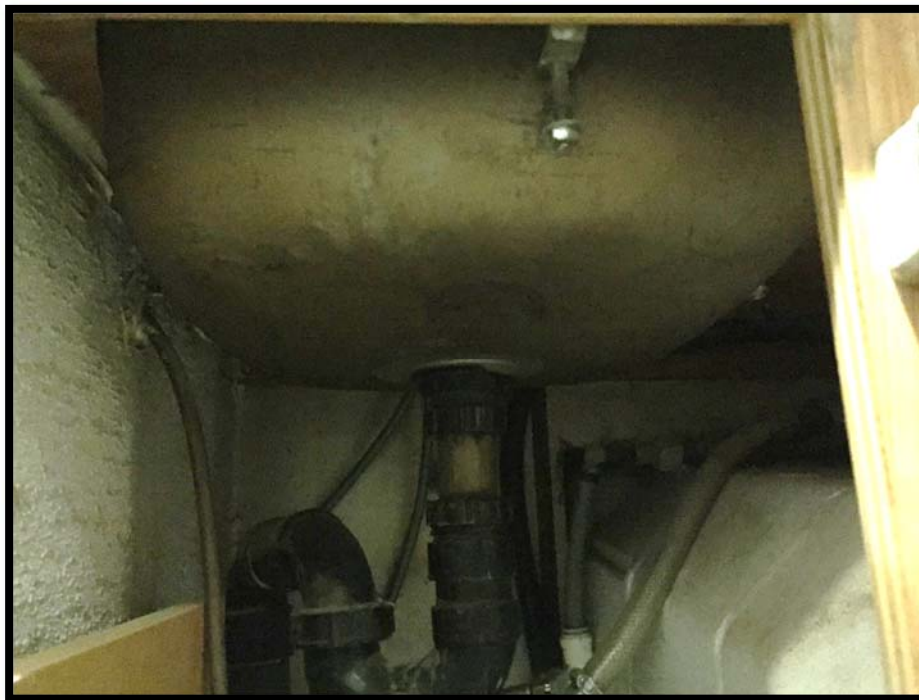
One (1) sample of gold sink undercoat was collected during the assessment. The sample collected was found to contain 2.3% Chrysotile asbestos. Asbestos-containing gold sink undercoat (see Photograph 1 in Appendix B) was observed in the following location:

- Room 100 (approximately 1 sink).

Asbestos was positively identified within the gold sink undercoat on Site. Asbestos was not identified in the remaining samples collected and analyzed.

Photograph 1: Asbestos-Containing Gold Sink Undercoat.

If scheduled for impact, sinks with asbestos-containing gold undercoat should be abated following low-risk abatement work procedures as outlined in the *Saskatchewan Asbestos Abatement Manual (2017)*. Alternatively, as the gold sink undercoat was observed in good condition, and with a priority rating of 5 (please see the room by room spreadsheet provided in Appendix C for a description of the priority ratings), it can be managed in place if not scheduled for impact.
