CITY OF SASKATOON

Asbestos-Containing Building Materials Assessment Report - Trailer 709

Report Number: 1667963

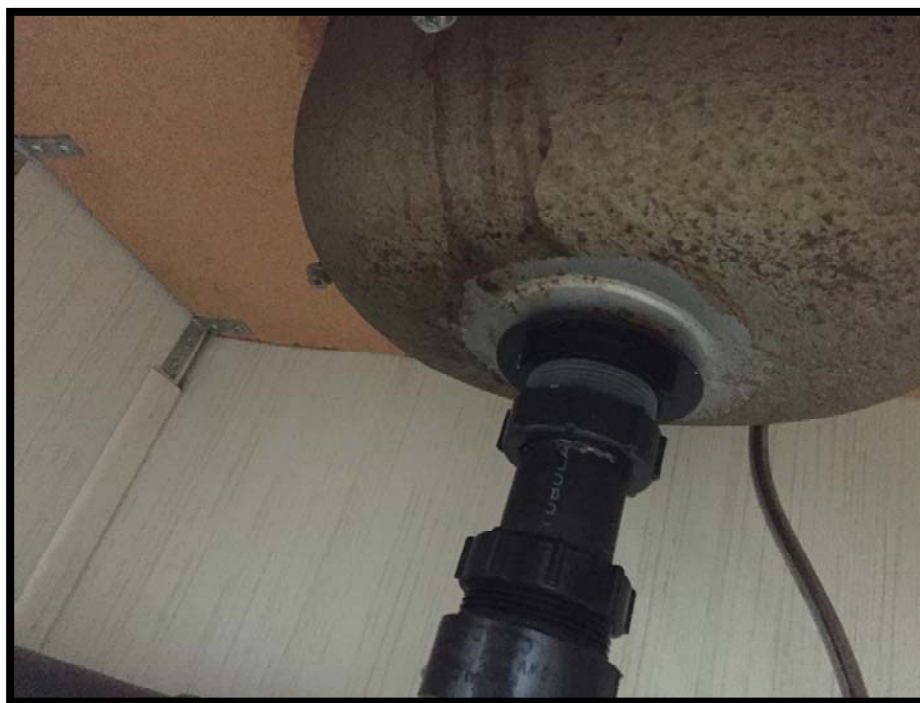
One (1) sample of silver sink undercoat was collected during the assessment. The sample collected was found to contain 1.3% Chrysotile asbestos. Asbestos-containing silver sink undercoat (see Photograph 1 in Appendix B) was observed in the following location:

- Room 100 (approximately 1 sink); and
- Room 101 (approximately 1 sink).

Asbestos was positively identified within the silver sink undercoat on Site. Asbestos was not identified in the remaining samples collected and analyzed.

Photograph 1: Asbestos-Containing Silver Sink Undercoat.

If scheduled for impact, sinks with asbestos-containing silver undercoat should be abated following low-risk abatement work procedures as outlined in the *Saskatchewan Asbestos Abatement Manual (2017)*. Alternatively, as the silver sink undercoat was observed in good condition, and with a priority rating of 5 (please see the room by room spreadsheet provided in Appendix C for a description of the priority ratings), it can be managed in place if not scheduled for impact.
