February 5, 2018

CITY OF SASKATOON

Asbestos-Containing Building Materials Assessment Report - Trailer 711

Report Number: 1667963

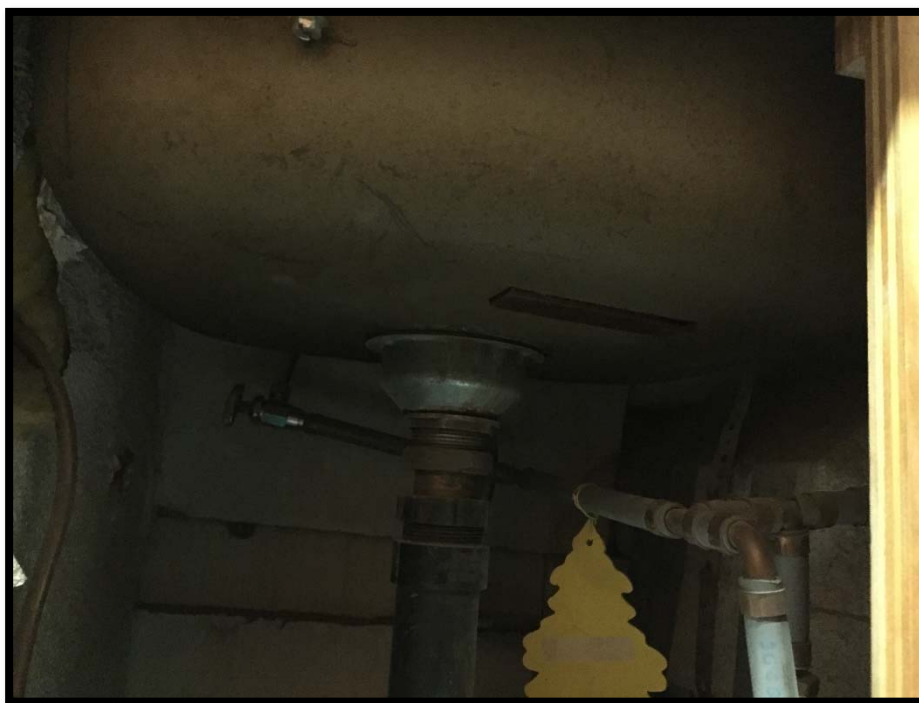
One (1) sample of gold sink undercoat was collected during the assessment. The sample collected was found to contain 3.2% Chrysotile asbestos. Asbestos-containing gold sink undercoat (see Photograph 1 in Appendix B) was observed in the following location:

- Room 100 (approximately 1 sink).

Photograph 1: Asbestos-Containing Gold Sink Undercoat.

| Included/ Excluded | Floor | Room # | Area Description | Elements | Subelements | Material Description | Accessibility | Suspect? | Sampled? | Asbestos Containing Material? | Condition | Field Notes | Sample Type | Sample ID | Sample Date | Asbestos Type | ACM Product | % of asbestos | Friable | Sprayed-on | Maintenance | Inspection | Priority | Potential for Disturbance | Recommended Action | Quantity | Photograph ID | Labelling Type |
|---|---|---|---|---|---|---|---|---|---|---|---|---|---|---|---|---|---|---|---|---|---|---|---|---|---|---|---|---|
| Included | M | 100 | Lunch Room | Plumbing | Sink | Gold Sink Undercoat | High | Yes | Yes | Yes | Good | | Bulk | A-002 | 15-Jan-18 | Chrysotile | Sink Undercoat | 3.2% | No | No | No | Annually | 5 | Moderate | Manage in place. | 1 Sink | Photograph 1 | Door Jamb |

If scheduled for impact, sinks with asbestos-containing gold undercoat should be abated following low-risk abatement work procedures as outlined in the *Saskatchewan Asbestos Abatement Manual* (2017). Alternatively, as the gold sink undercoat was observed in good condition, and with a priority rating of 5 (please see the room by room spreadsheet provided in Appendix C for a description of the priority ratings), it can be managed in place if not scheduled for impact.
