**TRANSIT STORAGE & ADMINISTRATION  
BUILDING  
ASBESTOS SURVEY REPORT**

**April 2014**

**Prepared For: City of Saskatoon – Infrastructure Services Department**  
1101 Avenue P North, Saskatoon SK, Canada S7L 7K6  
Attn: Brent Anderson

**Prepared By: Bersch & Associates Ltd.**  
**Project No. : B67SRD23**

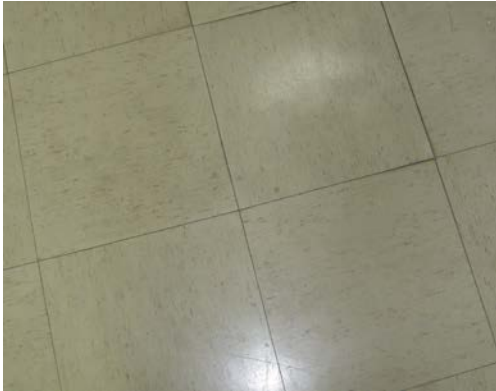
#14 & #23) Floor Tile

**Vinyl Asbestos Floor Tile** is located within the room. This material is considered a non-friable material and will not produce an elevated airborne fibre release unless mechanically disturbed. Recommendation is for the management of this material until renovations warrant removal.

<b>PRIORITY:</b>	<b>THREE</b>
<b>CONDITION:</b>	<b>GOOD</b>
<b>POTENTIAL FOR DISTURBANCE:</b>	<b>LOW</b>
<b>ACTION:</b>	<b>MANAGE</b>

**Vinyl Asbestos Floor Tile** is located within the room below the stair case. This material is considered a non-friable material and will not produce an elevated airborne fibre release unless mechanically disturbed. Recommendation is for the management of this material until renovations warrant removal.

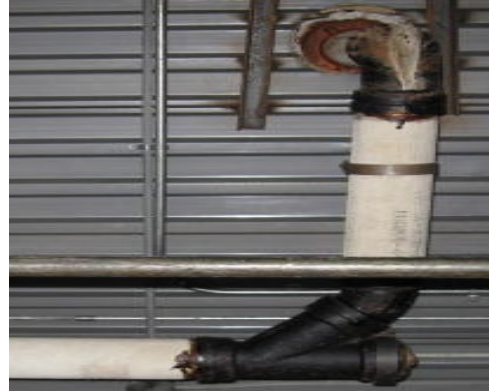
#2) Transite Pipe

**Transite Drain Pipe** is located within the Offices and Corridors above the suspended ceiling tile. This material is considered a non-friable material and will not produce an elevated airborne fibre release unless mechanically disturbed. Recommendation is for the management of this material until renovations warrant removal.

<b>PRIORITY:</b>	<b>THREE</b>
<b>CONDITION:</b>	<b>GOOD</b>
<b>POTENTIAL FOR DISTURBANCE:</b>	<b>LOW</b>
<b>ACTION:</b>	<b>MANAGE</b>
