## CITY OF SASKATOON

# Asbestos-Containing Building Materials Assessment Report - Transit Body Shop

**Report Number: 1667963**

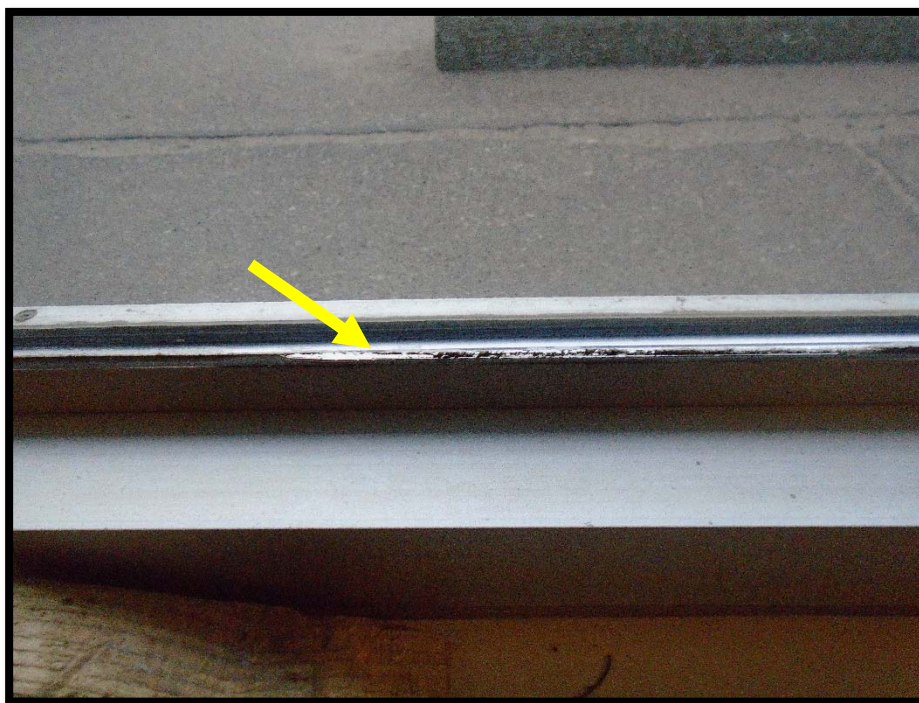
One (1) sample of black window caulking was collected during the assessment. The sample collected was found to contain 5.6% Chrysotile asbestos. Asbestos-containing black window caulking (see Photograph 1 in Appendix B) was observed in the following locations:

- Room 102 (approximately 15 linear ft).

**Photograph 1: Asbestos-Containing Black Window Caulking.**

If scheduled for impact, asbestos-containing black window caulking should be abated following low-risk abatement work procedures as outlined in the *Saskatchewan Asbestos Abatement Manual* (2017). Alternatively, as the caulking was observed in good condition, and with a priority rating of 5 (please see the room by room spreadsheet provided in Appendix C for a description of the priority ratings), the caulking can be managed in place if not scheduled for impact.
