**TRANSIT REPAIR TERMINAL NORTH
BUILDING
ASBESTOS SURVEY REPORT**

April 2014

Prepared By: Bersch & Associates Ltd.
Project No. : B67SRD21

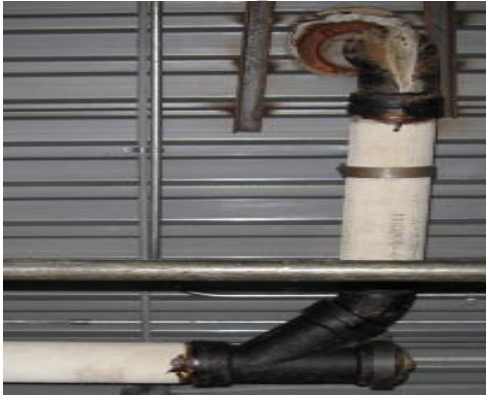
#2) Transite Pipe

Transite Drain Pipe is located at ceiling height running throughout the Shop Areas. This material is considered a non-friable material and will not produce an elevated airborne fibre release unless mechanically disturbed. Recommendation is for the management of this material until renovations warrant removal.

NO.	DATE	SAMPLE INFORMATION	ASBESTOS	%	ANALYST
1	21-May-13	Room # 110 - 1' x 1' Floor Tile, off white with dark streak	None detected		WB
2	21-May-13	Room # 111 - Transite Roof Drain Pipe	Chrysotile	40%	WB
3	21-May-13	Room # 111 - Lineal Pipeline Insulation on Hot Water Supply Line adjacent to Room # 114	None detected		WB
4	21-Apr-14	Room # 117- Office - 1' x 1' Floor Tile, off white with dark streak	None detected		WB
5	21-Apr-14	Room # 117- Office - 2' x 4' Ceiling Tile with pin hole and gash mark pattern	None detected		WB
6	21-Apr-14	Room # 117- Office - Ducting Insulation above suspended ceiling in northwest corner	None detected		WB
7	21-Apr-14	Room # 111- Repair Area - Green Tool Board on center of west wall	None detected		WB

PRIORITY:	THREE
CONDITION:	GOOD
POTENTIAL FOR DISTURBANCE:	LOW
ACTION:	MANAGE
