December 5, 2017

CITY OF SASKATOON

Asbestos-Containing Building Materials Assessment Report - Umea Vast Park Maintenance Building

Report Number: 1667963

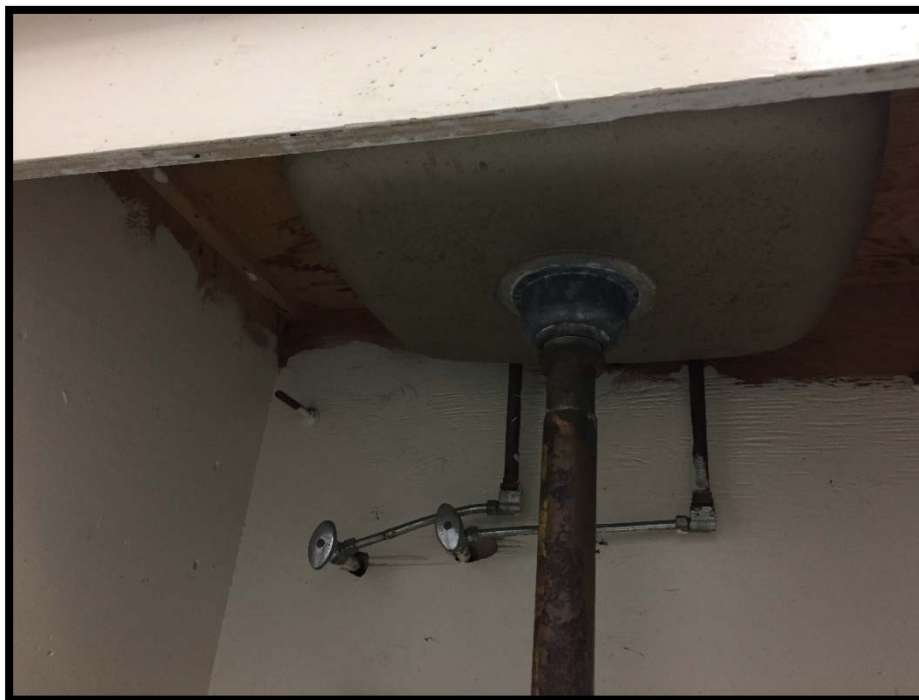
One (1) sample of silver sink undercoat was collected during the assessment. The sample collected was found to contain 1.7% Chrysotile asbestos. Asbestos-containing silver sink undercoat (see Photograph 2 in Appendix B) was observed in the following locations:

- Room 103 (approximately 1 sink).

Photograph 2: Asbestos-Containing Silver Sink Undercoat.

If scheduled for impact, asbestos-containing silver sink undercoat should be abated following low-risk abatement work procedures as outlined in the *Saskatchewan Asbestos Abatement Manual* (2017). Alternatively, as the silver sink undercoat was observed in good condition, and with a priority rating of 5 (please see the room by room spreadsheet provided in Appendix C for a description of the priority ratings), it can be managed in place if not scheduled for impact.
