## CITY OF SASKATOON

# Asbestos-Containing Building Materials Assessment Report - Vic Rempel Administration Building

**Report Number: 1667963**

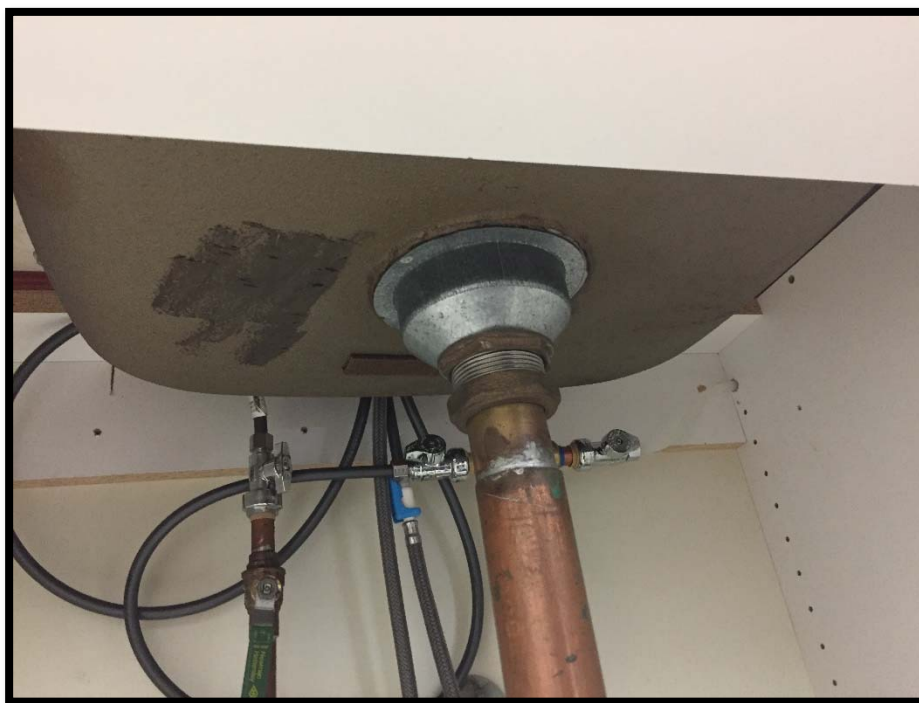
One (1) sample of gold sink undercoat was collected during the assessment. The sample collected was found to contain 4.1% Chrysotile asbestos. Asbestos-containing gold sink undercoat (see Photograph 1 in Appendix B) was observed in the following locations:

- Room 138 (approximately 1 sink).

**Photograph 1: Asbestos-Containing Gold Sink Undercoat.**

If scheduled for impact, asbestos-containing gold sink undercoat should be abated following low-risk abatement work procedures as outlined in the *Saskatchewan Asbestos Abatement Manual* (2017). Alternatively, as the gold sink undercoat was observed in good condition, and with a priority rating of 5 (please see the room by room spreadsheet provided in Appendix C for a description of the priority ratings), it can be managed in place if not scheduled for impact.
