## CITY OF SASKATOON

# Asbestos-Containing Building Materials Assessment Report - Victoria Park Boathouse

**Report Number: 1667963**

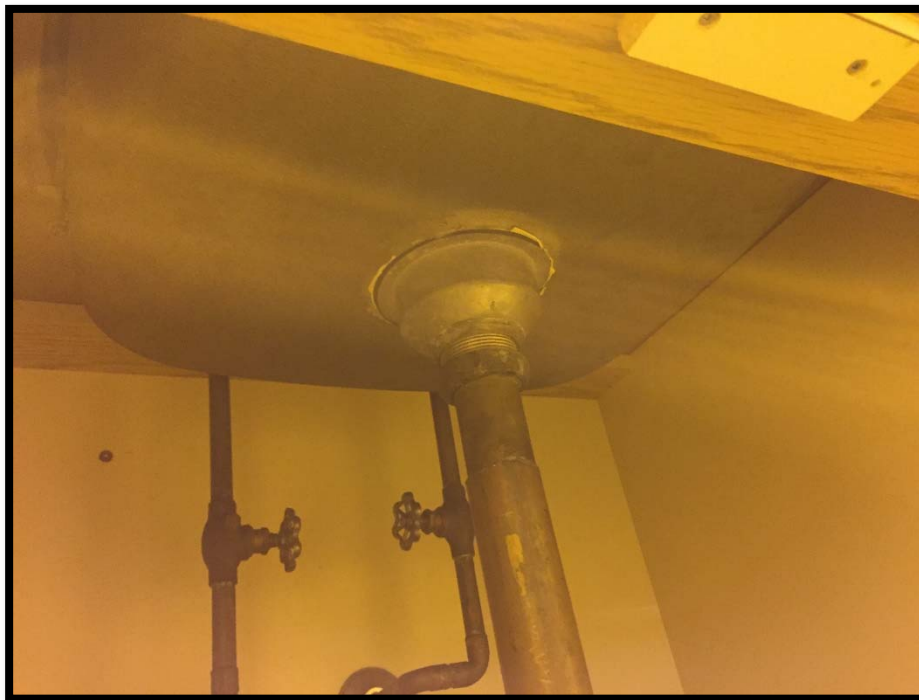
One (1) sample of gold sink undercoat was collected during the assessment. The sample collected was found to contain 2.1% Chrysotile asbestos. Asbestos-containing gold sink undercoat (see Photograph 1 in Appendix B) was observed in the following location:

- Room 106 (approximately 1 sink).

<b>Lab No.:</b> 6372496 <b>Client No.:</b> A-009	<b>Analyst Observation:</b> Gold Mastic <b>Client Description:</b> Gold Sink Undercoat	<b>Location:</b> Room 106 <b>Facility:</b>
<u>Percent Asbestos:</u> <b>PC 2.1 Chrysotile</b>	<u>Percent Non-Asbestos Fibrous Material:</u> None Detected	<u>Percent Non-Fibrous Material:</u> 97.9
<b>Lab No.:</b> 6372497 <b>Client No.:</b> A-010	<b>Analyst Observation:</b> White Joint Compound <b>Client Description:</b> Drywall Joint Compound	<b>Location:</b> Room 106 <b>Facility:</b>
<u>Percent Asbestos:</u> None Detected	<u>Percent Non-Asbestos Fibrous Material:</u> None Detected	<u>Percent Non-Fibrous Material:</u> 100
<b>Lab No.:</b> 6372498 <b>Client No.:</b> A-011	<b>Analyst Observation:</b> Grey Insulation <b>Client Description:</b> Pipe-Fitting Insulation	<b>Location:</b> Room 107 <b>Facility:</b>
<u>Percent Asbestos:</u> None Detected	<u>Percent Non-Asbestos Fibrous Material:</u> 30 Fibrous Glass	<u>Percent Non-Fibrous Material:</u> 70

**Photograph 1: Asbestos-Containing Gold Sink Undercoat.**

If scheduled for impact, asbestos-containing gold sink undercoat should be abated following low-risk abatement work procedures as outlined in the *Saskatchewan Asbestos Abatement Manual* (2017). Alternatively, as the gold sink undercoat was observed in good condition, and with a priority rating of 5 (please see the room by room spreadsheet provided in Appendix C for a description of the priority ratings), it can be managed in place if not scheduled for impact.

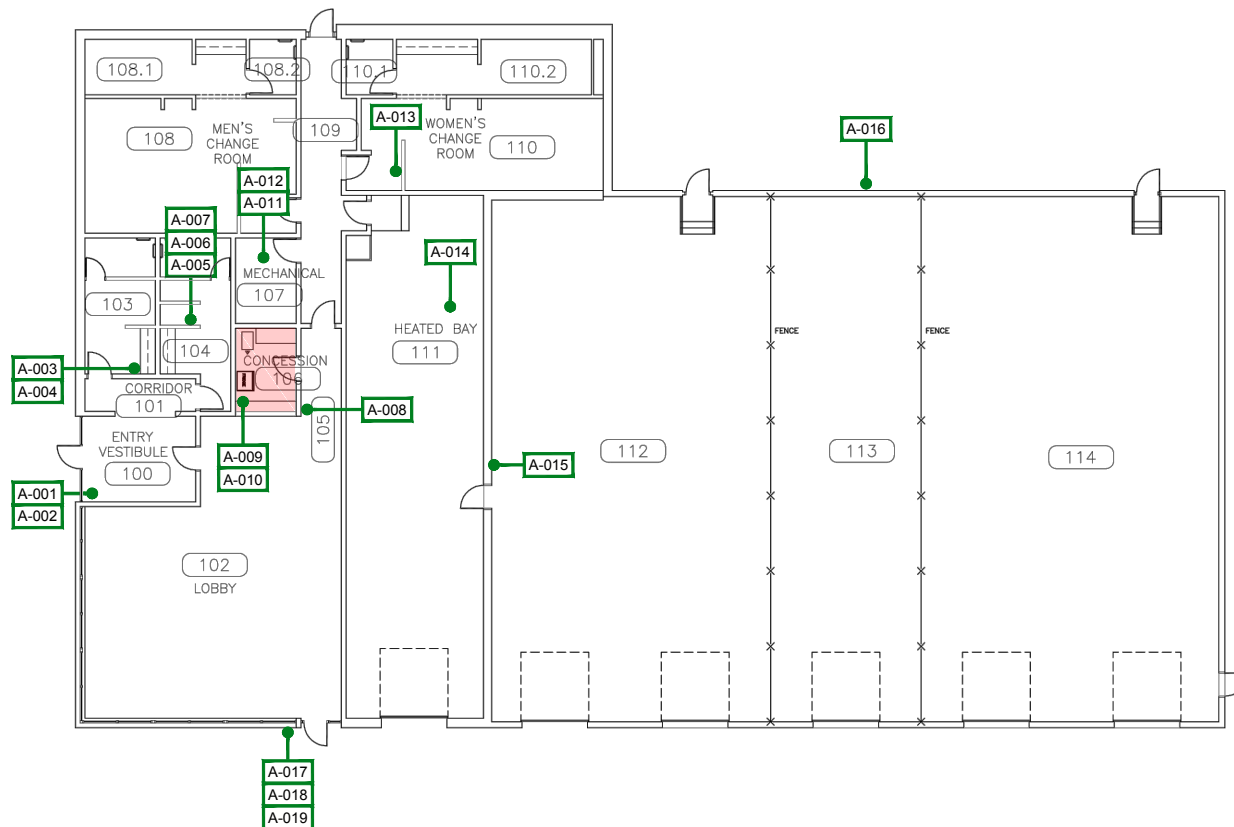
TITLE  
**MAIN FLOOR**

■ ASBESTOS - CONTAINING SINK UNDERCOAT
