Bersch Consulting Ltd.

Pre-Demolition Assessment

Project: V. Rempel Yards Equip. Storage

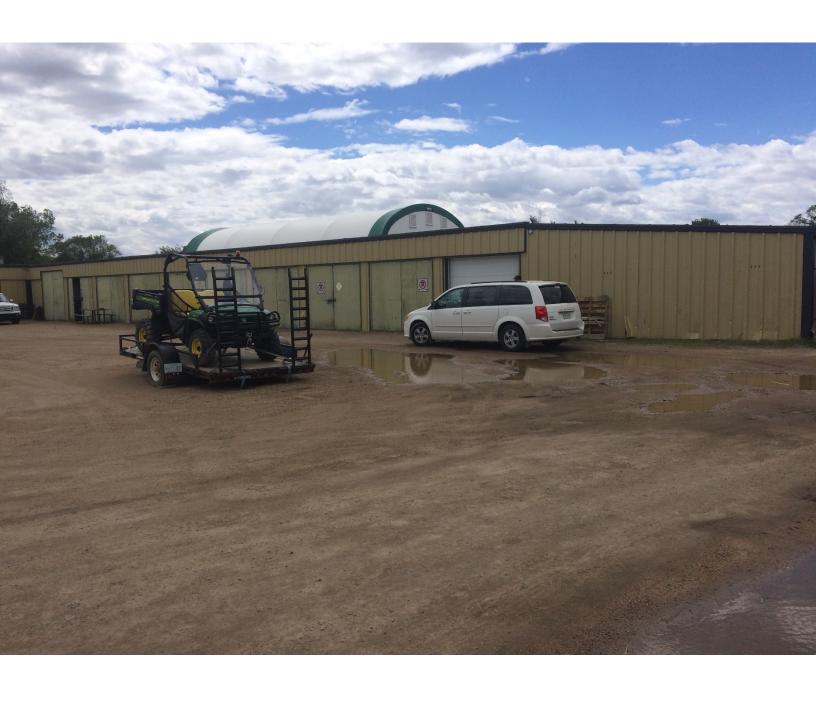
Photo 001- V. Rempel Yards Equip. Storage

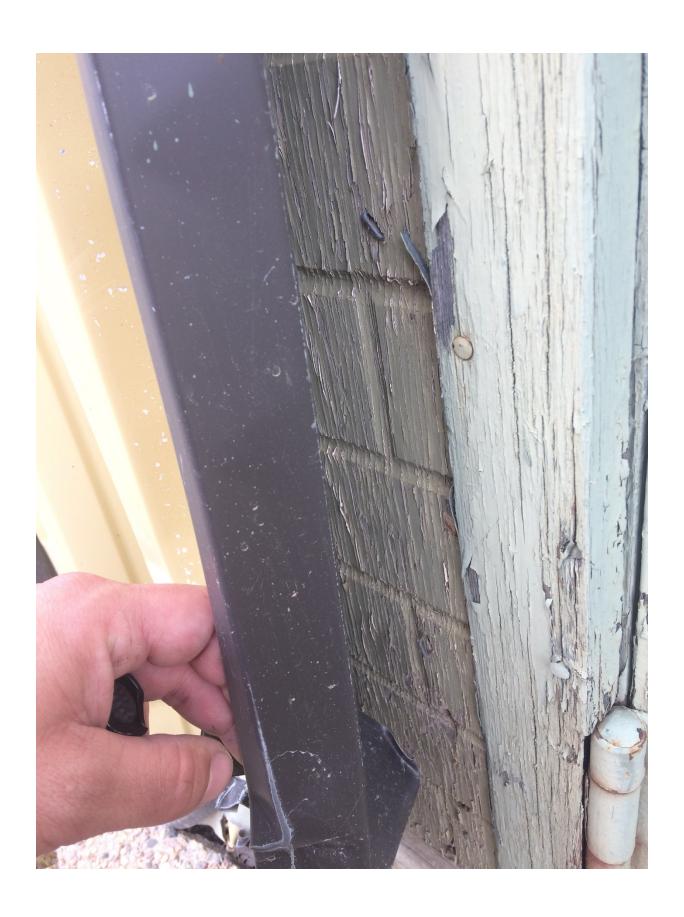
Photo 002- Faux Brick Façade behind Metal Cladding

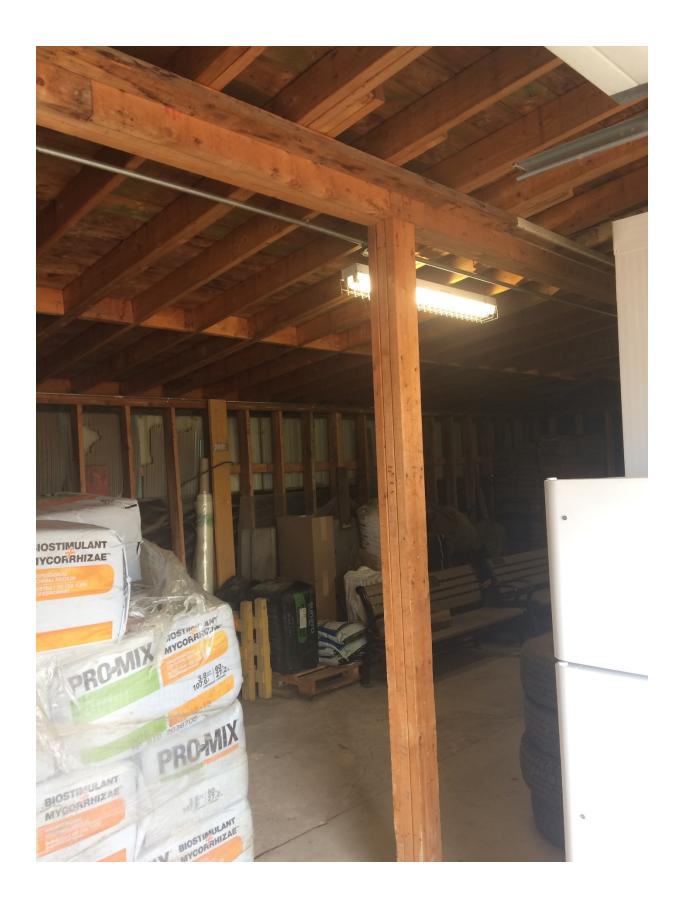
Photo 003-Interior of Unit 101

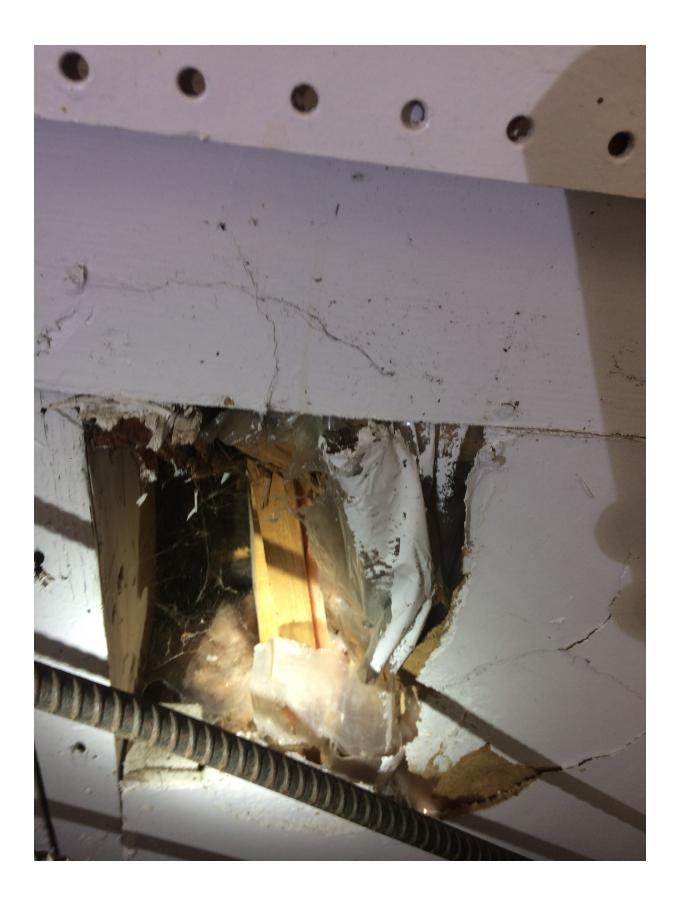
The V. Rempel Yards Equipment Storage is a wood framed storage building built directly over a concrete pad. With the exception of unit 107 the building is not insulated. The insulation within unit 107 consists of non-asbestos fiberglass insulation. The construction of the building consists of wood framing with metal cladding exterior. The lower five feet of the interior includes a tar-paper wrapped plywood sheet fastened between the cladding and wood studs. Cladding has been fastened to a previous faux brick, particle board façade in some areas. The roof of the building consists of lapping wood boards with a tar-paper layer followed by plywood, tar roofing and rolled on shingles. Please see *Appendix III* for site photos. Samples of tar-paper, concrete, ceiling tile, tar-roofing and shingle were collected. Please see *Appendix III* for sample locations. All sample were tested for the presence/absence of asbestos. Asbestos was not detected within the samples.

Photo 004- Wall Insulation- Unit 107

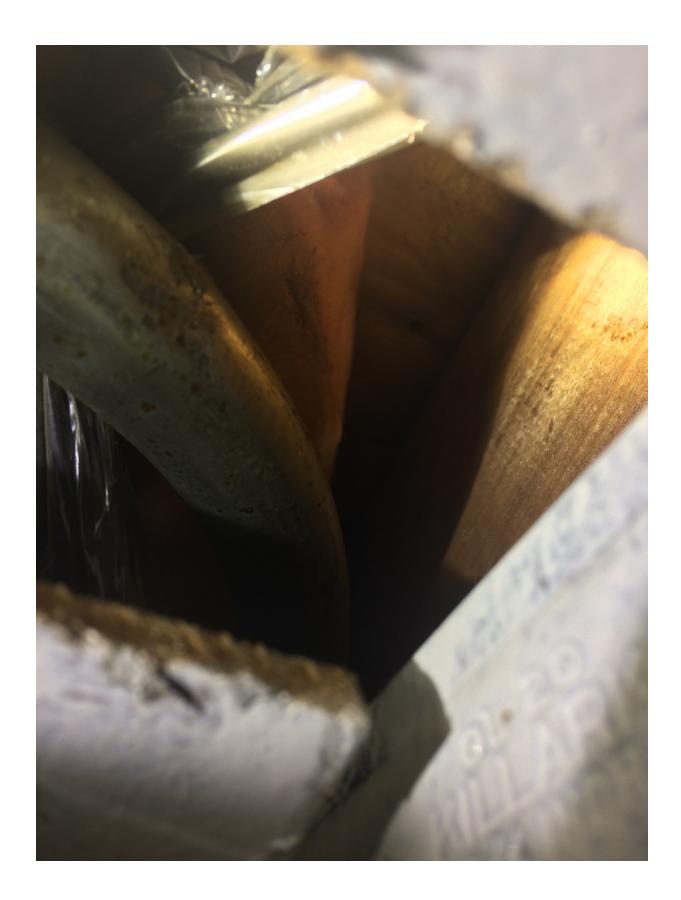
Photo 005- Roof Insulation- Unit 007

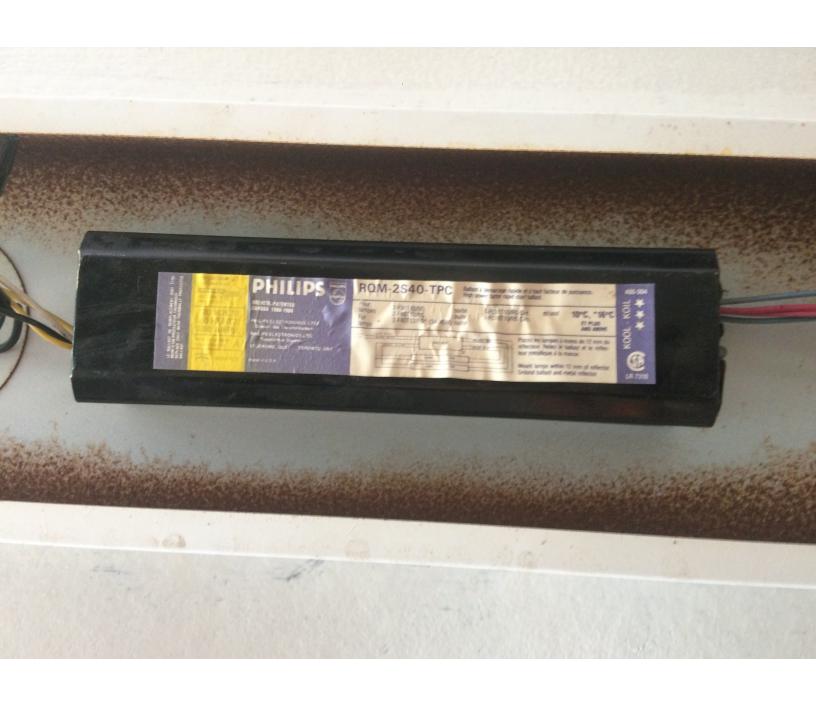
lighting equipped with electronic ballasts. Fixtures containing outdated T8 florescent tubes were examined and found to contain ballasts labelled "non-PCB".

Photo 006- Non-PCB Light Ballast- Unit 007

The building is illuminated by florescent lighting in most areas. Prior to demolition florescent tubes should be removed and recycled appropriately. In most areas florescent light consists of modern T6 florescent

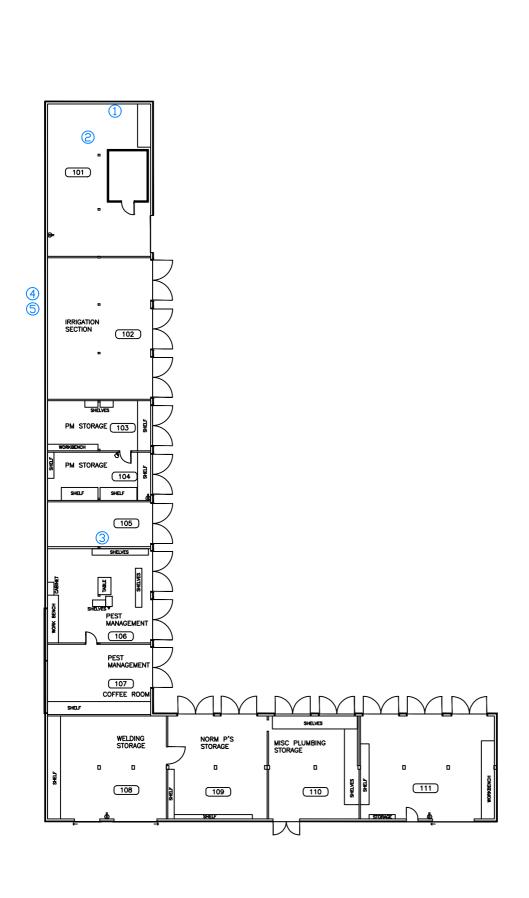
V, Rempel Yards # Sample Location Equip, Storage Main Floor Pre-Demolition Survey

Sample Number	Sample Date	Sample Material	Sample Location and Information	Asbestos	%	Analyst
1	2018/06/12	Tar Paper	Room 101 North Wall	No Asbestos Detected		EMSL
2	2018/06/12	Concrete	Room 101	No Asbestos Detected		EMSL
3	2018/06/12	Ceiling Tile	Room 105 2'x4' Pinhole Gash	No Asbestos Detected		EMSL
4	2018/06/12	Roofing Tar	Rooftop	No Asbestos Detected		EMSL
5	2018/06/12	Roll on Shingle	Rooftop	No Asbestos Detected		EMSL
