## CITY OF SASKATOON

# Asbestos-Containing Building Materials Assessment Report - William A. Reid Park Rec Unit

**Report Number: 1667963**

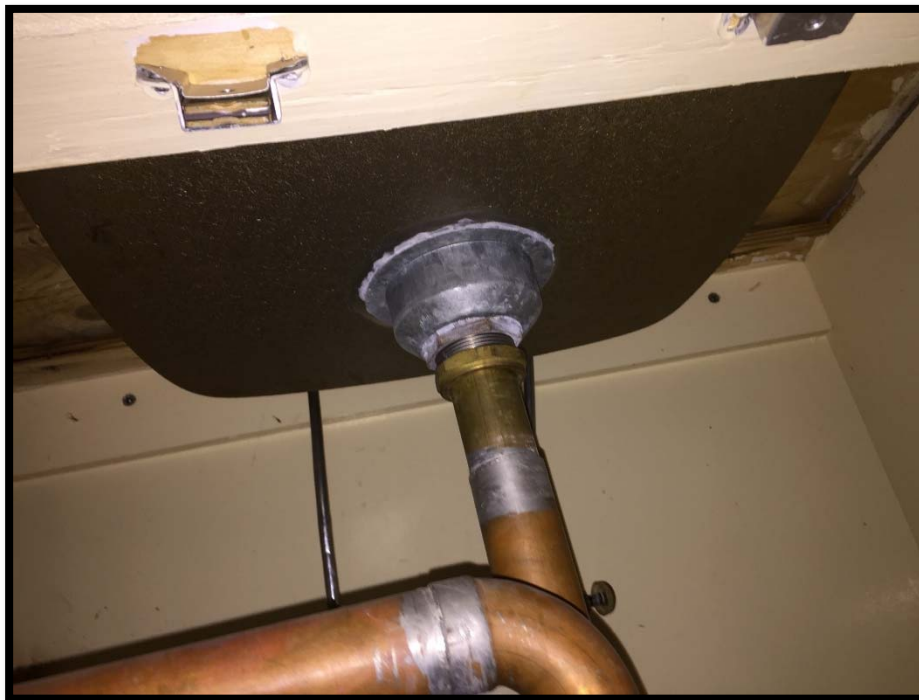
One (1) sample of gold sink undercoat was collected during the assessment. The sample collected was found to contain 1.9% Chrysotile asbestos. Asbestos-containing gold sink undercoat (see Photograph 1 in Appendix B) was observed in the following location:

- Room 106 (approximately 1 sink).

**Photograph 1: Asbestos-Containing Gold Sink Undercoat.**

If scheduled for impact, asbestos-containing gold sink undercoat should be abated following low-risk abatement work procedures as outlined in the *Saskatchewan Asbestos Abatement Manual* (2017). Alternatively, as the gold sink undercoat was observed in good condition, and with a priority rating of 5 (please see the room by room spreadsheet provided in Appendix C for a description of the priority ratings), it can be managed in place if not scheduled for impact.
