**Weaver Park  
Asbestos Survey Report**

**February 2014**

**Prepared For: City Of Saskatoon- Infrastructure Services Department**  
1101 Avenue P North, Saskatoon, SK.  
Attn: Brent Anderson

**Prepared By: Bersch & Associates Ltd.**  
**Project No. : B67SRE22**

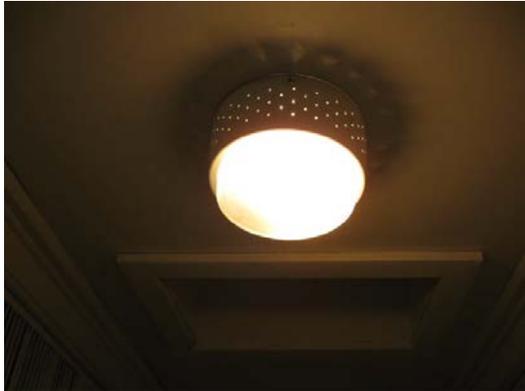
#1) Light Fixture Heat Shield

- **Transite Board** is located on the ceiling of the Furnace Room.
- **Heat Shield Material** is found within nine light fixtures throughout the facility.

NO.	DATE	SAMPLE INFORMATION	ASBESTOS	%	ANALYST
1	22-May-13	Corridor adjacent Washroom - Heat shield material within light fixture	Chrysotile	60	WB
2	22-May-13	4 - Furnace Room - Transite board on ceiling	Chrysotile	30	WB
3	22-May-13	3 - Waiting Room - Composite flooring compound	None detected		WB
4	11-Feb-14	2 - Men's Washroom - Wall parging	None detected		WB

On December 14<sup>th</sup>, 2016, Kevin Olexson with Hub City Contracting was on site to remove nine (9) asbestos heat shields and the subsequent light fixtures from within the Weaver Park Rec Unit.

Mitch Webber of Bersch & Associates Ltd. was on site near the completion of the removal to observe work procedures implemented and to verify that all the asbestos heat shields had been removed from within Weaver Park Rec Unit. The heat shield removal was completed at 14:30 hr without incident. Inspection concluded that no asbestos containing heat shield materials remains within the facility. It should be noted that fibre glass insulation is present above the wood ceiling that surrounds the light fixture electrical junction boxes. Bersch & Associates Ltd confirms that the Weaver Park Rec Unit remains suitable for occupancy by staff and patron.

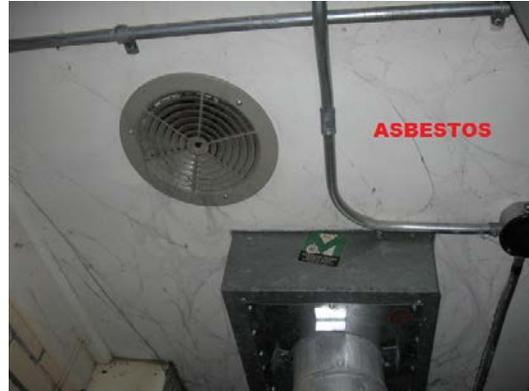
#2) Transite Board

M	4	Furnace Room	Sample	B67-ASB.2	22-May-13	Chrysotile	30%	Transite Board	Good	3	Corridor adjacent Washroom - Light fixture heat shield material	Transite Board on Ceiling	Low/Mod	Manage	Heat shield material is contained within eight light fixtures. Replace the globe of one light fixture to prevent disturbance.
M	5	Dressing Rooms	Sample Rep	B67-ASB.1	22-May-13	Chrysotile	60%	Heat Shield Material	Good	2		Heat Shield Material in Light Fixture	Moderate	Manage	All attic accesses have been nailed shut and were inaccessible at time of survey.
A		Attic
