CITY OF SASKATOON

Asbestos-Containing Building Materials Assessment Report - Landfill Weight Scale Building

Report Number: 1667963

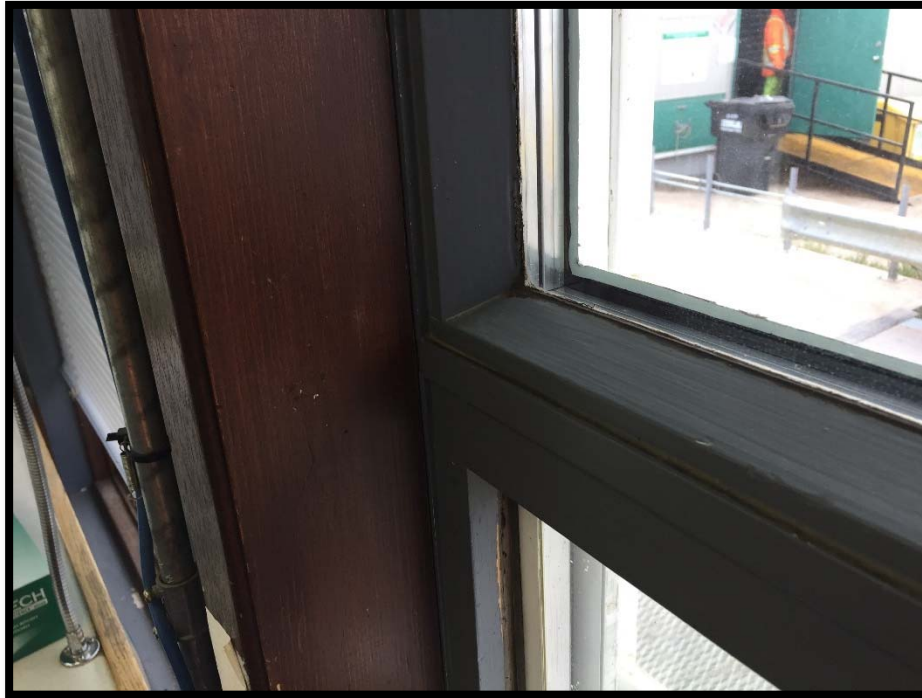
One (1) sample of black interior window caulking was collected during the assessment. The sample collected was found to contain 4.4% Chrysotile asbestos. Asbestos-containing black interior window caulking (see Photograph 1 in Appendix B) was observed in the following location:

- Room 100 (approximately 50 linear ft).

Photograph 1: Asbestos-Containing Black Interior Window Caulking.

If scheduled for impact, asbestos-containing black interior window caulking should be abated following low-risk abatement work procedures as outlined in the *Saskatchewan Asbestos Abatement Manual* (2017). Alternatively, as the black interior window caulking was observed in good condition, and with a priority rating of 5 (please see the room by room spreadsheet provided in Appendix C for a description of the priority ratings), it can be managed in place if not scheduled for impact.

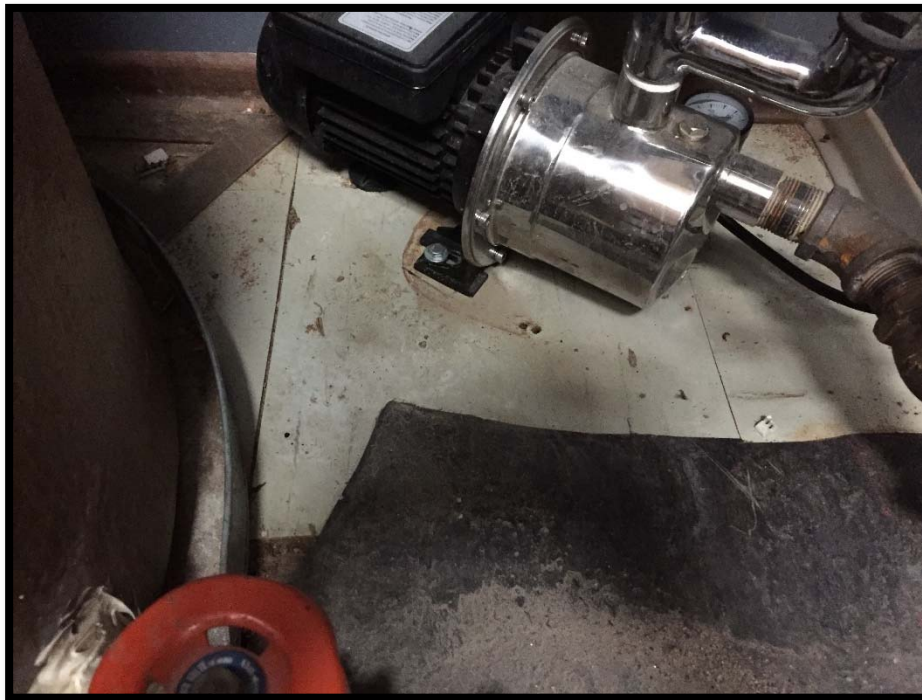
One (1) sample of 12"x12" off-white floor tile with black streaks was collected during the assessment. The sample collected was found to contain 2.2% Chrysotile asbestos. Asbestos-containing 12"x12" off-white floor tile with black streaks (see Photograph 2 in Appendix B) was observed in the following location:

- Room 103 (approximately 50 ft²).

It appears that the asbestos-containing 12"x12" off-white floor tile with black streaks is only located within Room 103, however additional floor tile may be located below the black vinyl flooring throughout the Site.

Photograph 2: Asbestos-Containing 12"x12" Off-White Floor Tile with Black Streaks.

If scheduled for impact, asbestos-containing 12"x12" off-white floor tile with black streaks should be abated following low-risk abatement work procedures as outlined in the *Saskatchewan Asbestos Abatement Manual* (2017). Alternatively, as the 12"x12" off-white floor tile with black streaks was observed in good condition, and with a priority rating of 5 (please see the room by room spreadsheet provided in Appendix C for a description of the priority ratings), it can be managed in place if not scheduled for impact.

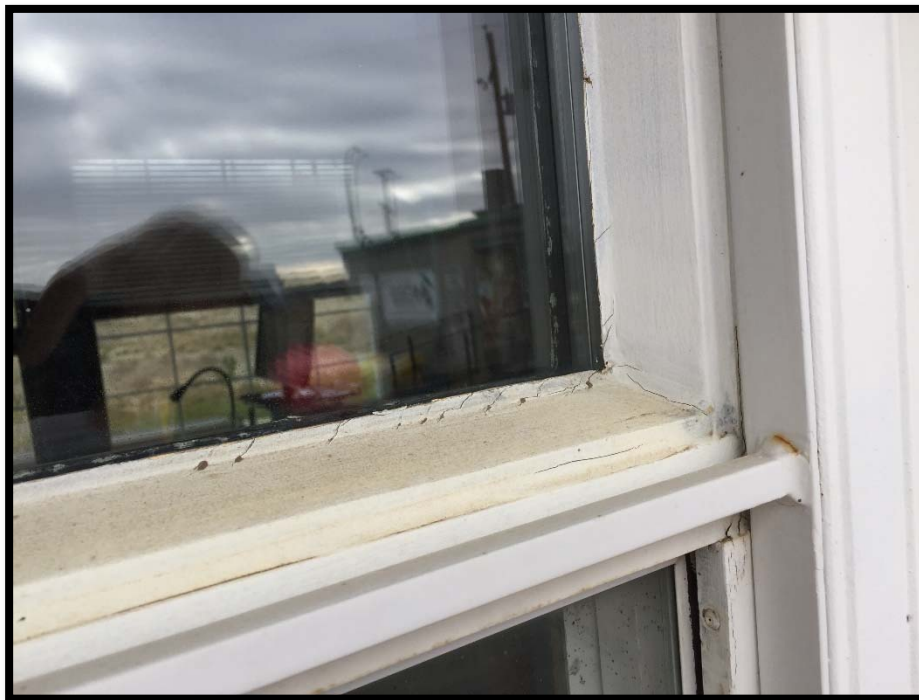
One (1) sample of white exterior window caulking was collected during the assessment. The sample collected was found to contain 1.8% Chrysotile asbestos. Asbestos-containing white exterior window caulking (see Photograph 3 in Appendix B) was observed in the following location:

- Exterior (approximately 50 linear ft).

Photograph 3: Asbestos-Containing White Exterior Window Caulking.

If scheduled for impact, asbestos-containing white exterior window caulking should be abated following low-risk abatement work procedures as outlined in the *Saskatchewan Asbestos Abatement Manual* (2017). Alternatively, as the white exterior window caulking was observed in good condition, and with a priority rating of 5 (please see the room by room spreadsheet provided in Appendix C for a description of the priority ratings), it can be managed in place if not scheduled for impact.
