November 28, 2017

CITY OF SASKATOON

Asbestos-Containing Building Materials Assessment Report - Water Treatment Acadia Pumphouse

Report Number: 1667963

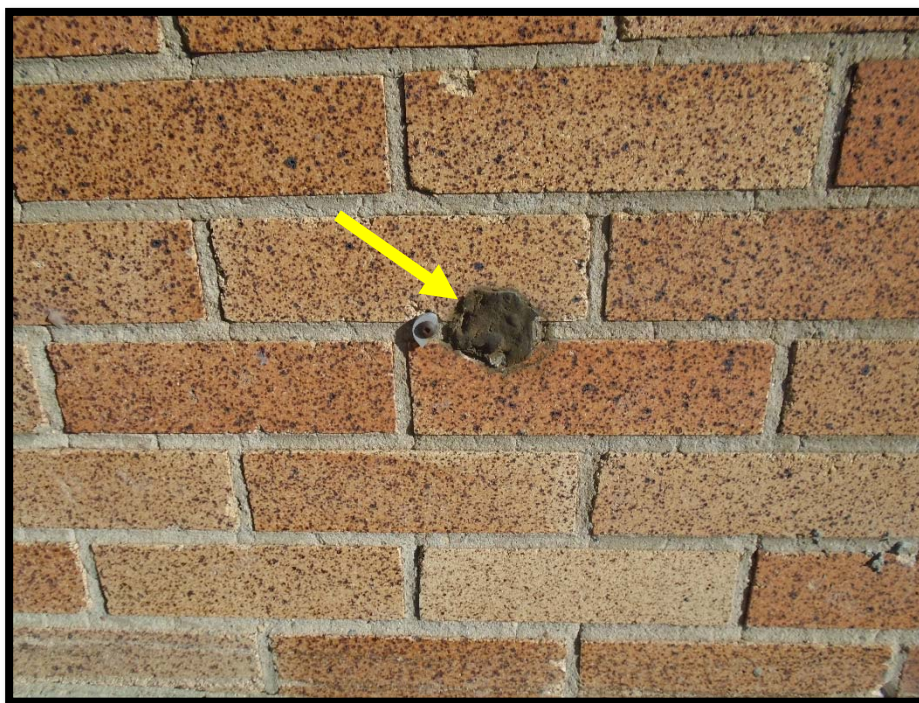
One (1) sample of grey firestop putty was collected during the assessment. The sample collected was found to contain 8.7% Chrysotile asbestos. Asbestos-containing grey firestop putty (see Photograph 1 in Appendix B) was observed in the following locations:

- Exterior (1 ft²).

Asbestos was positively identified within the exterior grey firestop putty on Site. Asbestos was not identified in the remaining samples collected and analyzed.

Photograph 1: Asbestos-Containing Grey Firestop Putty

If scheduled for impact, asbestos-containing exterior grey firestop putty should be abated following low-risk abatement work procedures as outlined in the *Saskatchewan Asbestos Abatement Manual* (2017). Alternatively, as the firestop was observed in good condition, and with a priority rating of 5 (please see the room by room spreadsheet provided in Appendix C for a description of the priority ratings), the firestop can be managed in place if not scheduled for impact.
