FINAL **Hazardous Building** **Materials** **Assessment**

Water Treatment Plant
1030 Avenue H South,
Saskatoon, SK

September 26, 2016

PWL File: 7587F

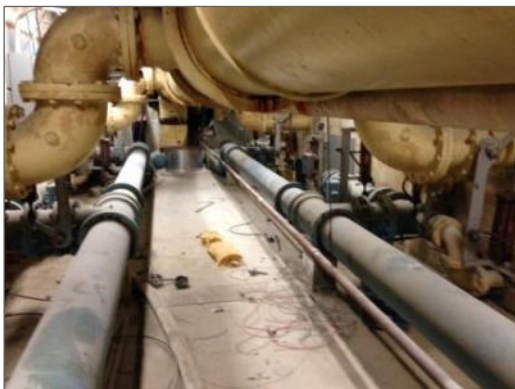
All paint samples collected on the pipes in the 1928 Pipe Gallery (loc. 1) are lead containing. The paint on the concrete walls in the settling tanks in the 1928 Plant Settling Tank Area (loc. 2) is also lead containing.

Photo 1 – View of lead based paints in the pipe gallery.

Dispose of painted non-metallic materials exceeding the criteria for leachable lead as hazardous waste. Well adhered paints containing elevated levels of lead on metal substrates do not require leachable lead analysis as the materials can be recycled with the paint intact.

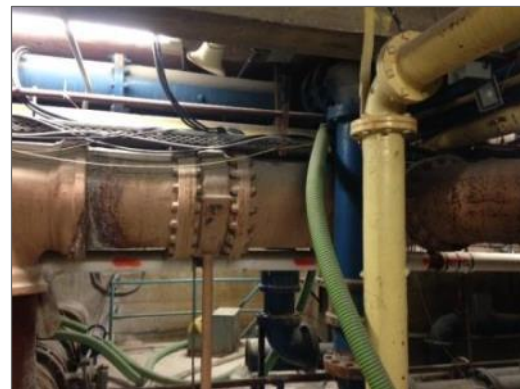
Photo 2 – view of various lead based paint in the pipe gallery

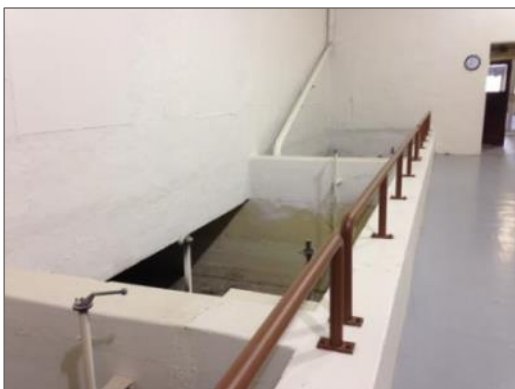
Photo 3– View of lead based paints in the 1928 plant settling tank area.

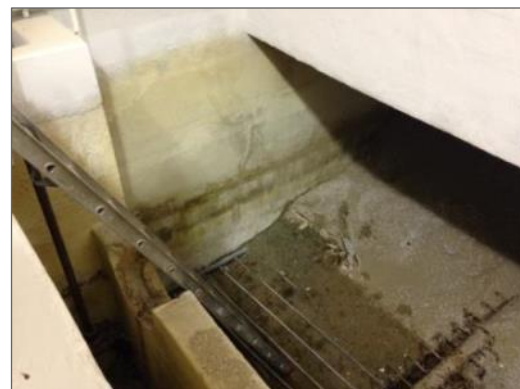
Photo 4– View of white and green lead based paint in a filter tank.
