PRE-RENOVATION ASSESSMENT

502 48TH STREET EAST

Project: 502 48th Street East Pre-Renovation / Pre-Occupancy

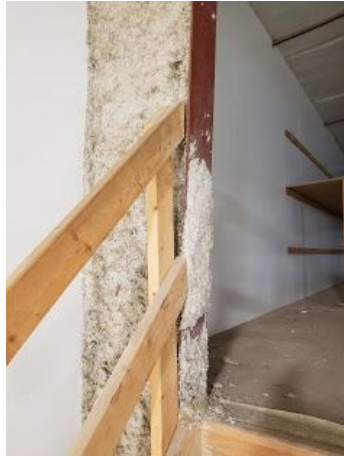
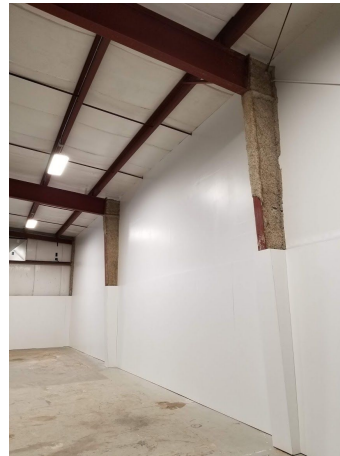
- 1) The fireproofing on the columns along the east wall of the shop was suspect and sampled.
- 2) The drywall joint compound was sampled.
- 3) The floor tile throughout the office area is newer tile.
- 4) The insulation throughout the walls and roof is fiberglass.

- 1) **Spray Applied Fireproofing on Columns on East Shop Wall (non-asbestos) Sample 1**

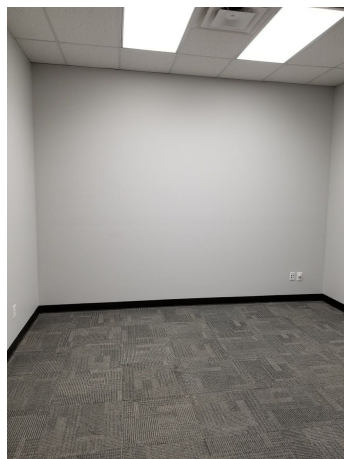
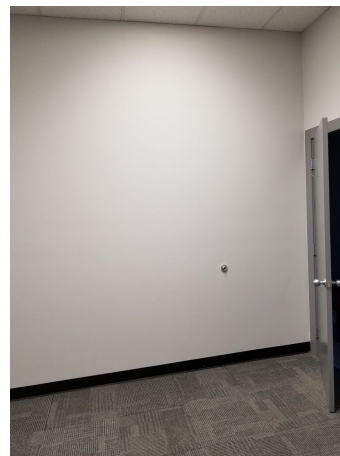
- 2) **Drywall Joint Compound Sampled from west wall of Boardroom & east wall of West Office (non-asbestos) Sample 2**

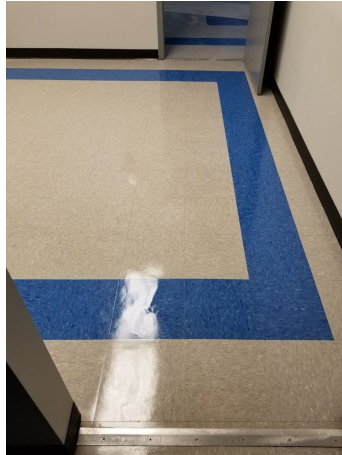
3) 1' X 1' floor tile (non-asbestos)

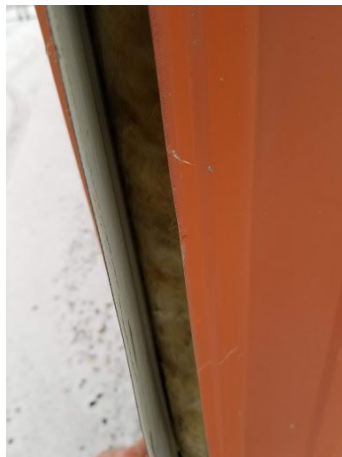
4) Fiberglass Exterior Wall Insulation (non-asbestos)
