December 5, 2017

CITY OF SASKATOON

Asbestos-Containing Building Materials Assessment Report - Water Treatment Reservoir B

Report Number: 1667963

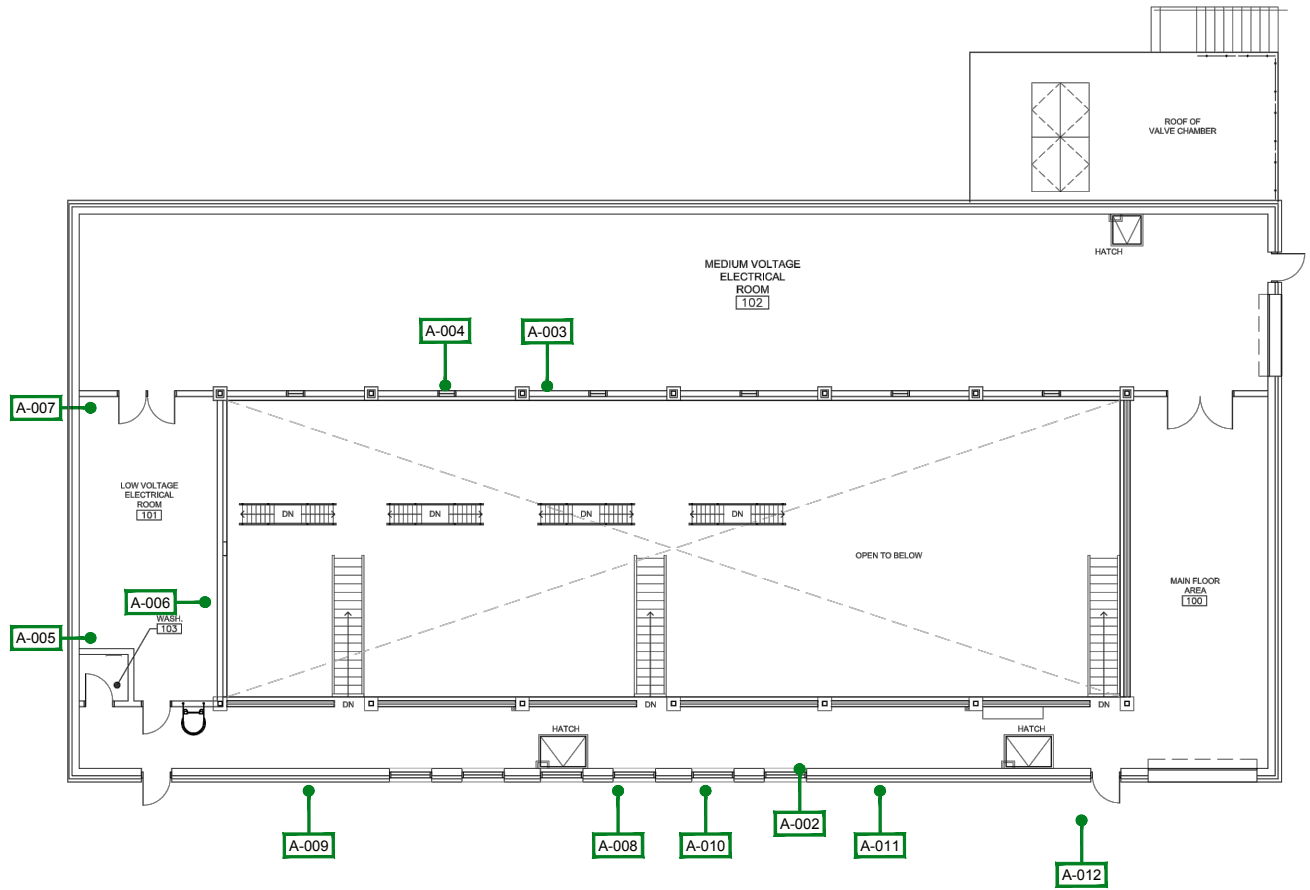
FIGURE
1

1. ASBESTOS IS A CARCINOGEN. DO NOT BREATHE ASBESTOS DUST.
2. SAMPLES A-013 AND A-014 WERE COLLECTED FROM THE ADJACENT RESERVOIRS.
3. ASBESTOS-CONTAINING MATERIALS WERE NOT OBSERVED ON SITE DURING THE ASSESSMENT.

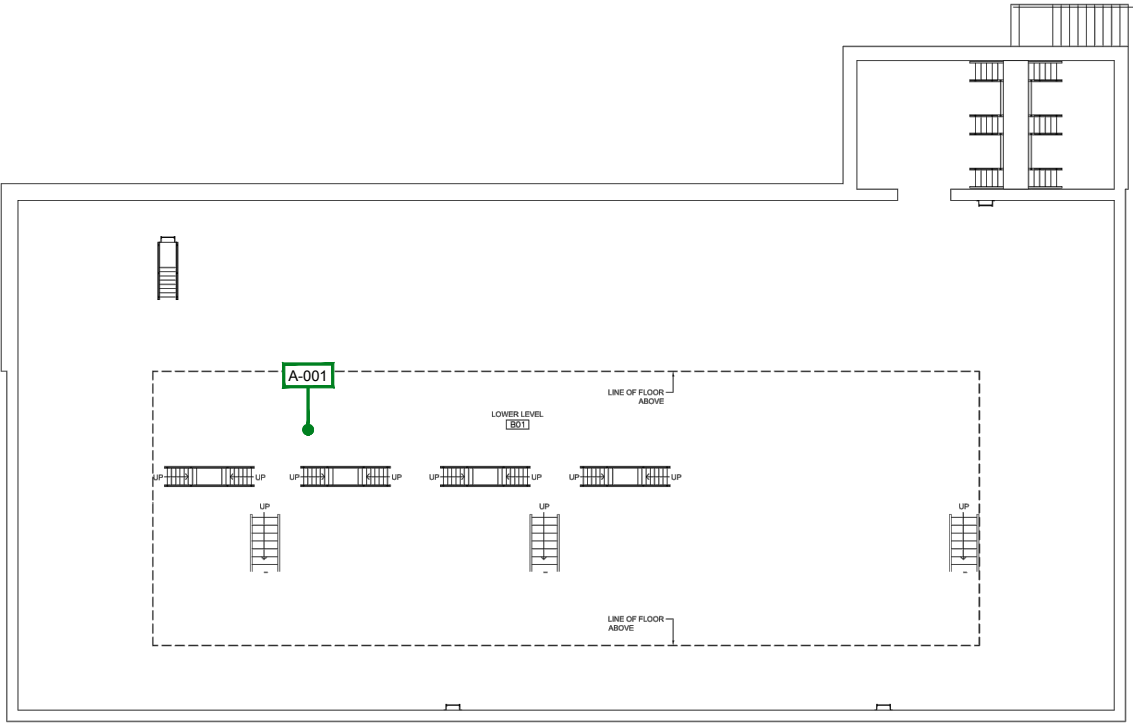
FIGURE 2

1. ASBESTOS IS A CARCINOGEN. DO NOT BREATHE ASBESTOS DUST.
2. SAMPLES A-013 AND A-014 WERE COLLECTED FROM THE ADJACENT RESERVOIRS.
3. ASBESTOS-CONTAINING MATERIALS WERE NOT OBSERVED ON SITE DURING THE ASSESSMENT.
