## CITY OF SASKATOON

# Asbestos-Containing Building Materials Assessment Report - Water Meter Shop

**Report Number: 1667963**

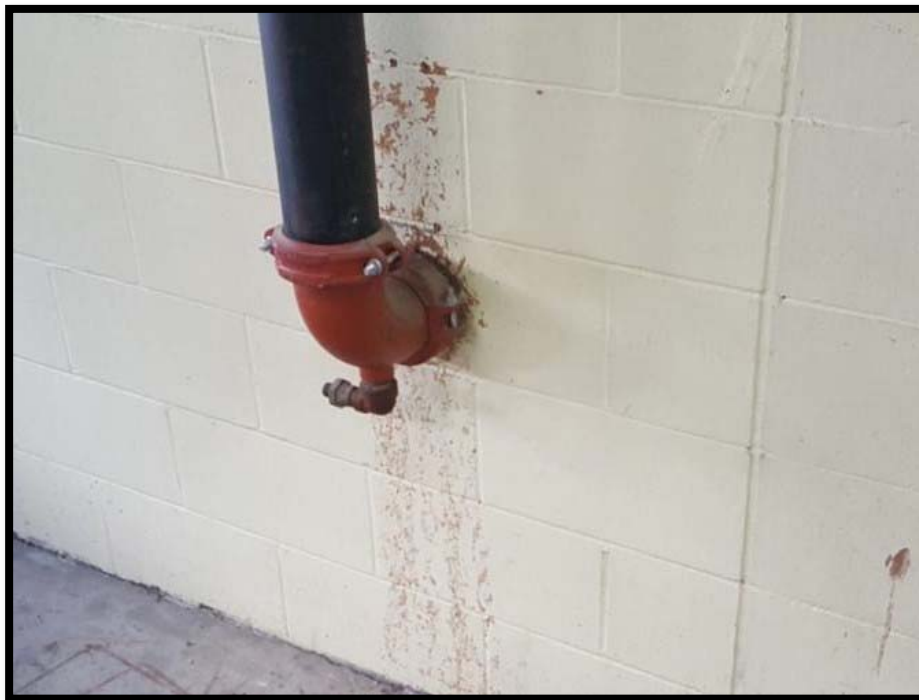
One (1) sample of loose-fill vermiculite insulation was collected during the assessment. The sample collected was found to contain trace amount of Actinolite asbestos. Asbestos-containing loose-fill vermiculite insulation (see Photograph 1 in Appendix B) was observed to have leaked from the wall cavity in Room 131. The loose vermiculite was subsequently cleaned by the Client following its identification.

There is the potential for the material to be present within other cinderblock walls throughout the building.

**Photograph 1: Block Wall with Potential Asbestos-Containing Loose-Fill Vermiculite Insulation.**

If scheduled for impact, asbestos-containing loose-fill vermiculite insulation should be abated following high-risk abatement work procedures as outlined in the *Saskatchewan Asbestos Abatement Manual* (2017). Alternatively, as the loose-fill vermiculite insulation is located within the cinderblock wall cavities, and with a priority rating of 5 (please see the room by room spreadsheet provided in Appendix C for a description of the priority ratings), the vermiculite can be managed in place if not scheduled for impact. If vermiculite is observed to have leaked from openings within the cinderblock walls, the material should be cleaned up following low-risk abatement work procedures as outlined in the *Saskatchewan Asbestos Abatement Manual* (2017).
