December 4, 2017

## CITY OF SASKATOON

# Asbestos-Containing Building Materials Assessment Report - Wildwood Golf Course Clubhouse

**Report Number: 1667963**

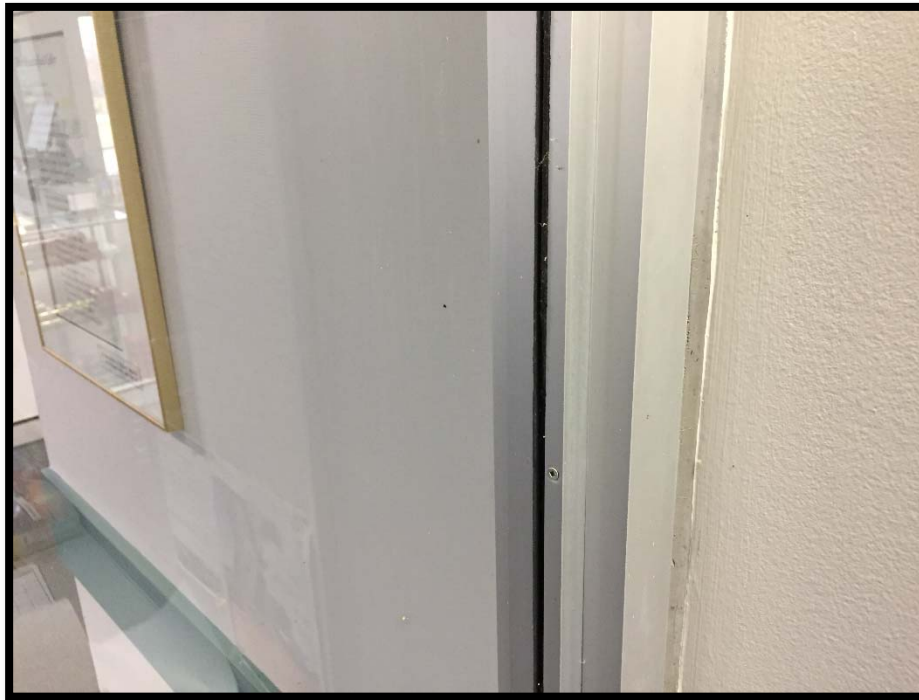
One (1) sample of black interior window caulking was collected during the assessment. The sample collected was found to contain 3.8% Chrysotile asbestos. Asbestos-containing black interior window caulking (see Photograph 3 in Appendix B) was observed in the following location:

- Room 106 (approximately 20 linear feet).

**Photograph 3: Asbestos-Containing Black Interior Window Caulking.**

If scheduled for impact, asbestos-containing black interior window caulking should be abated following low-risk abatement work procedures as outlined in the *Saskatchewan Asbestos Abatement Manual* (2017). Alternatively, as the black interior window caulking was observed in good condition, and with a priority rating of 5 (please see the room by room spreadsheet provided in Appendix C for a description of the priority ratings), it can be managed in place if not scheduled for impact.

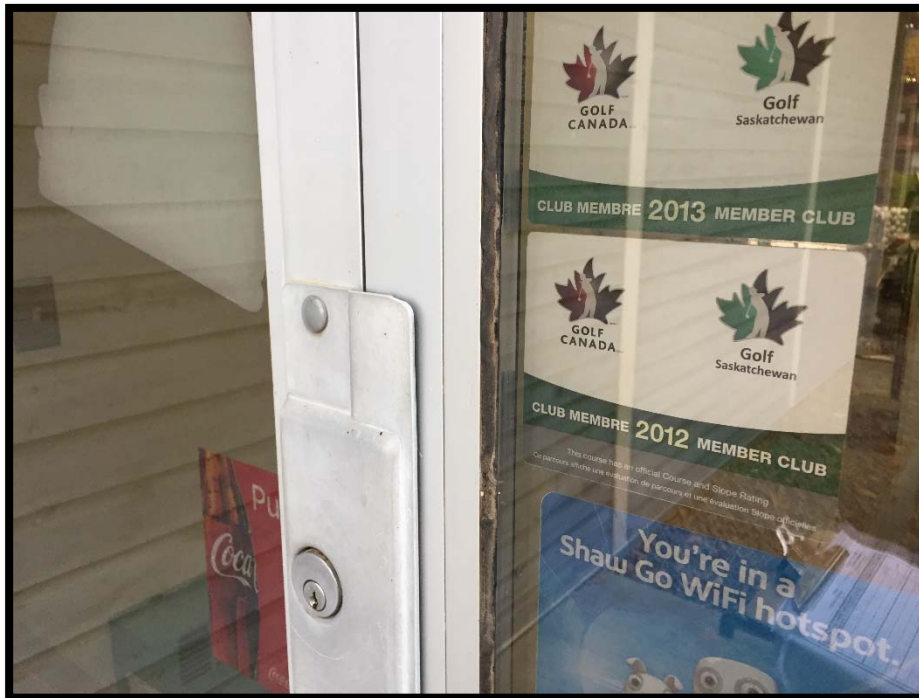
One (1) sample of black exterior window caulking was collected during the assessment. The sample collected was found to contain 5.3% Chrysotile asbestos. Asbestos-containing black exterior window caulking (see Photograph 4 in Appendix B) was observed in the following location:

- Exterior (approximately 275 linear feet).

**Photograph 4: Asbestos-Containing Black Exterior Window Caulking.**

If scheduled for impact, asbestos-containing black exterior window caulking should be abated following low-risk abatement work procedures as outlined in the *Saskatchewan Asbestos Abatement Manual* (2017). Alternatively, as the black exterior window caulking was observed in good condition, and with a priority rating of 5 (please see the room by room spreadsheet provided in Appendix C for a description of the priority ratings), it can be managed in place if not scheduled for impact.
