CITY OF SASKATOON

Asbestos-Containing Building Materials Assessment Report - Wildwood Golf Course Maintenance Building

Report Number: 1667963

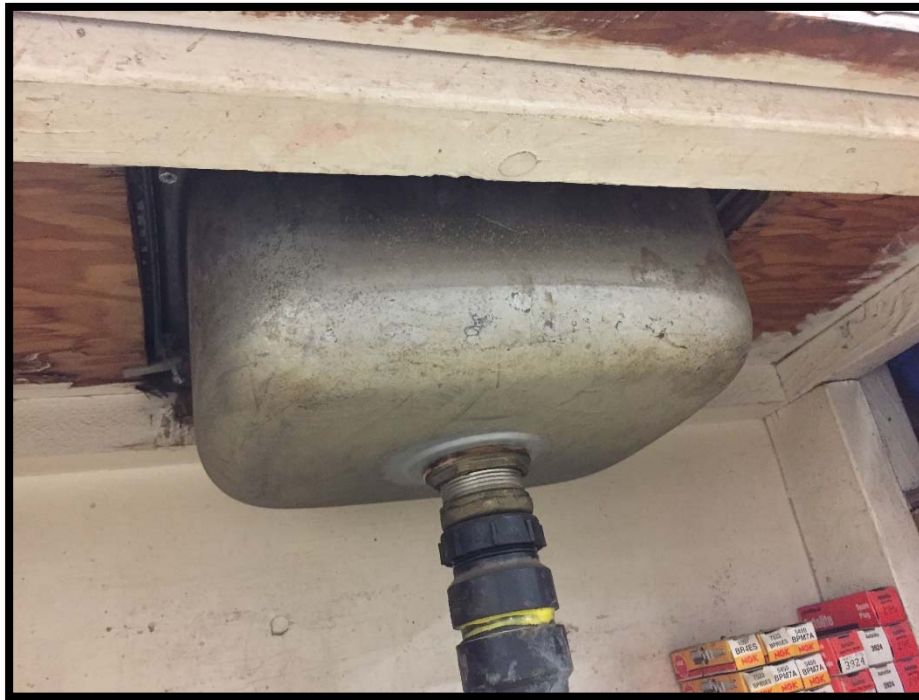
One (1) sample of gold sink undercoat was collected during the assessment. The sample collected was found to contain 1.9% Chrysotile asbestos. Asbestos-containing gold sink undercoat (see Photograph 1 in Appendix B) was observed in the following location:

- Room 100 (approximately 1 sink).

Asbestos was positively identified within the gold sink undercoat on Site. Asbestos was not identified in the remaining samples collected and analyzed.

Photograph 1: Asbestos-Containing Gold Sink Undercoat.

If scheduled for impact, asbestos-containing gold sink undercoat should be abated following low-risk abatement work procedures as outlined in the *Saskatchewan Asbestos Abatement Manual* (2017). Alternatively, as the gold sink undercoat was observed in good condition, and with a priority rating of 5 (please see the room by room spreadsheet provided in Appendix C for a description of the priority ratings), it can be managed in place if not scheduled for impact.

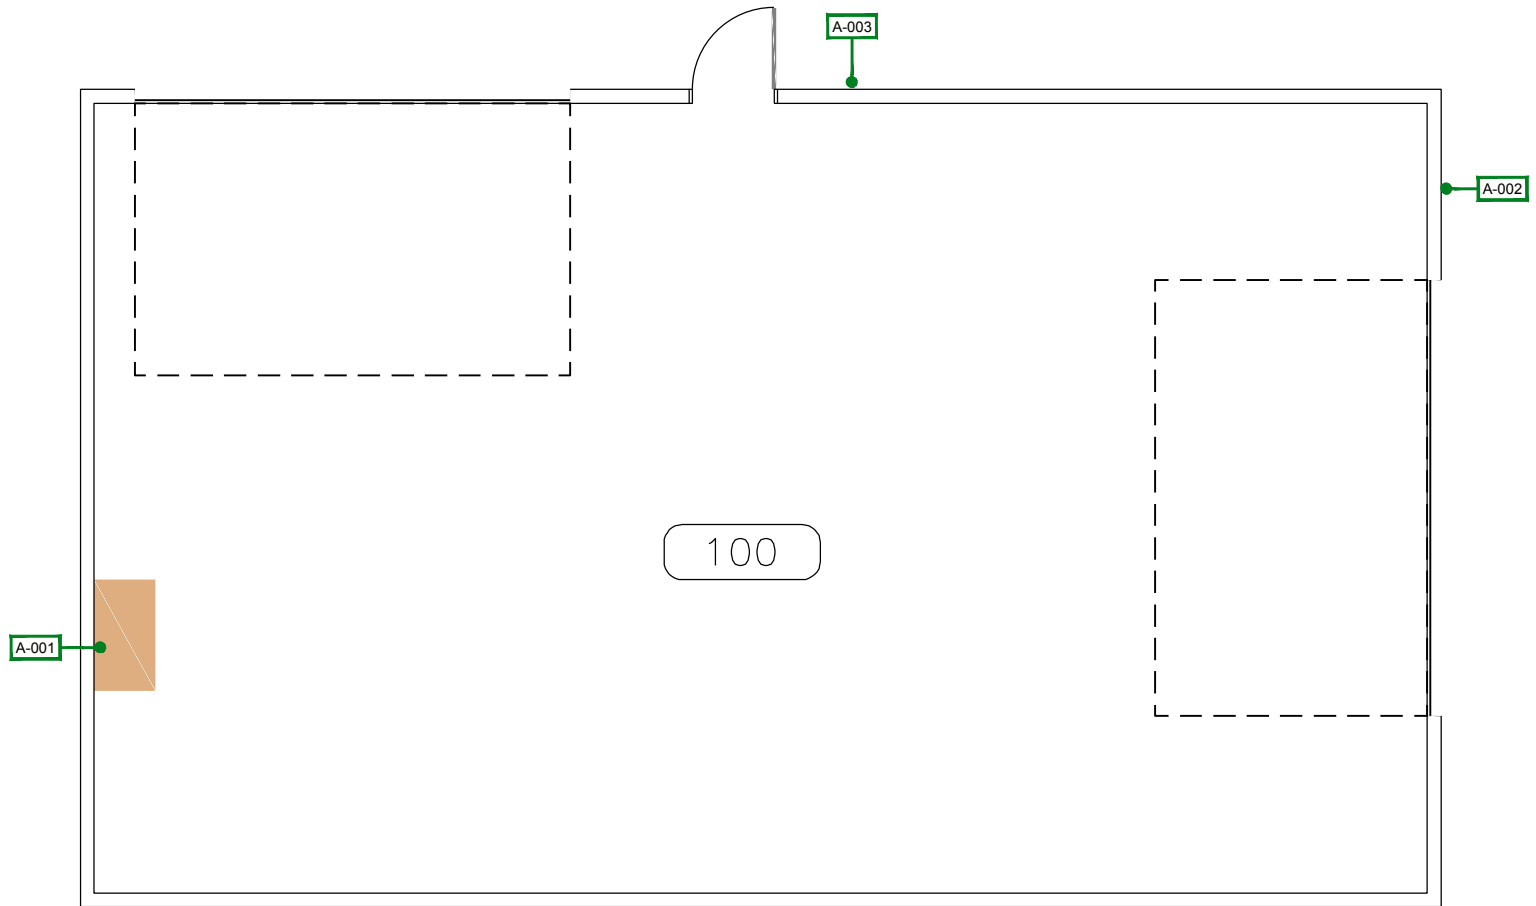
FIGURE
 1

ASBESTOS - CONTAINING SINK UNDERCOAT
-
