February 5, 2018

## CITY OF SASKATOON

# Asbestos-Containing Building Materials Assessment Report - Waste Water Treatment Plant Administration Building

**Report Number: 1667963**

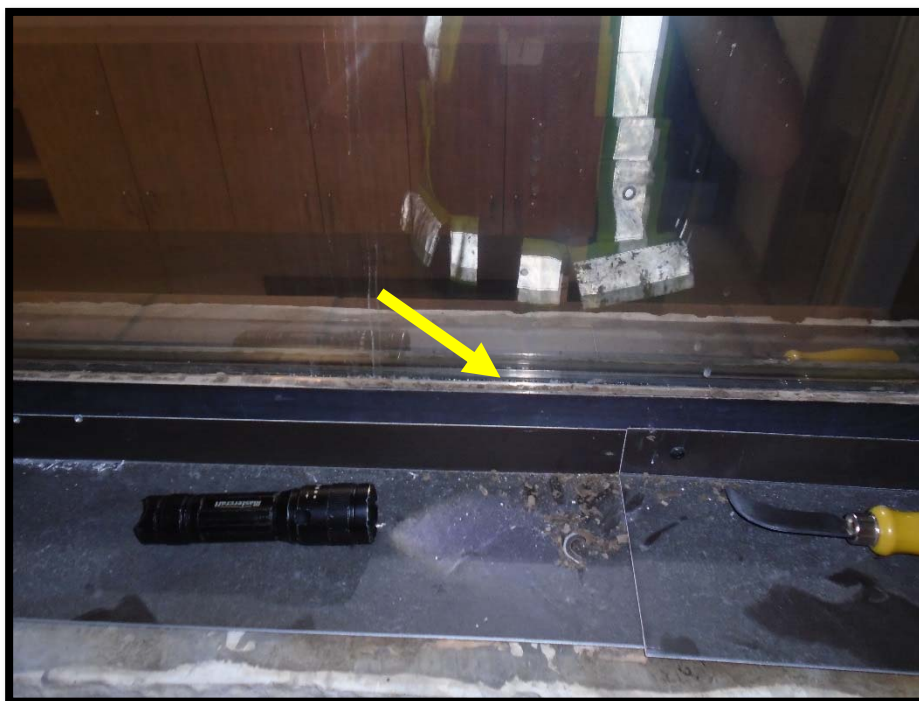
One (1) sample of grey window caulking was collected during the assessment. The sample collected was found to contain 10% Chrysotile asbestos. A layer of black window caulking was found on the sample and found to contain 5.1% Chrysotile asbestos. Asbestos-containing window caulking (see Photograph 1 in Appendix B) was observed in the following locations:

- Room 102.1 (70 linear ft.) on window panes;
- Room 106 (20 linear ft.) on window panes; and
- Room 129.1 (70 linear ft.) on window panes.

Asbestos was positively identified within grey and black window caulking on Site. Asbestos was not identified in the remaining samples collected and analyzed.

**Photograph 1: Asbestos-Containing Grey and Black Window Caulking**

If scheduled for impact, asbestos-containing window caulking should be abated following low-risk abatement work procedures as outlined in the *Saskatchewan Asbestos Abatement Manual* (2017). Alternatively, as the caulking was observed in good condition, and with a priority rating of 5 (please see the room by room spreadsheet provided in Appendix C for a description of the priority ratings), the glazing can be managed in place if not scheduled for impact.

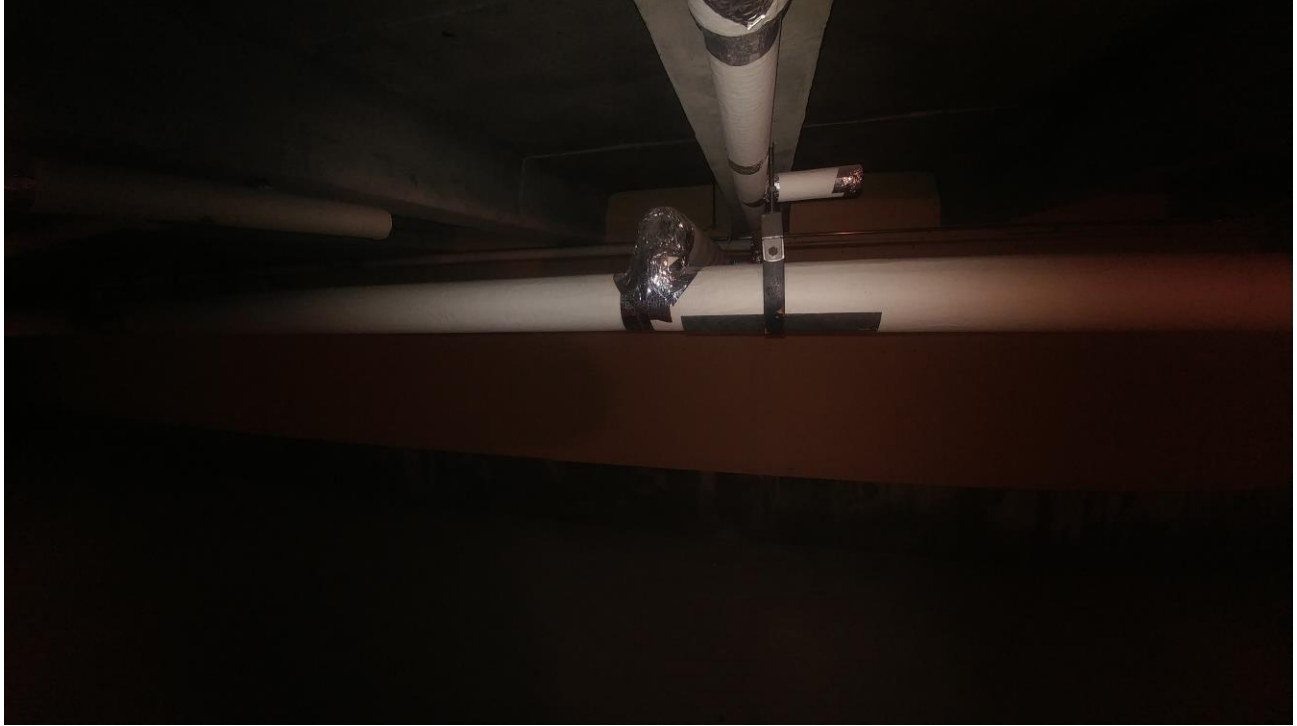
**PHOTO 1 – Fiberglass Lineal Pipe Insulation w Fiberglass Elbow in Foil Wrap**

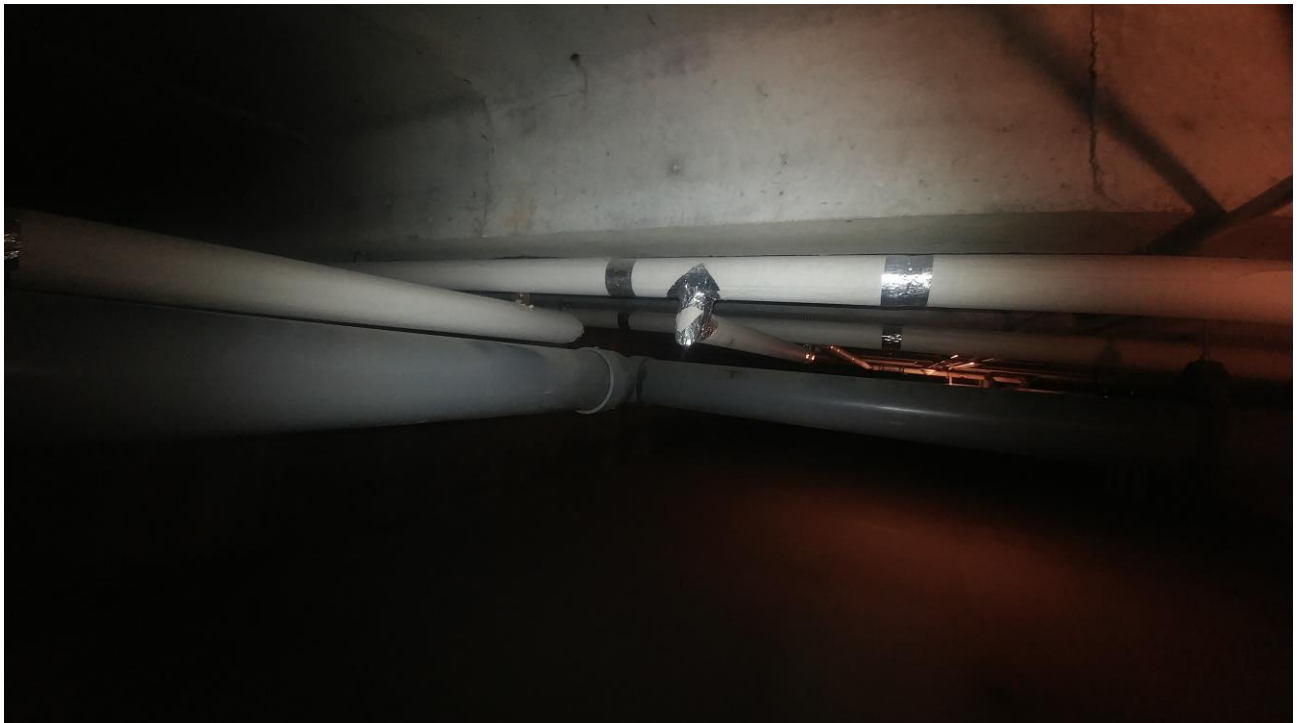
**PHOTO 2 – Fiberglass Lineal Pipe Insulation & PVC Drainpipe**

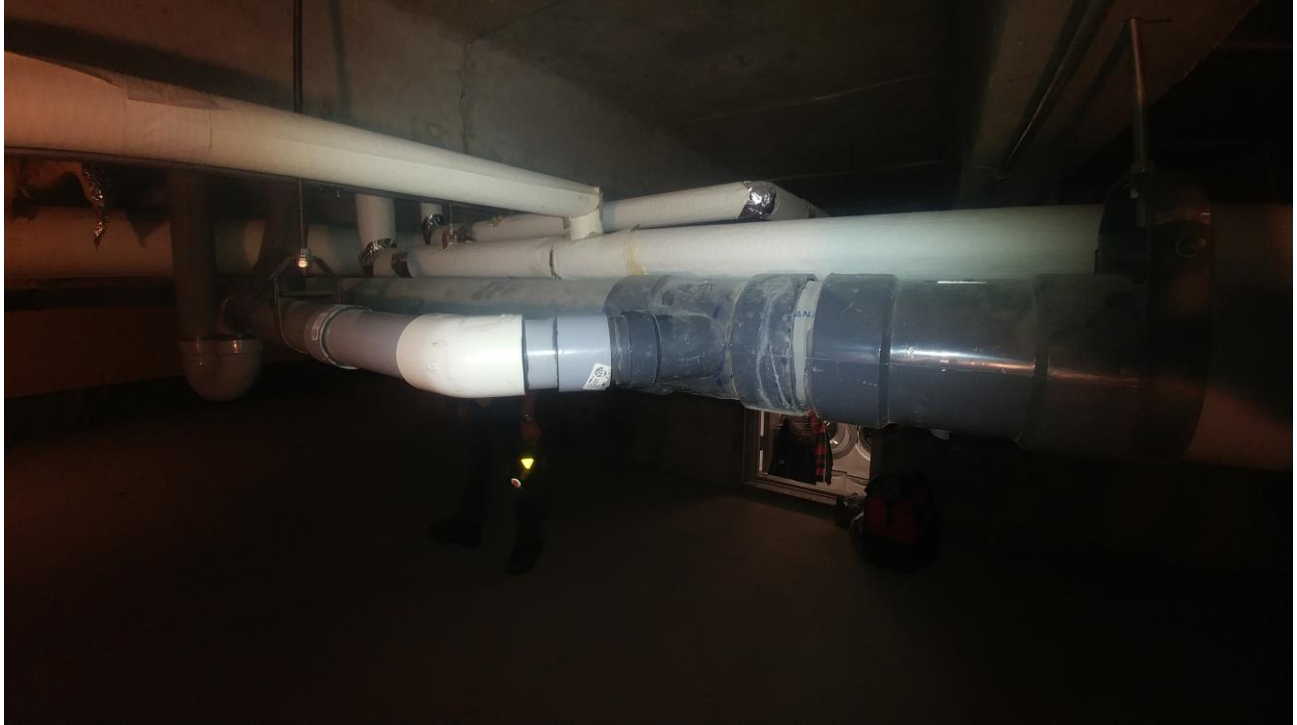
**PHOTO 3 – Fiberglass Lineal Pipe Insulation & PVC Drainpipe**

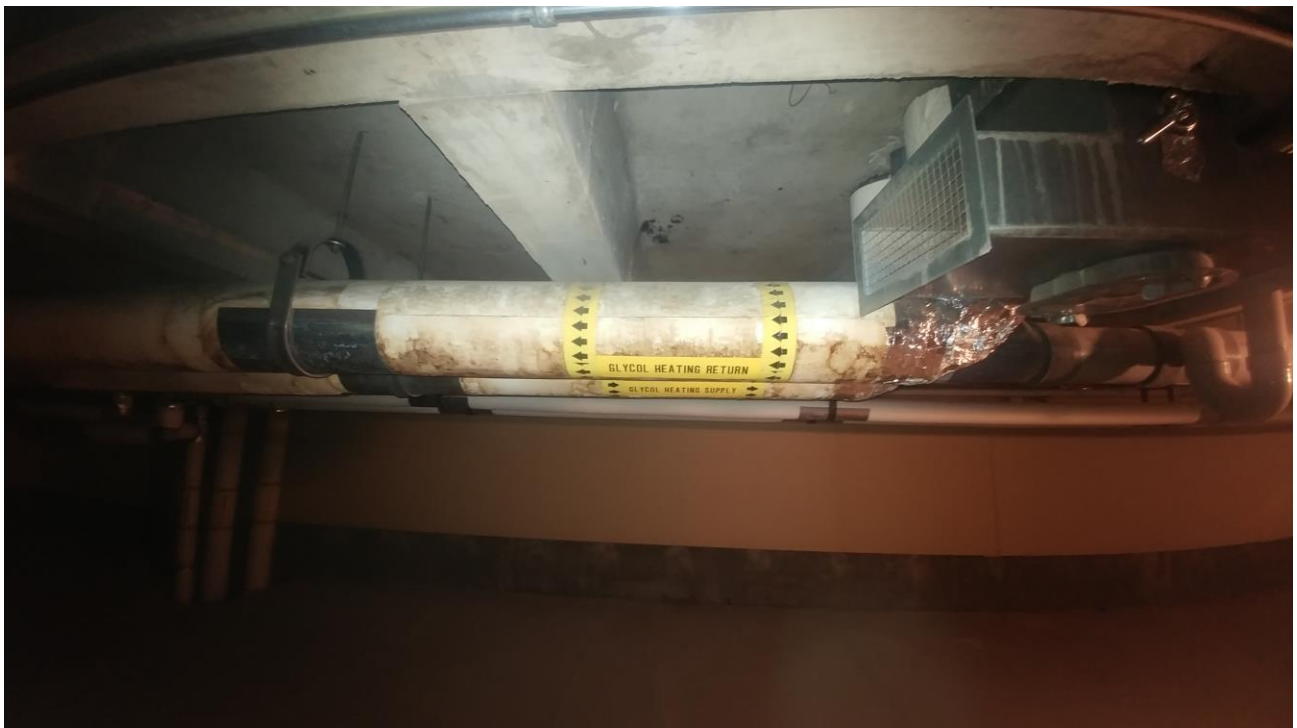
**Photo 4- Glycol Heating Lines -Fiberglass Insulation- Adj. Supply Air Duct**
