CITY OF SASKATOON

Asbestos-Containing Building Materials Assessment Report - Waste Water Primary Clarifiers and Access Buildings

Report Number: 1667963

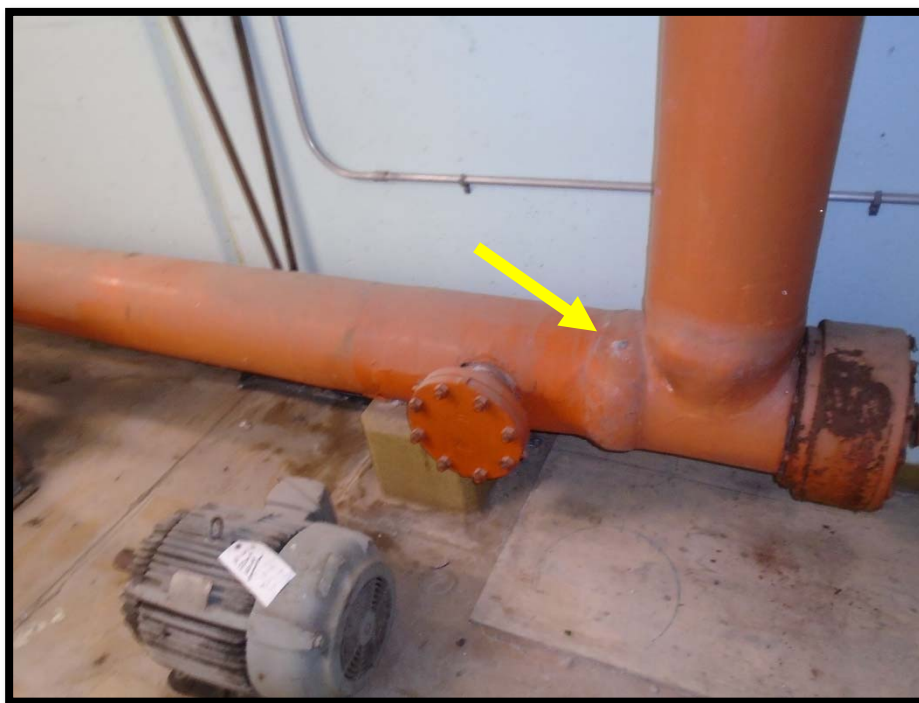
Seven (7) samples of pipe-fitting insulation were collected during the assessment. The sample collected from the aerator line within the North Stairwell was found to contain 60% Chrysotile asbestos. Asbestos-containing pipe-fitting insulation (see Photograph 1 in Appendix B) was observed in the following locations:

- North Stairwell - Aerator line (approximately 25 fittings).

Percent Asbestos:
60 Chrysotile

Photograph 1: Asbestos-Containing Pipe-Fitting Insulation, Aerator Line.

If scheduled for impact, asbestos-containing pipe-fitting insulation within the North Stairwell should be abated following moderate-risk glovebag or high-risk abatement work procedures as outlined in the *Saskatchewan Asbestos Abatement Manual* (2017). Alternatively, as the pipe-fitting insulation was observed in good condition, and with a priority rating of 5 (please see the room by room spreadsheet provided in Appendix C for a description of the priority ratings), the pipe-fitting insulation can be managed in place if not scheduled for impact.
