## CITY OF SASKATOON

# Asbestos-Containing Building Materials Assessment Report - Waste Water Digester Building and Digesters

**Report Number: 1667963**

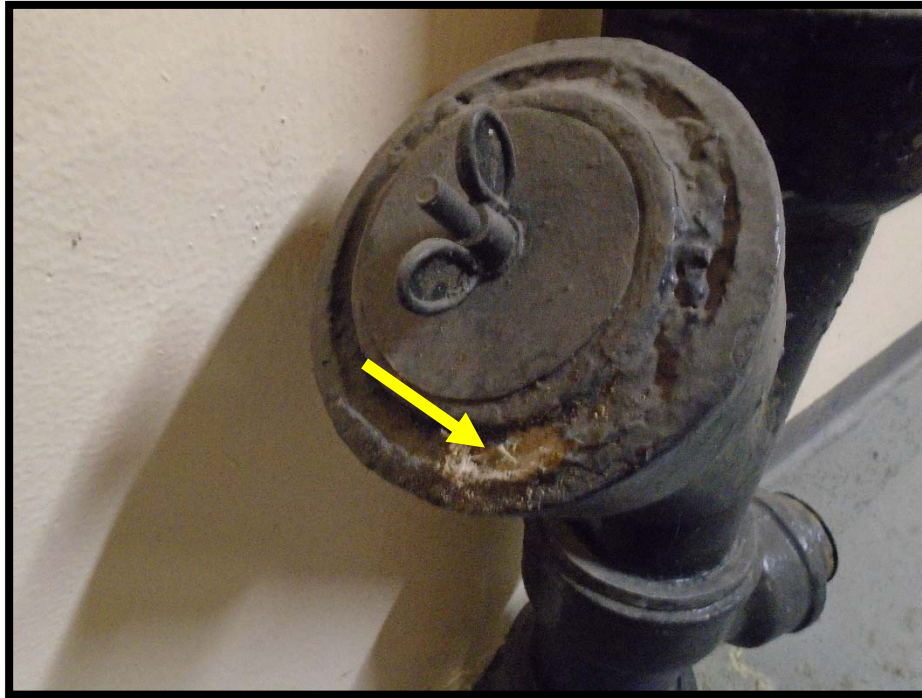
One (1) sample of cast iron joint packing was collected during the assessment. The sample collected was found to contain 30% Amosite asbestos. Asbestos-containing cast iron joint packing (see Photograph 1 in Appendix B) was observed in the following locations:

- Basement (approximately one joint).

**Photograph 1: Asbestos-Containing Cast Iron Joint Packing.**

If scheduled for impact, asbestos-containing cast iron joint caulking should be abated following moderate-risk glovebag or high-risk abatement work procedures as outlined in the *Saskatchewan Asbestos Abatement Manual* (2017). Alternatively, as the joint packing was observed in good condition, and with a priority rating of 5 (please see the room by room spreadsheet provided in Appendix C for a description of the priority ratings), the packing can be managed in place if not scheduled for impact.

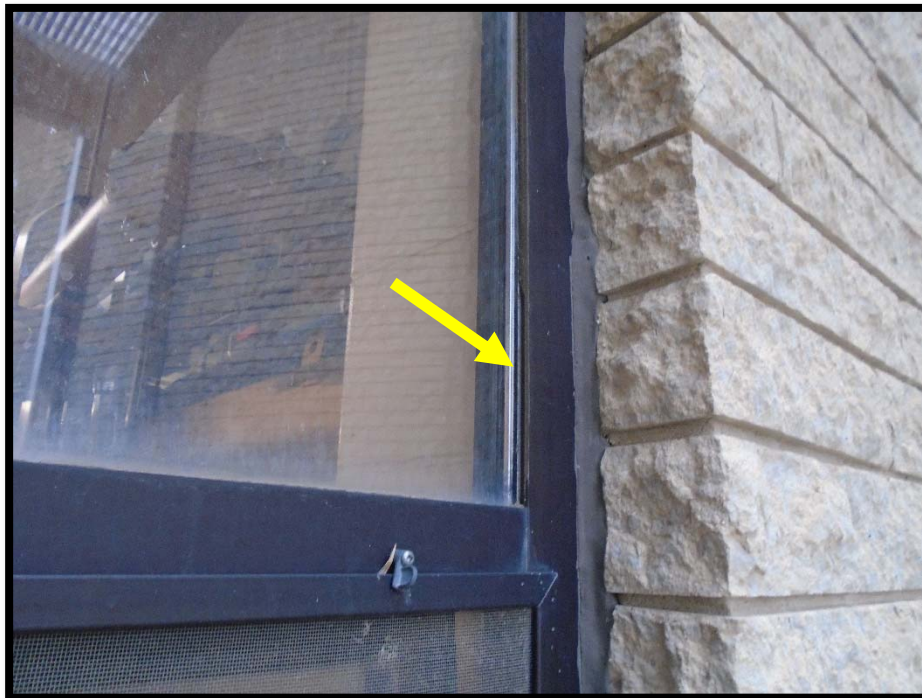
One (1) sample of exterior black window caulking was collected during the assessment. The sample collected was found to contain 20% Chrysotile asbestos. Asbestos-containing black window caulking (see Photograph 2 in Appendix B) was observed in the following locations:

- Exterior (approximately 850 linear ft.)

**Photograph 2: Asbestos-Containing Exterior Black Window Caulking.**

If scheduled for impact, asbestos-containing black window caulking should be abated following low-risk abatement work procedures as outlined in the *Saskatchewan Asbestos Abatement Manual* (2017). Alternatively, as the caulking was observed in good condition, and with a priority rating of 5 (please see the room by room spreadsheet provided in Appendix C for a description of the priority ratings), the caulking can be managed in place if not scheduled for impact.
