CITY OF SASKATOON

Asbestos-Containing Building Materials Assessment Report - Waste Water Screen Building

Report Number: 1667963

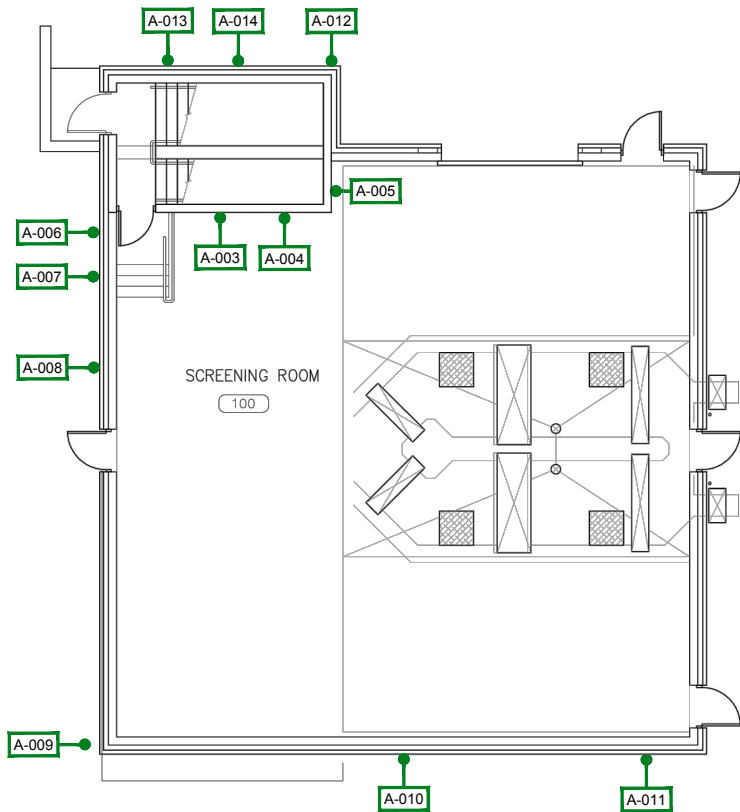
TITLE
MAIN FLOOR

2. ASBESTOS-CONTAINING MATERIALS WERE NOT OBSERVED WITHIN THE BUILDING AT THE TIME OF THE ASSESSMENT.

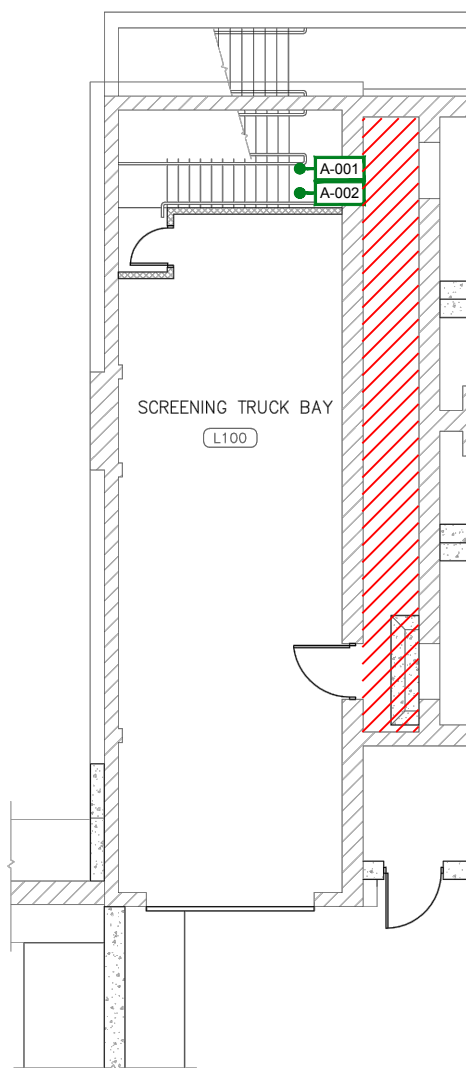
TITLE
LOWER FLOOR

- NOTE(S)**
1. ASBESTOS IS A CARCINOGEN. DO NOT BREATHE ASBESTOS DUST.
 2. ASBESTOS-CONTAINING MATERIALS WERE NOT OBSERVED WITHIN THE BUILDING AT THE TIME OF THE ASSESSMENT.
