## CITY OF SASKATOON

# Asbestos-Containing Building Materials Assessment Report - Waste Water Sodium Hypochlorite Building

**Report Number: 1667963**

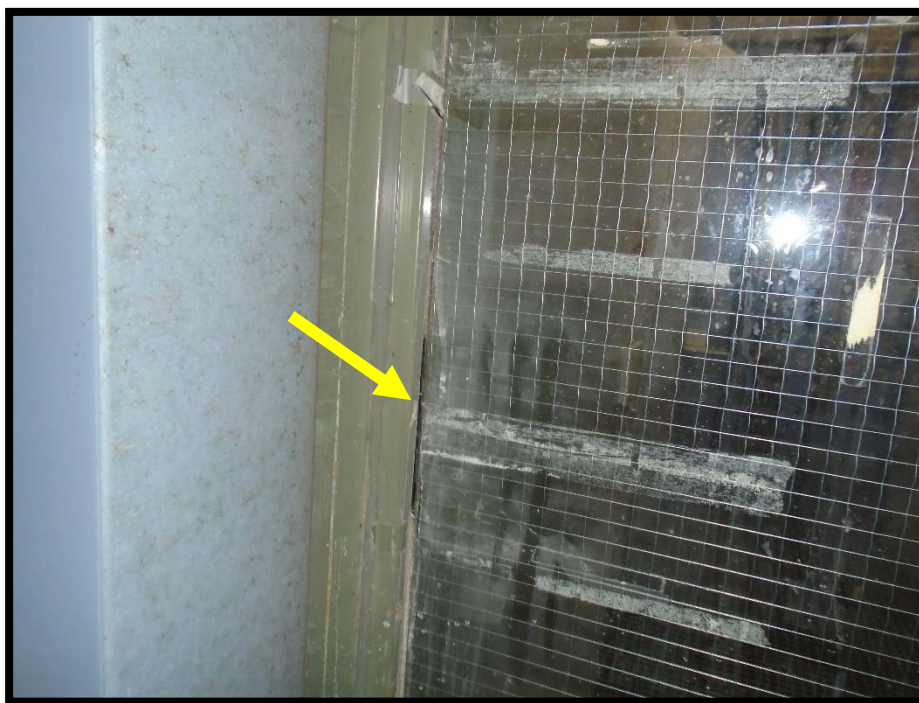
One (1) sample of black window glazing was collected during the assessment. The sample collected was found to contain 10% Chrysotile asbestos. Asbestos-containing black window glazing (see Photograph 1 in Appendix B) was observed in the following locations:

- Room 100 (approximately 10 ft);
- Room 102 (approximately 20 ft);
- Room 103 (approximately 20 ft); and
- Room 104 (approximately 40 ft).

**Photograph 1: Asbestos-Containing Black Window Glazing.**

If scheduled for impact, asbestos-containing black window glazing should be abated following low-risk abatement work procedures as outlined in the *Saskatchewan Asbestos Abatement Manual* (2017). Alternatively, as the glazing was observed in good condition, and with a priority rating of 5 (please see the room by room spreadsheet provided in Appendix C for a description of the priority ratings), the glazing can be managed in place if not scheduled for impact.

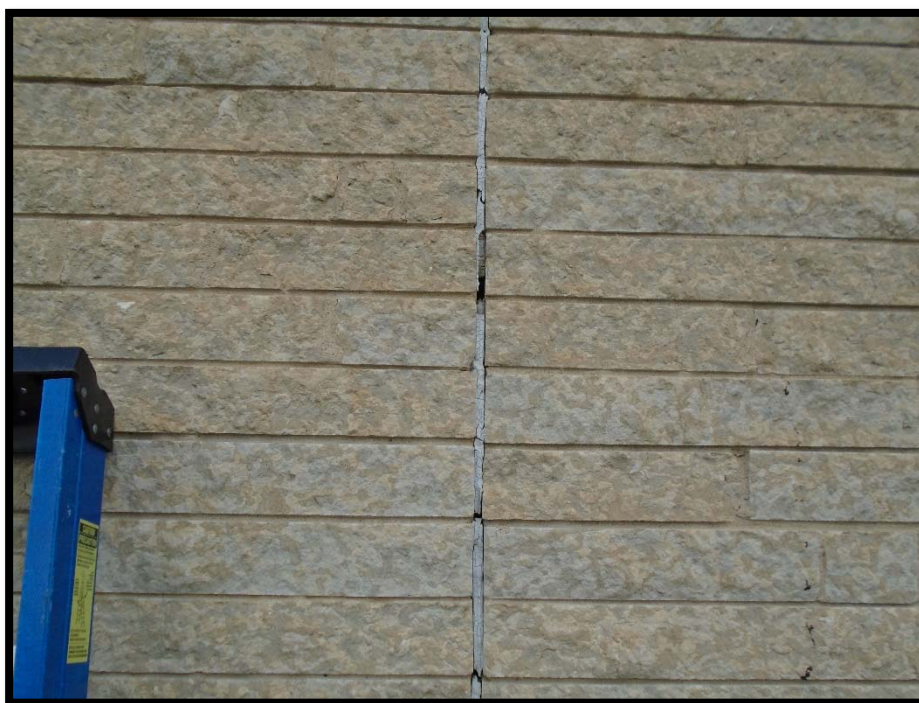
One (1) sample of exterior grey expansion joint caulking was collected during the assessment. The sample collected was found to contain 2.1% Chrysotile asbestos. Asbestos-containing grey expansion joint caulking (see Photograph 2 in Appendix B) was observed in the following locations:

- Exterior (approximately 100 ft).

**Photograph 2: Asbestos-Containing Grey Expansion Joint Caulking.**

If scheduled for impact, asbestos-containing grey expansion joint caulking should be abated following low-risk abatement work procedures as outlined in the *Saskatchewan Asbestos Abatement Manual* (2017). Alternatively, as the caulking was observed in good condition, and with a priority rating of 5 (please see the room by room spreadsheet provided in Appendix C for a description of the priority ratings), the caulking can be managed in place if not scheduled for impact.
