CITY OF SASKATOON

Asbestos-Containing Building Materials Assessment Report - Supernatant Pump Station (North 40 Sludge)

Report Number: 1667963

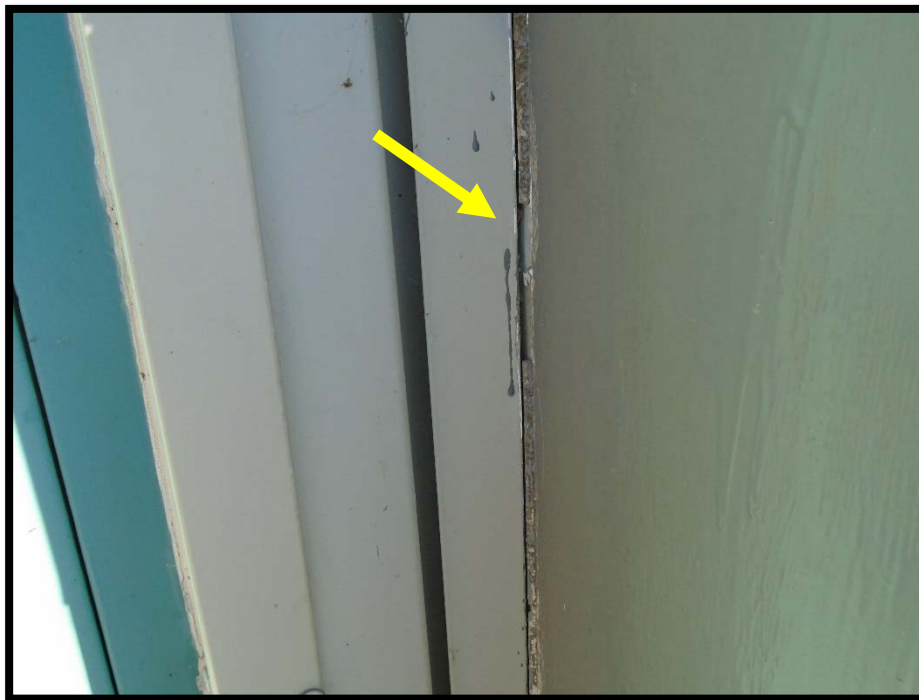
One (1) sample of grey caulking was collected during the assessment. The sample collected was found to contain 0.25% Chrysotile asbestos. Asbestos-containing grey caulking (see Photograph 1 in Appendix B) was observed in the following locations:

- Exterior (30 linear ft.)

Photograph 1: Asbestos-Containing Grey Caulking

If scheduled for impact, asbestos-containing exterior grey caulking should be abated following low-risk abatement work procedures as outlined in the *Saskatchewan Asbestos Abatement Manual* (2017). Alternatively, as the caulking was observed in good condition, and with a priority rating of 5 (please see the room by room spreadsheet provided in Appendix C for a description of the priority ratings), the caulking can be managed in place if not scheduled for impact.
