## TECHNICAL MEMORANDUM

**Project No.** 20138294

### NUTANA SLOPE INSTABILITY UPDATE – MAY 2021

This memorandum presents monitoring data for the slope failures (referred to as the west slide and east slide) at the Nutana Slope Instability site. Locations of survey pins are shown in Figure 1. Locations of slope inclinometers, piezometers, settlement points, crack meters, and tilt plates are shown in Figure 2. Locations of the Saskatoon Light & Power (SL&P) tilt plates and survey pins installed on power poles are shown in Figure 3.

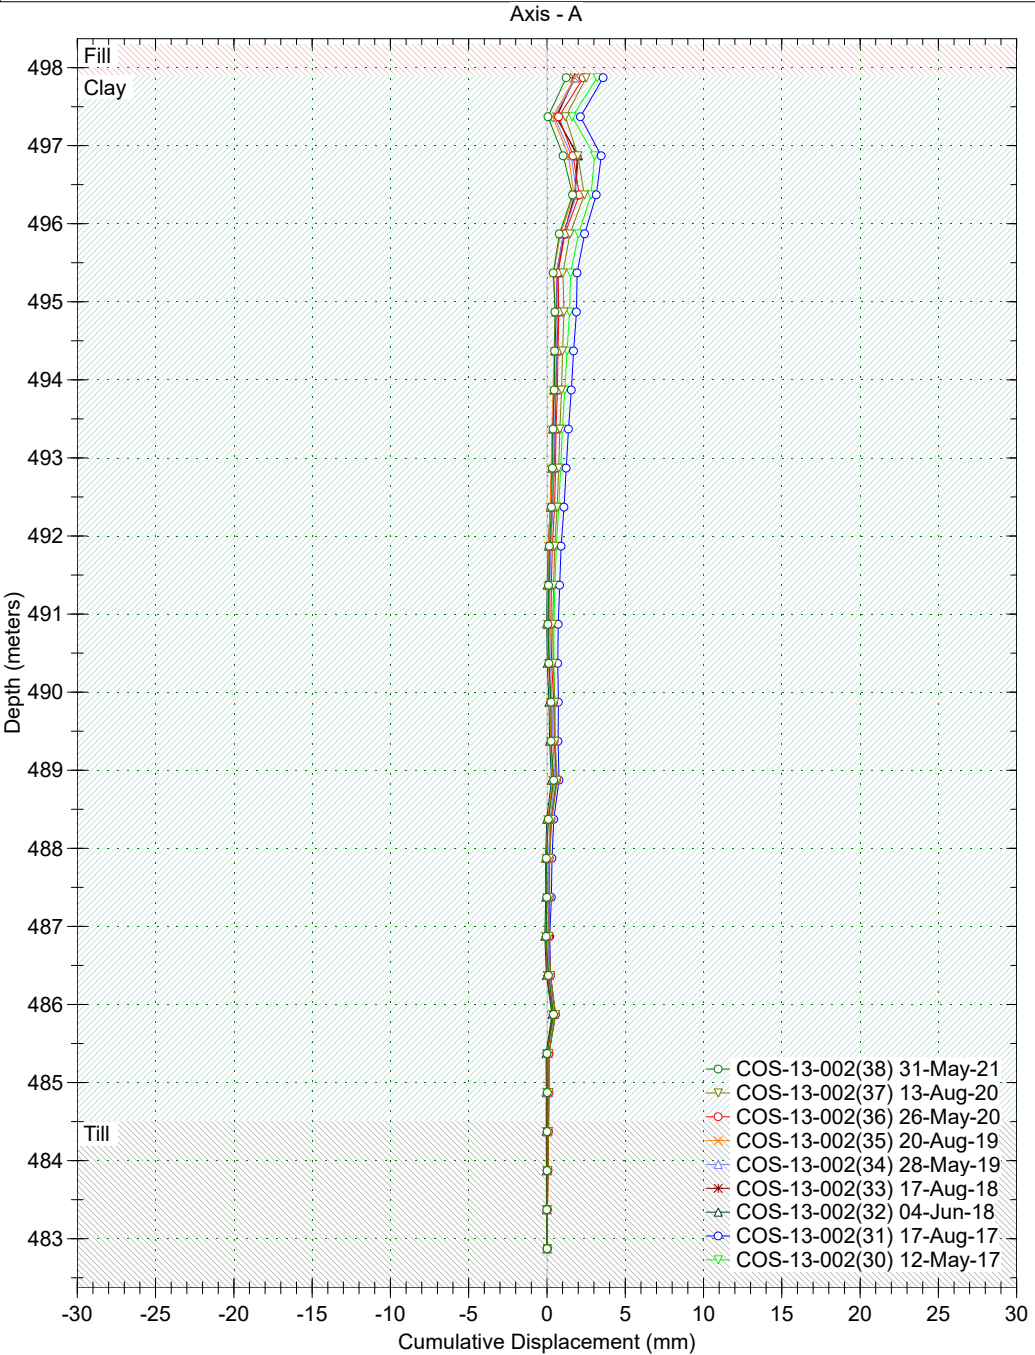
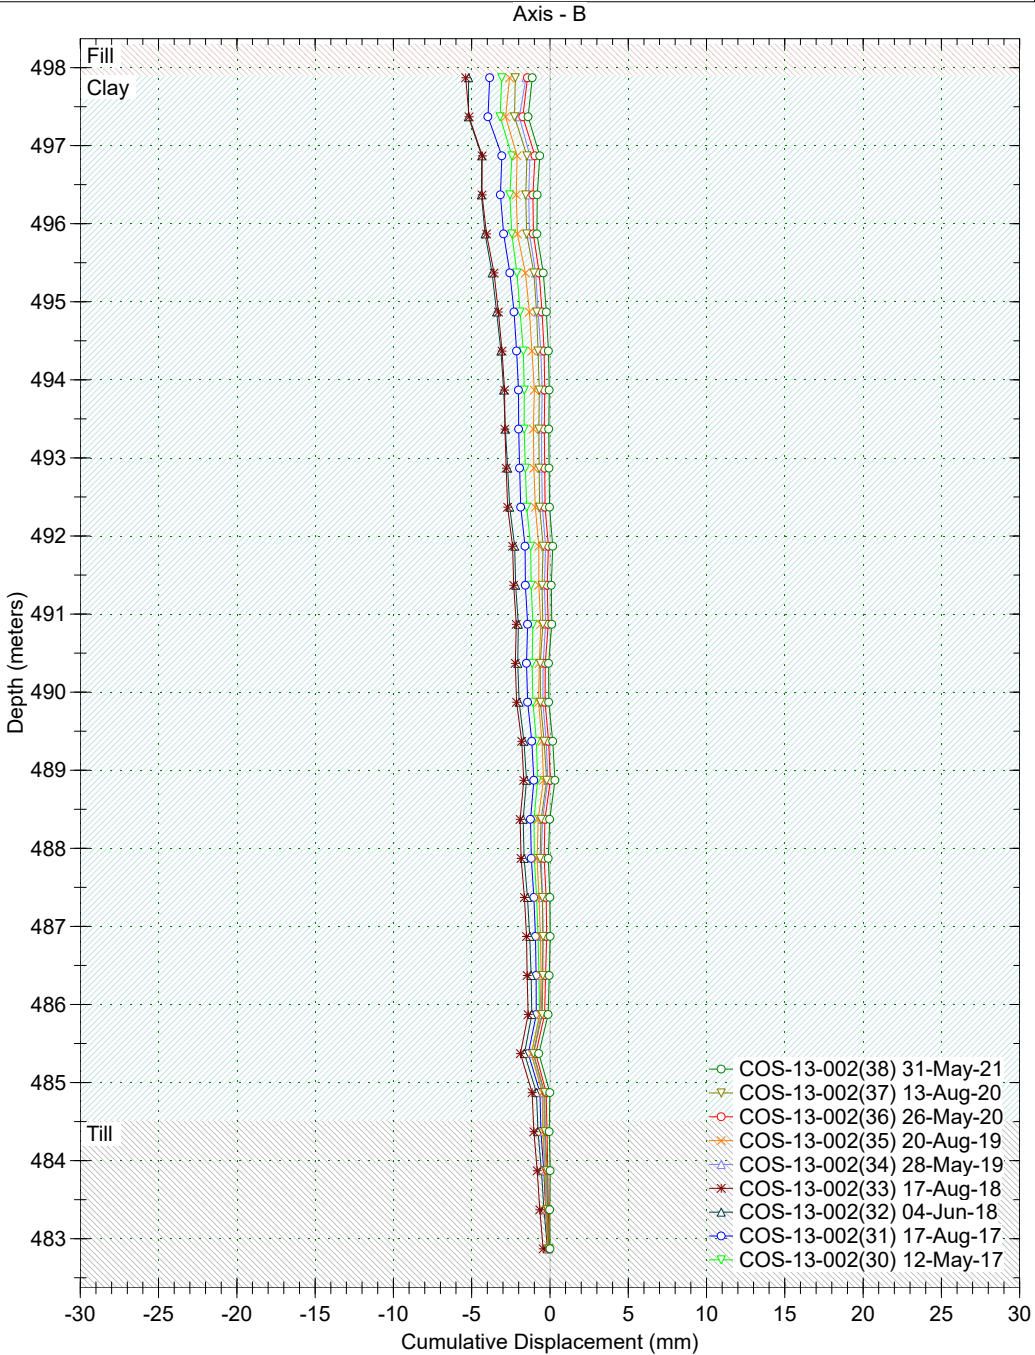
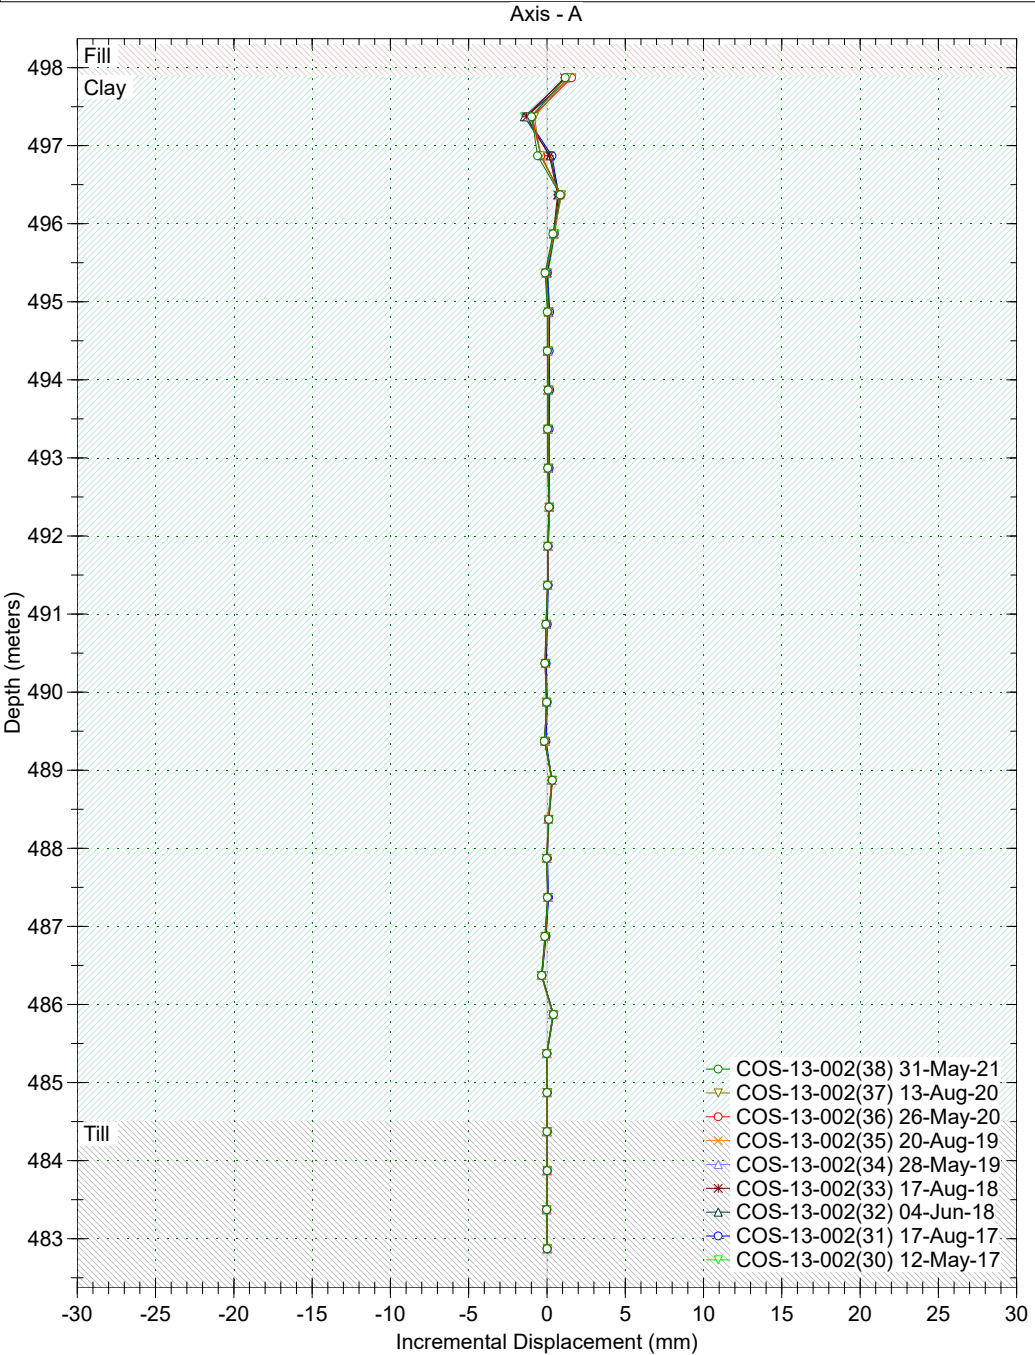
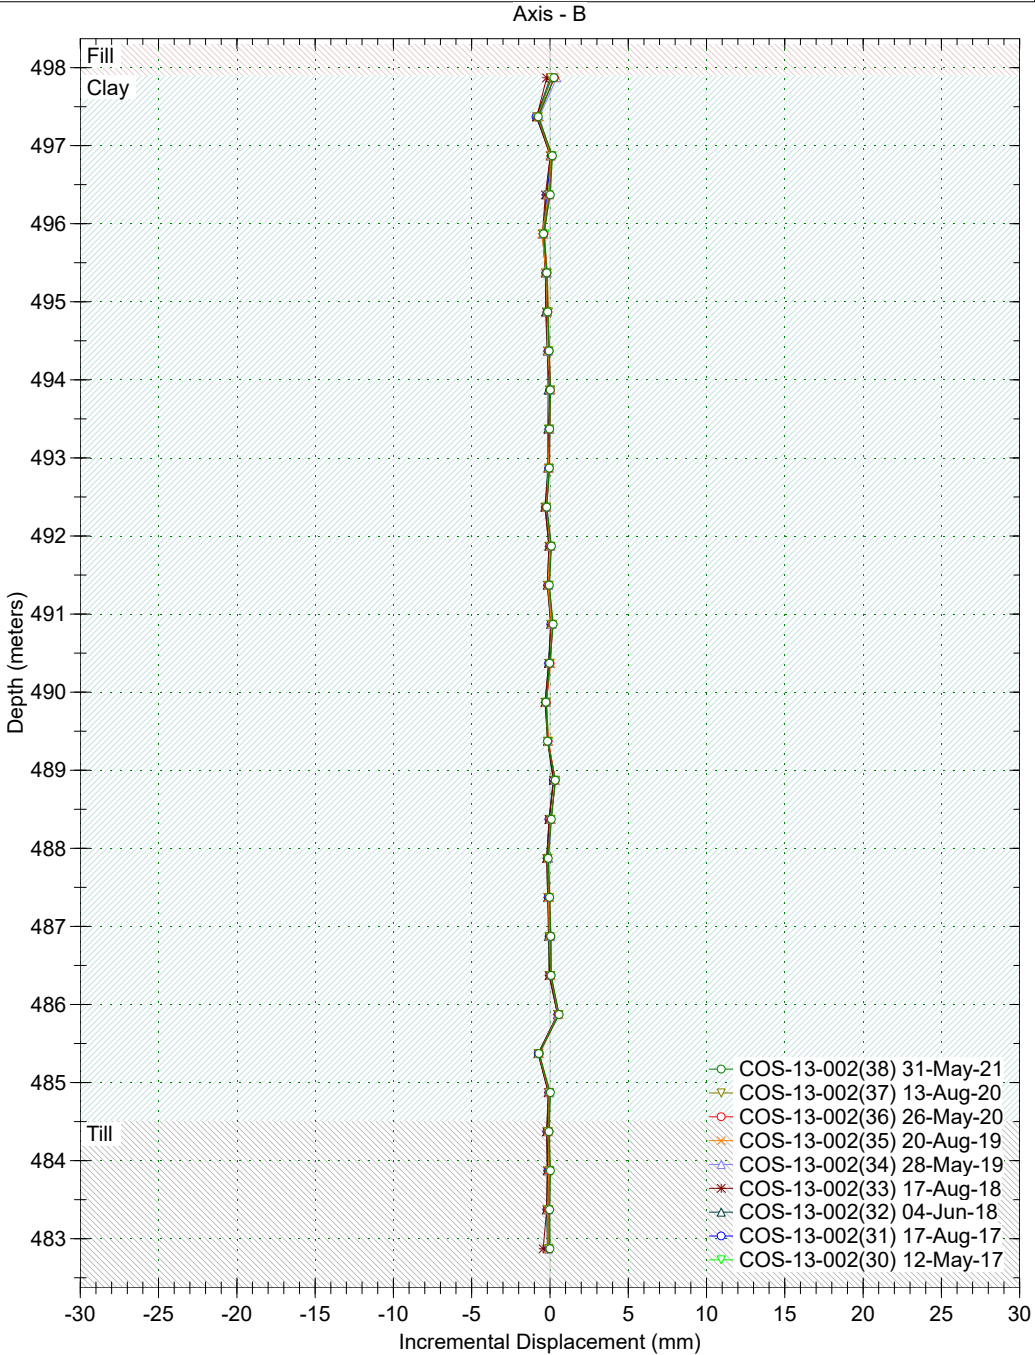
Borehole : COS-13-002  
Project : Nutana Slope  
Location : 307 11th St. E. (Front)  
Northing : 5775567.41  
Easting : 386043.54  
Collar : -0.113

- Inclinometer COS-13-002 indicated insignificant movement (less than 2 mm or 0.08 in) between August 13, 2020 and May 31, 2021.
- Inclinometer COS-13-004 indicated insignificant movement (less than 2 mm or 0.08 in) between August 13, 2020 and June 3, 2021.
- As discussed in the previous monitoring update, the inclinometer casing for COS-13-005 was cut off by approximately 6.5 centimetres (2.6 inches) in 2020. During this monitoring period the August 13, 2020 reading was used as a new baseline. Inclinometer COS-13-005 indicated insignificant movement (less than 2 mm or 0.08 in) between August 13, 2020 and May 31, 2021.
- Inclinometer COS-13-006 was decommissioned in 2020 and will no longer be read.

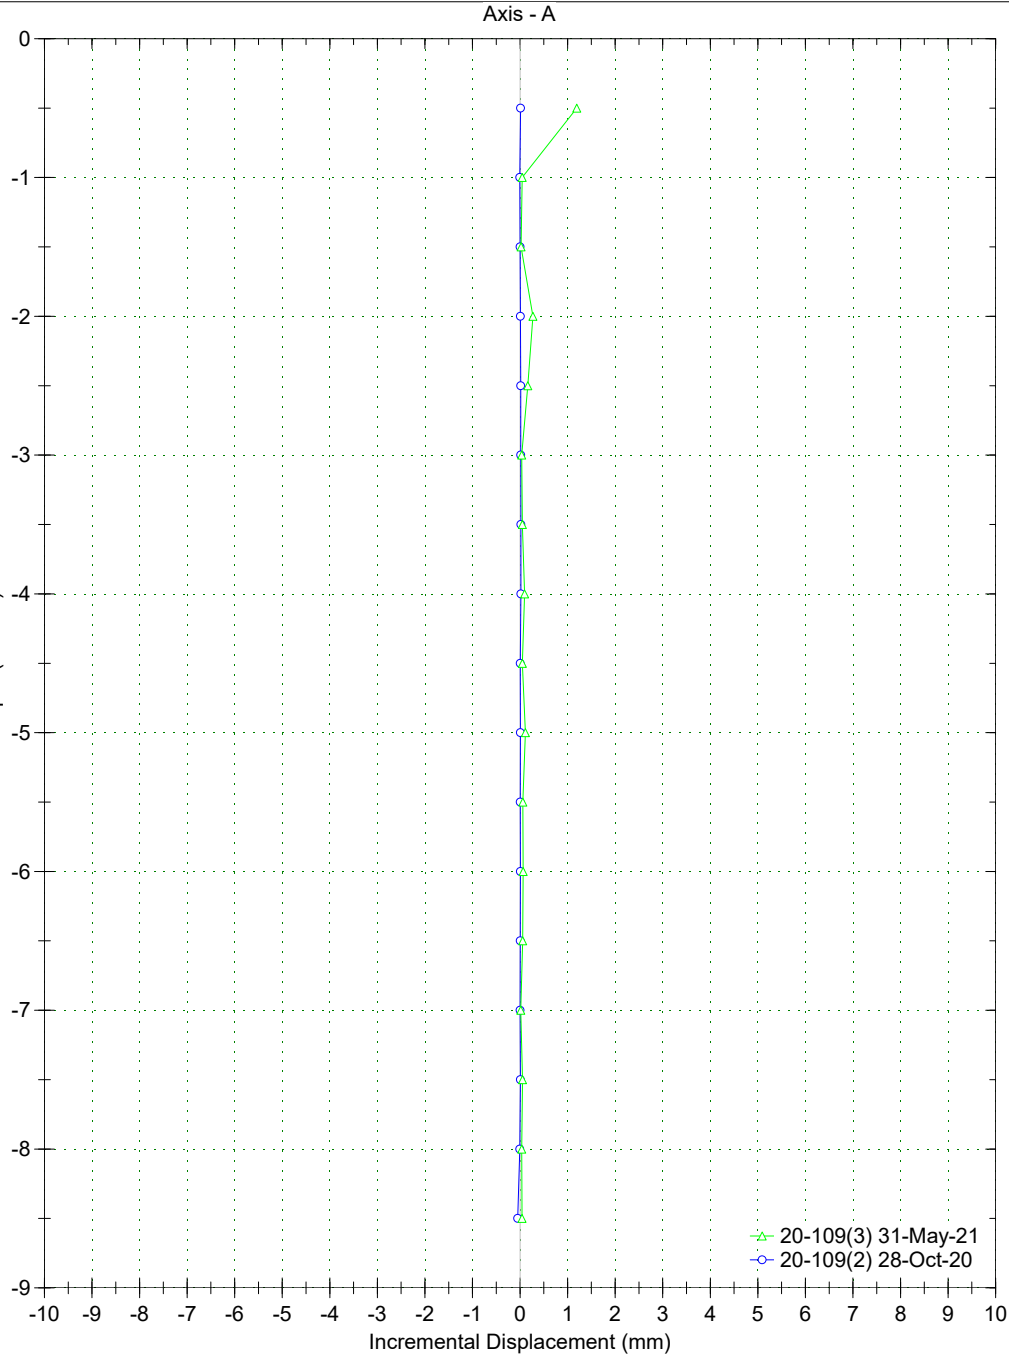
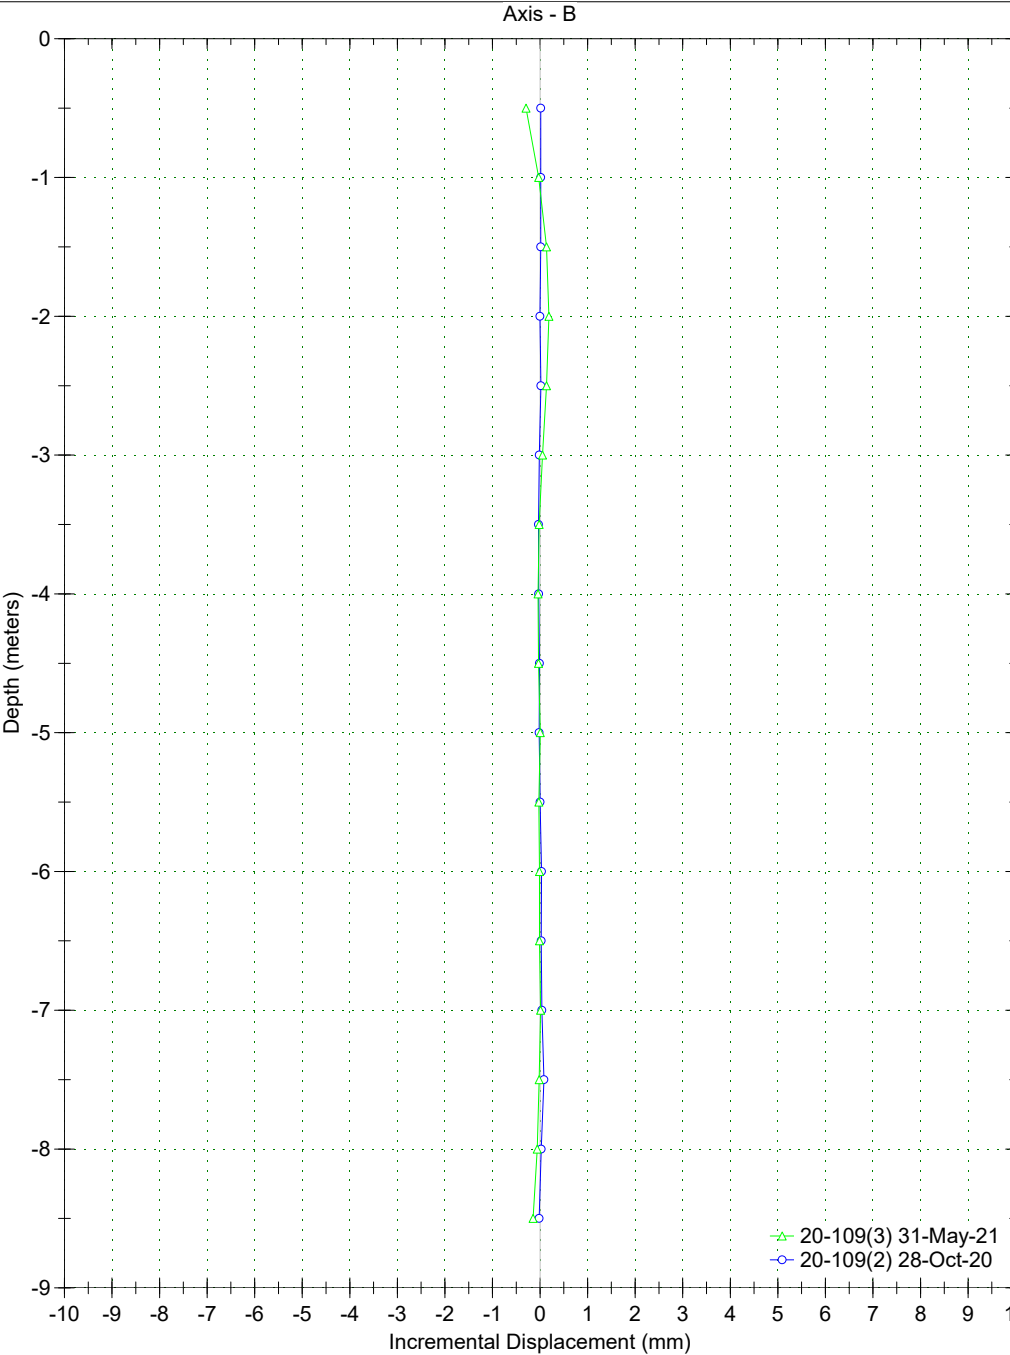
Borehole : 20-109  
Project : Nutana Slope  
Location :  
Northing : 5775622  
Easting : 385977  
Collar :

- Inclinometer 20-109 was installed in 2020 and Golder collected a baseline reading in October 2020. This inclinometer indicated less than 2.5 mm (0.10 in) of movement between October 28, 2020 and May 31, 2021.
- Inclinometer 20-111 was installed in 2020 and a baseline reading was collected in October 2020. This inclinometer indicated insignificant movement (less than 2 mm or 0.08 in) between October 28, 2020 and May 31, 2021.

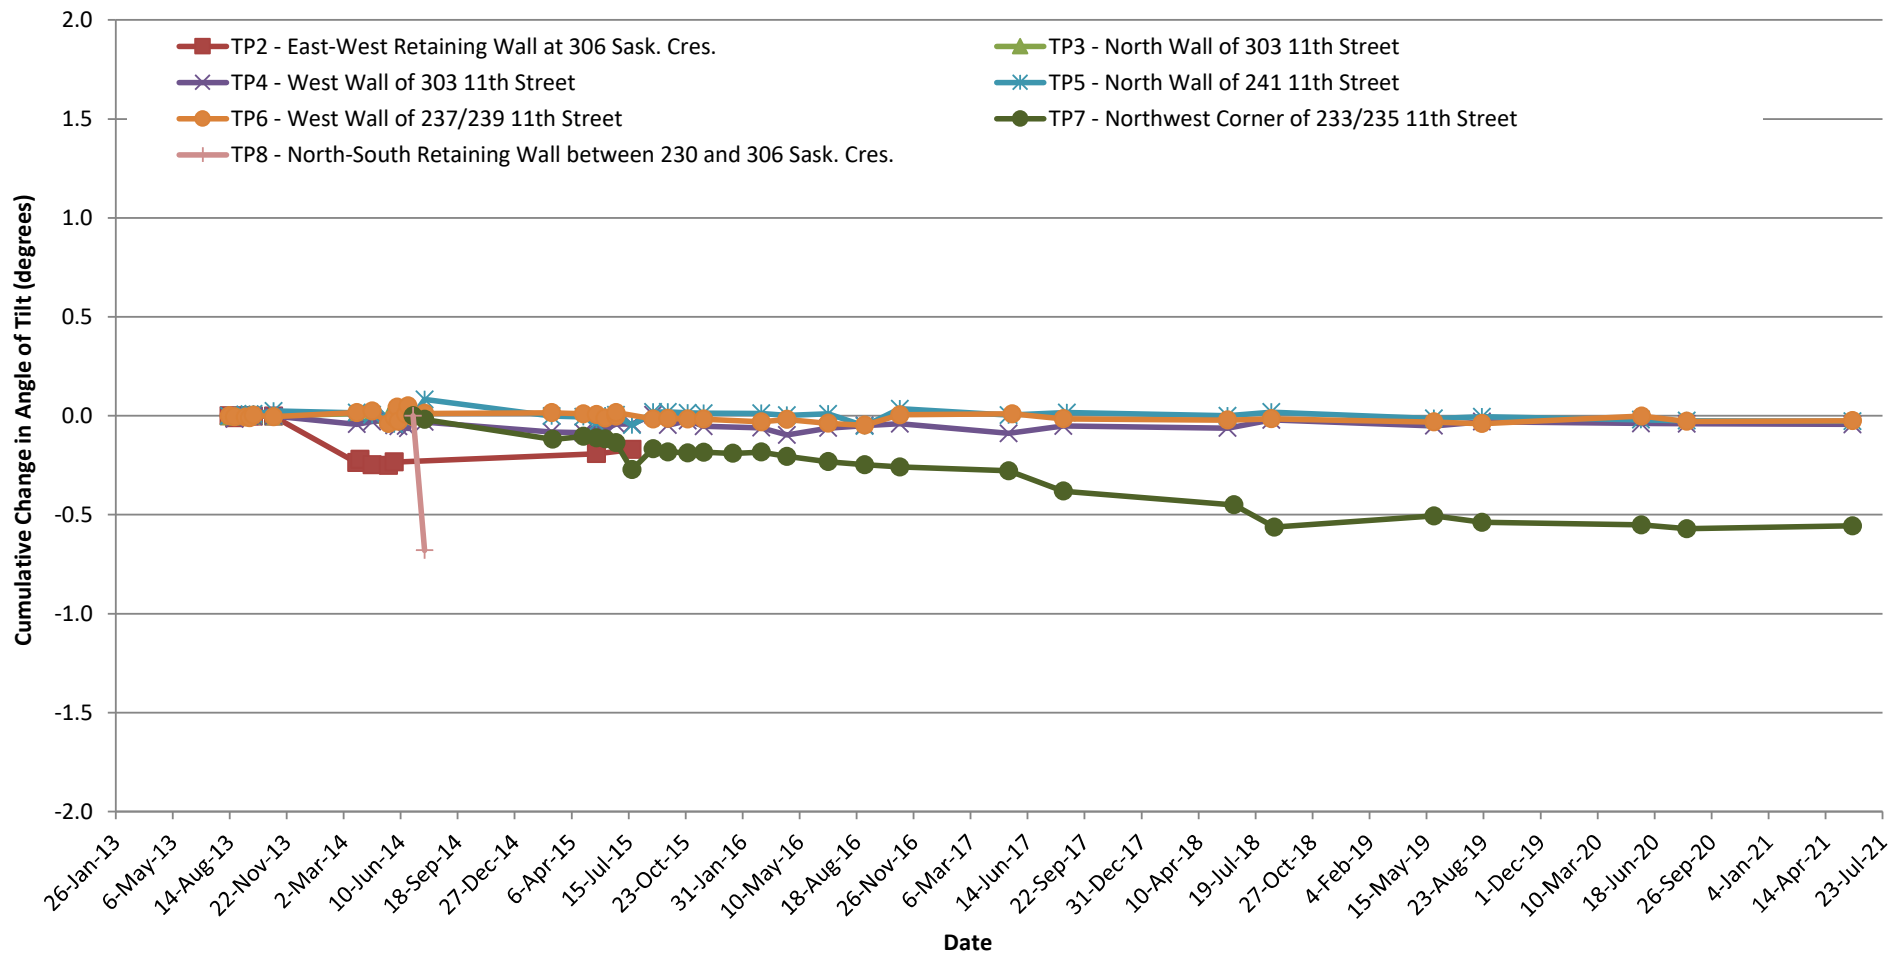
FIGURE: 4

- The results of tilt plate monitoring are shown on Figure 4 for the City of Saskatoon tilt plates, and in Figure 5 for the tilt plates installed on SL&P power poles.
- Tilt plates TP4, TP5, TP6, and TP7 indicate insignificant changes in angle of tilt (less than 0.05 degrees) between August 13, 2020 and May 31, 2021.
- Tilt plates SLP4, SLP5, and SLP 6 indicated insignificant changes in angle of tilt (less than 0.05 degrees) between August 13, 2020 and May 31, 2021.
- Tilt plate SLP3 indicated a change in angle of tilt of approximately 0.47 degrees, towards the north, between August 13, 2020 and May 31, 2021.

- 1) Positive changes in tilt indicate tilting toward the monitoring structure.
- 2) TP1, located on the retaining wall between 230 and 306 Sask. Cres., is not monitored for health and safety reasons; monitoring results for this tilt plate show a change in angle of tilt of approximately 9 degrees between August 2013 and June 2014.
- 3) TP3 and TP8 are destroyed, and TP2 is buried.

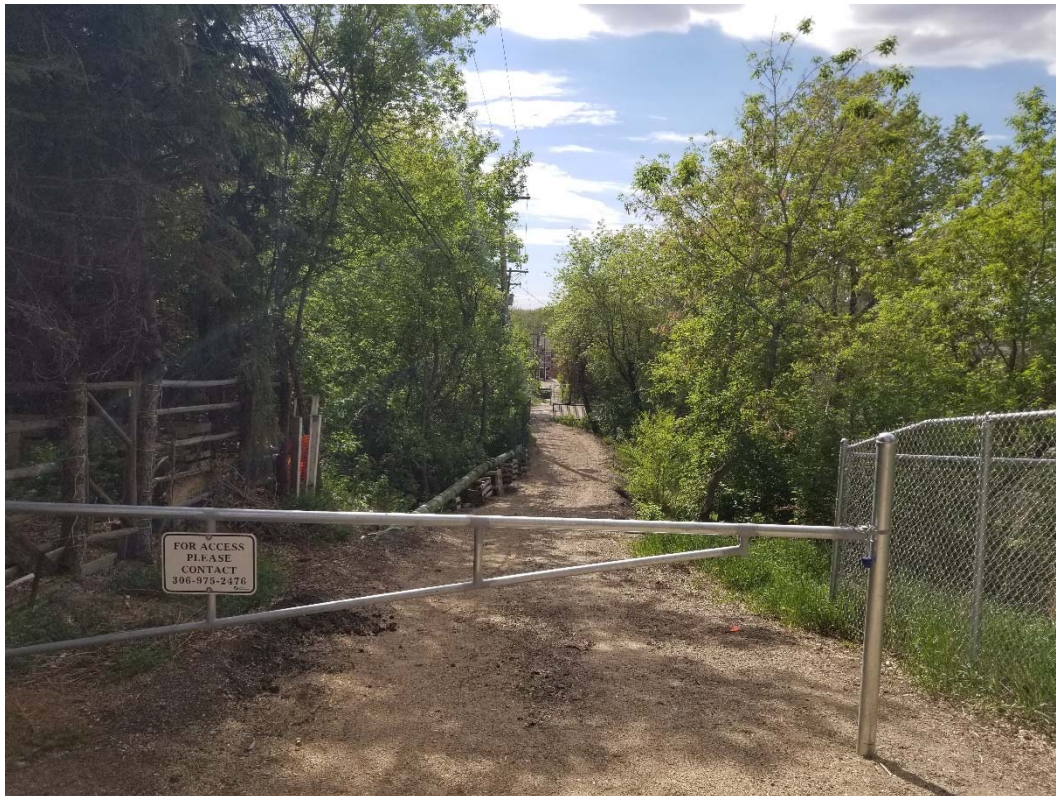
**Photograph 1: Looking west down the back alley at the East Failure (May 31, 2021)**

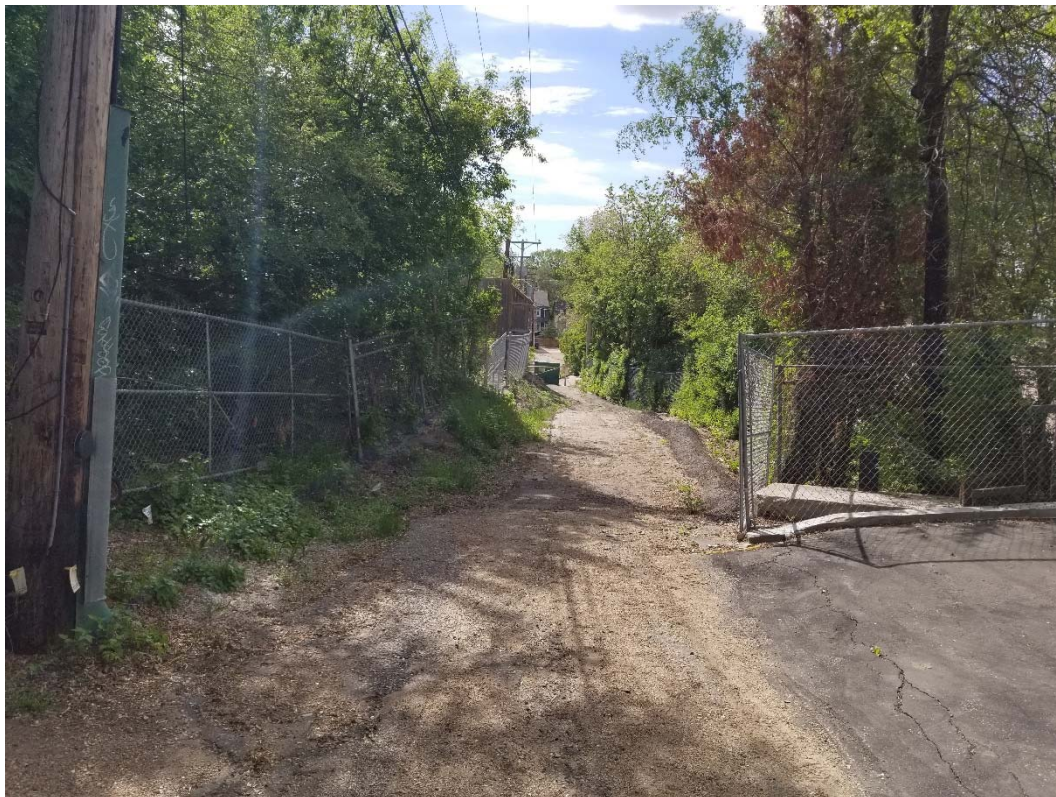
**Photograph 2: Looking west down the back alley at the West Failure (May 31, 2021)**
