## TECHNICAL MEMORANDUM

**Project No.** 20138294

### NUTANA SLOPE INSTABILITY UPDATE – MAY 2020

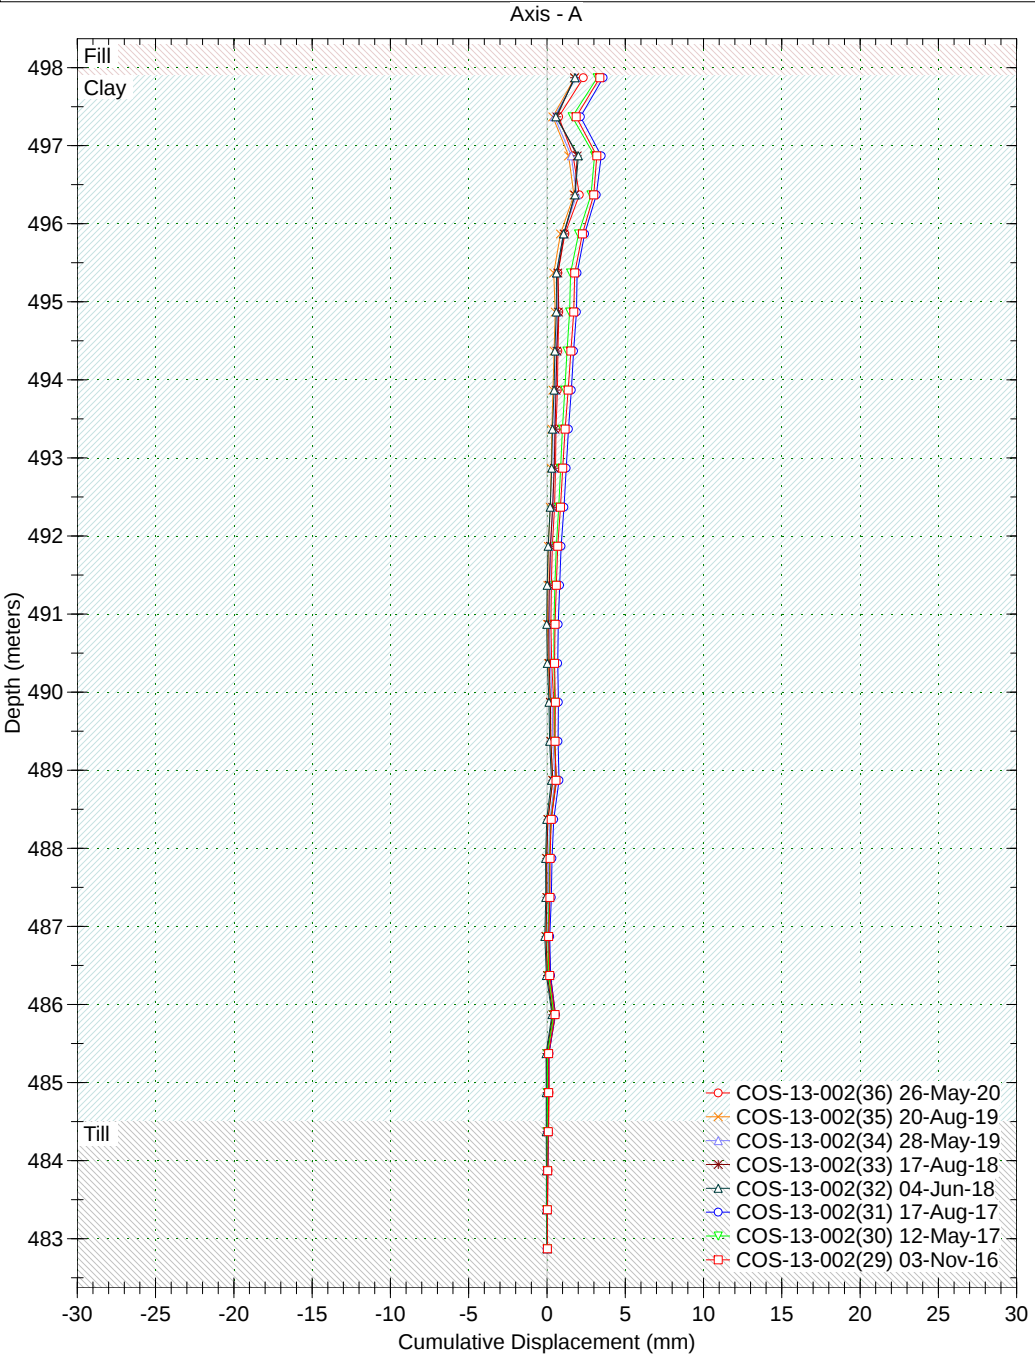
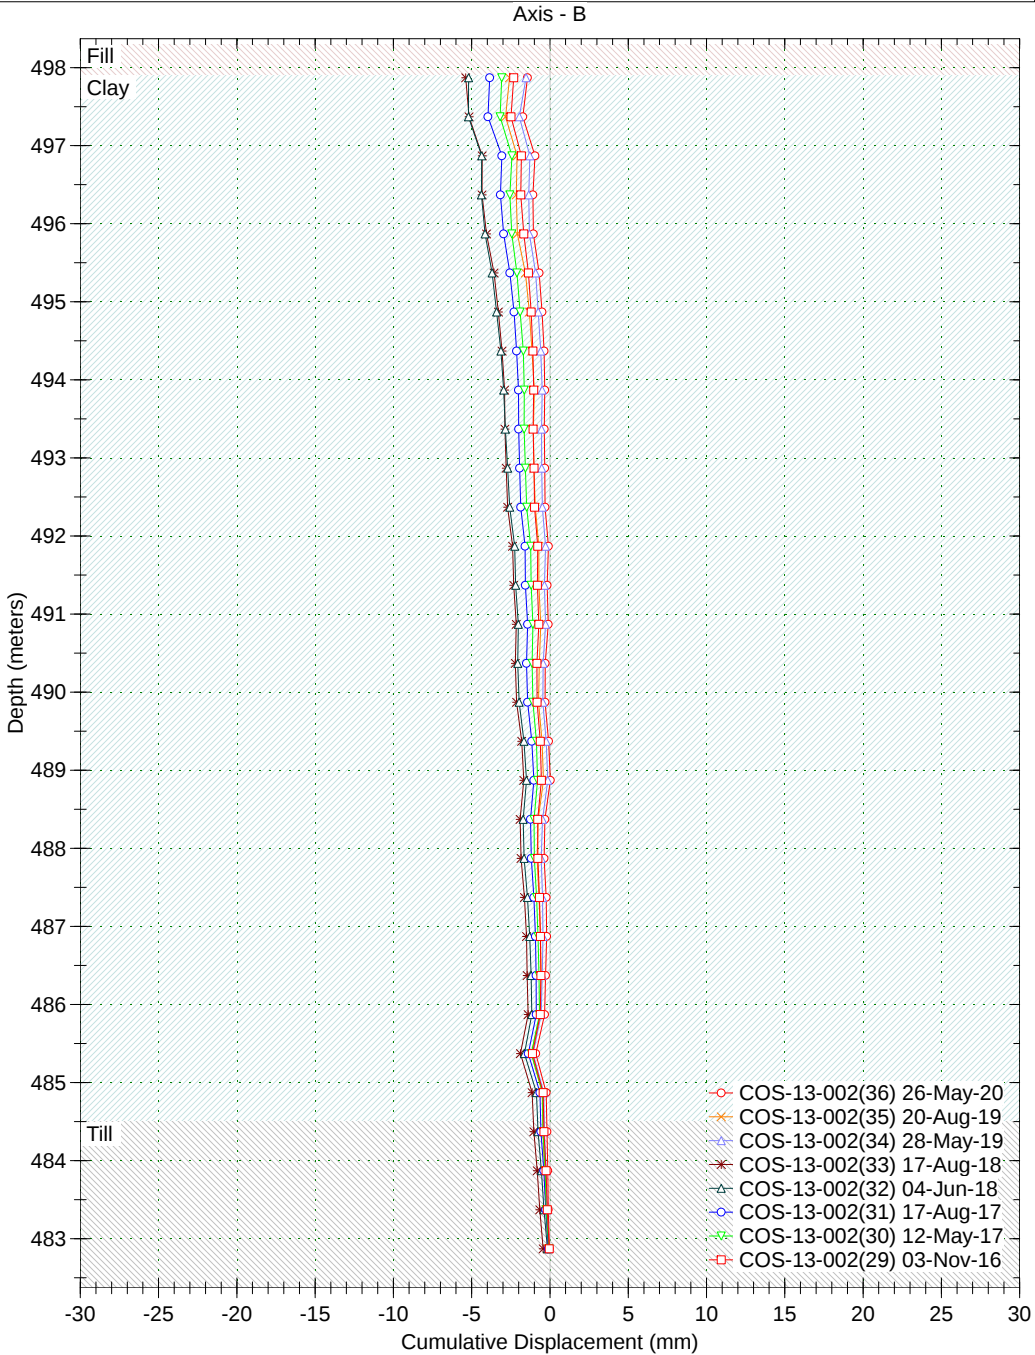
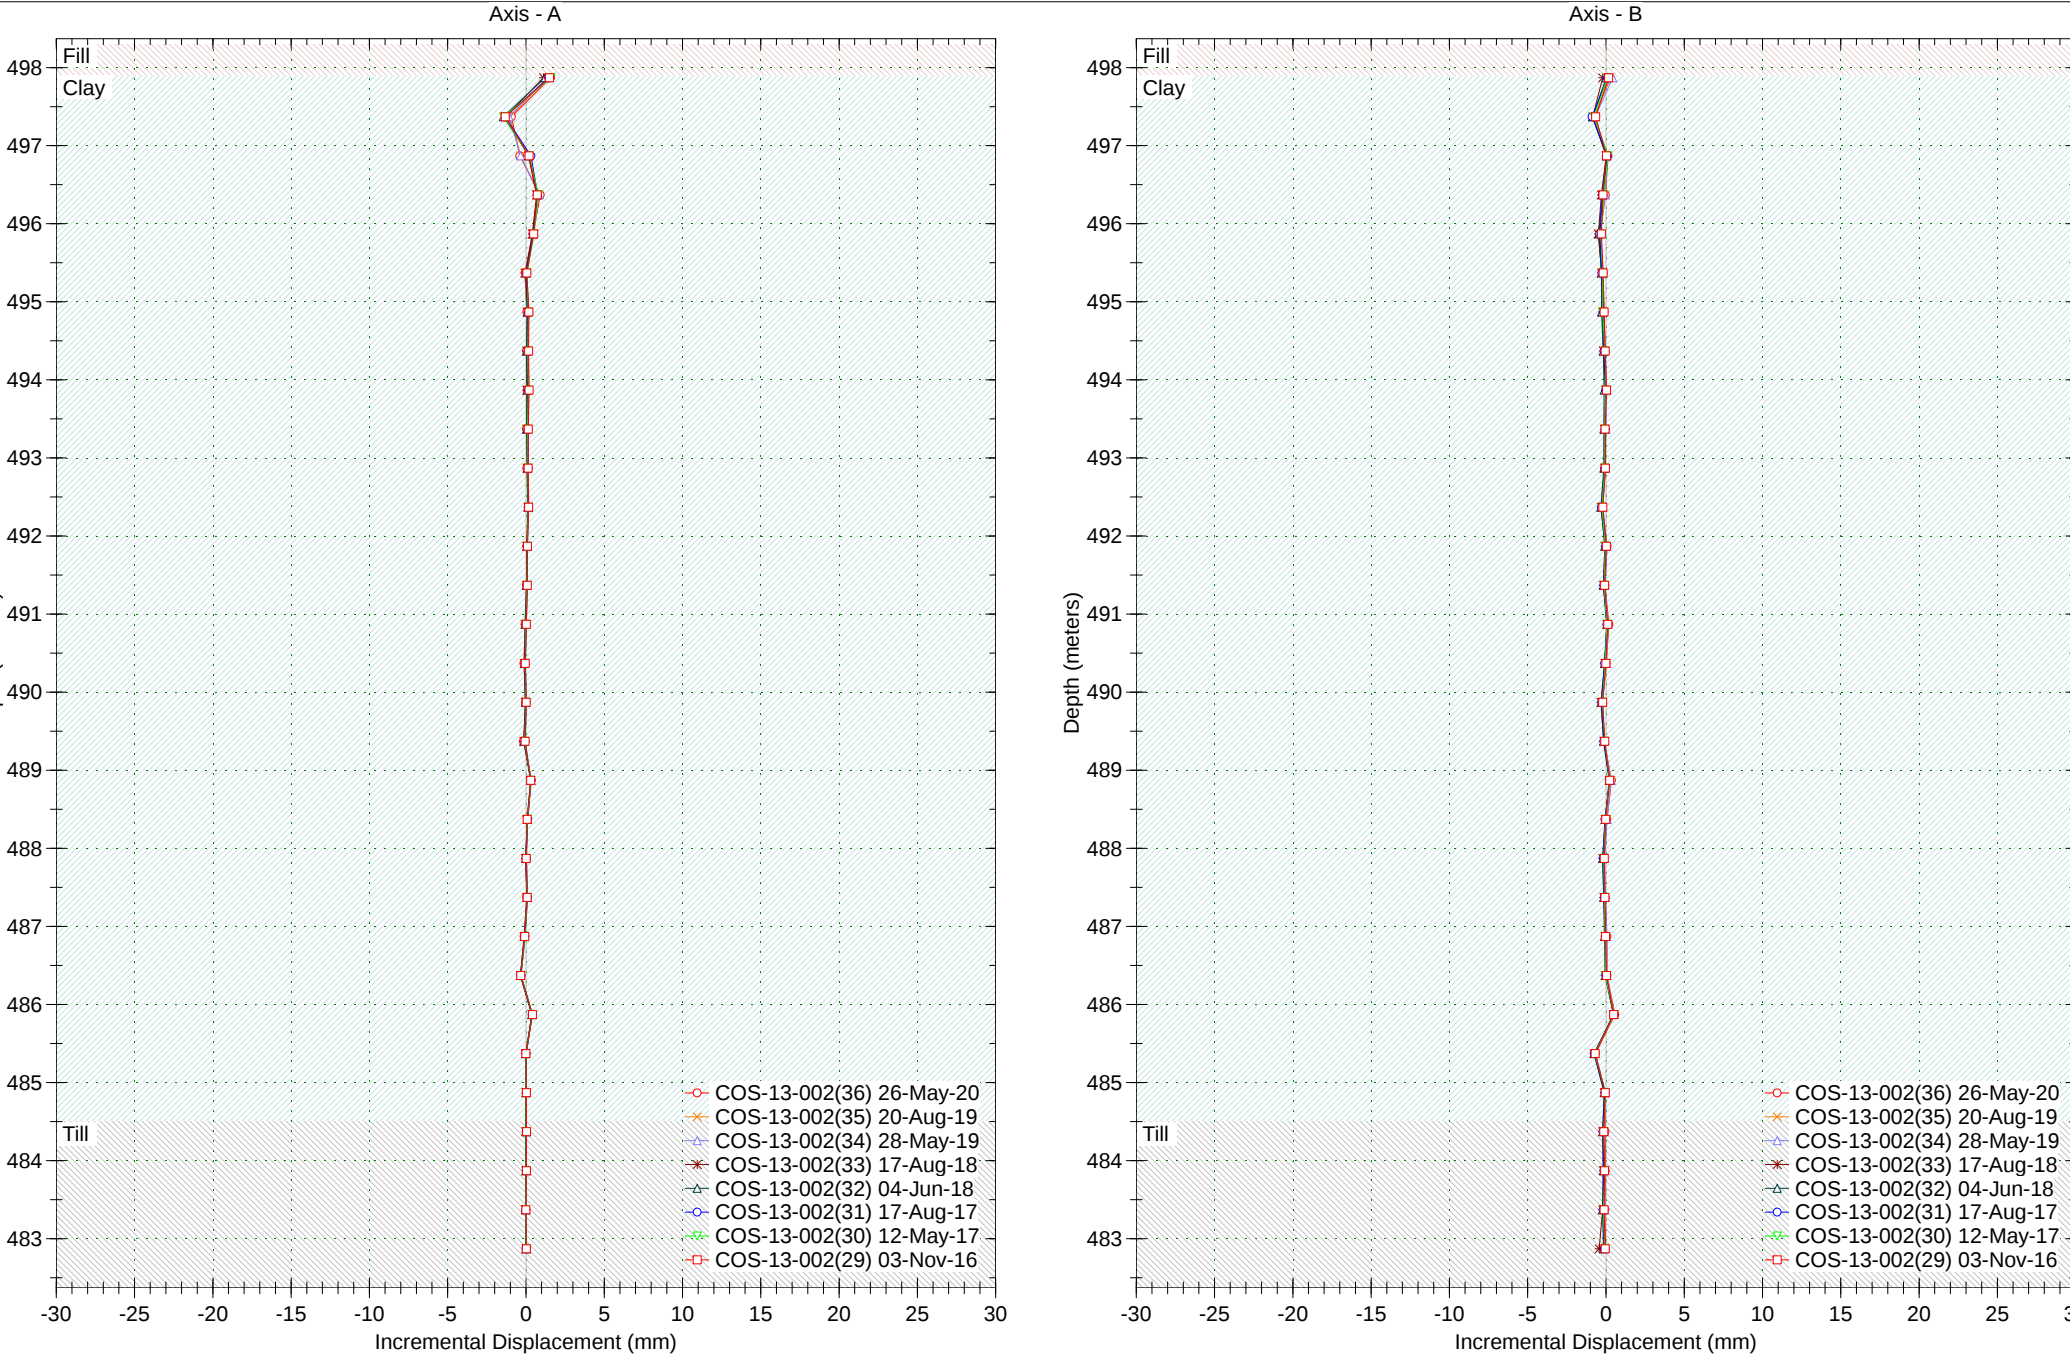
Borehole : COS-13-002  
Project : Nutana Slope  
Location : 307 11th St. E. (Front)  
Northing : 5775567.41  
Easting : 386043.54  
Collar : -0.113

- Inclinometers COS-13-002, COS-13-004, and COS-13-005 indicate insignificant movement (less than 2 mm or 0.08 in) between August 20, 2019 and May 26, 2020.
- Inclinometer COS-13-006 indicates some slight shifting (less than 4 mm or 0.16 in) between August 20, 2019 and May 26, 2020.

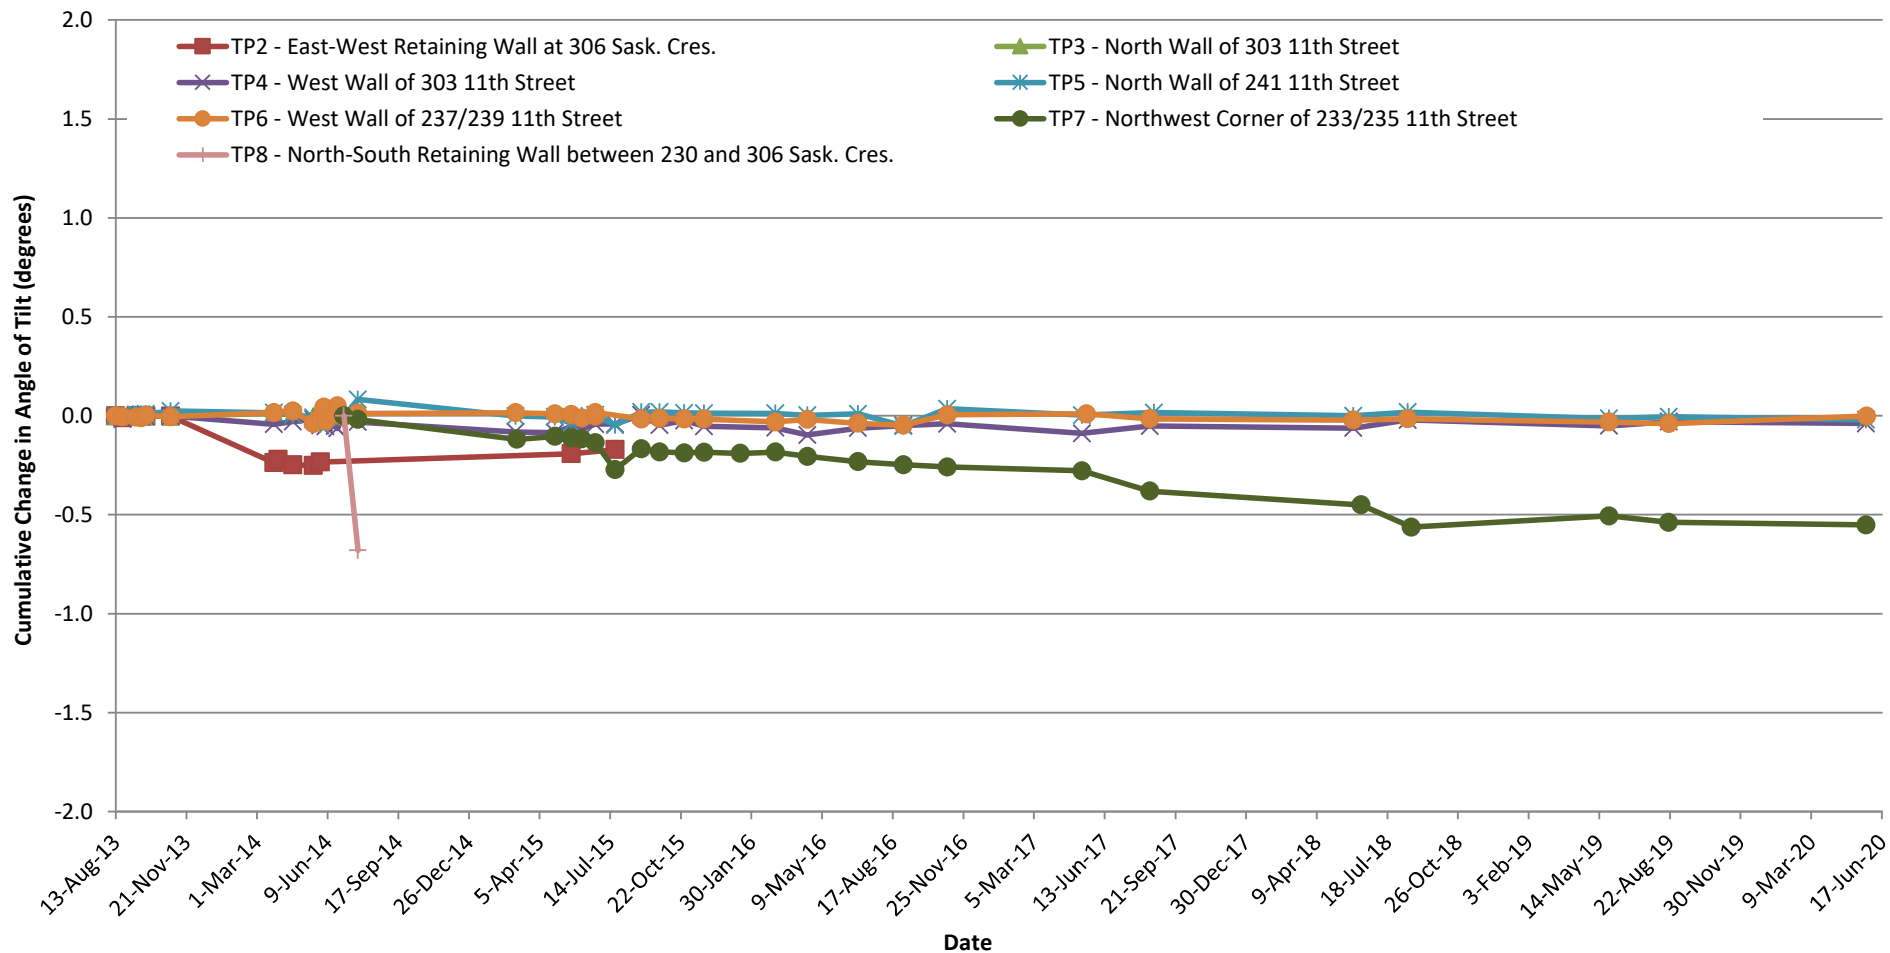
| CADD | | FIGURE: 4 | | |

- Tilt plates TP4, TP5, TP6, and TP7 indicate insignificant changes in angle of tilt (less than 0.05 degrees) between May 25/26, 2020 and August 20, 2019.

- 1) Positive changes in tilt indicate tilting toward the monitoring structure.
- 2) TP1, located on the retaining wall between 230 and 306 Sask. Cres., is not monitored for health and safety reasons; monitoring results for this tilt plate show a change in angle of tilt of approximately 9 degrees between August 2013 and June 2014.
- 3) TP3 and TP8 are destroyed, and TP2 is buried.

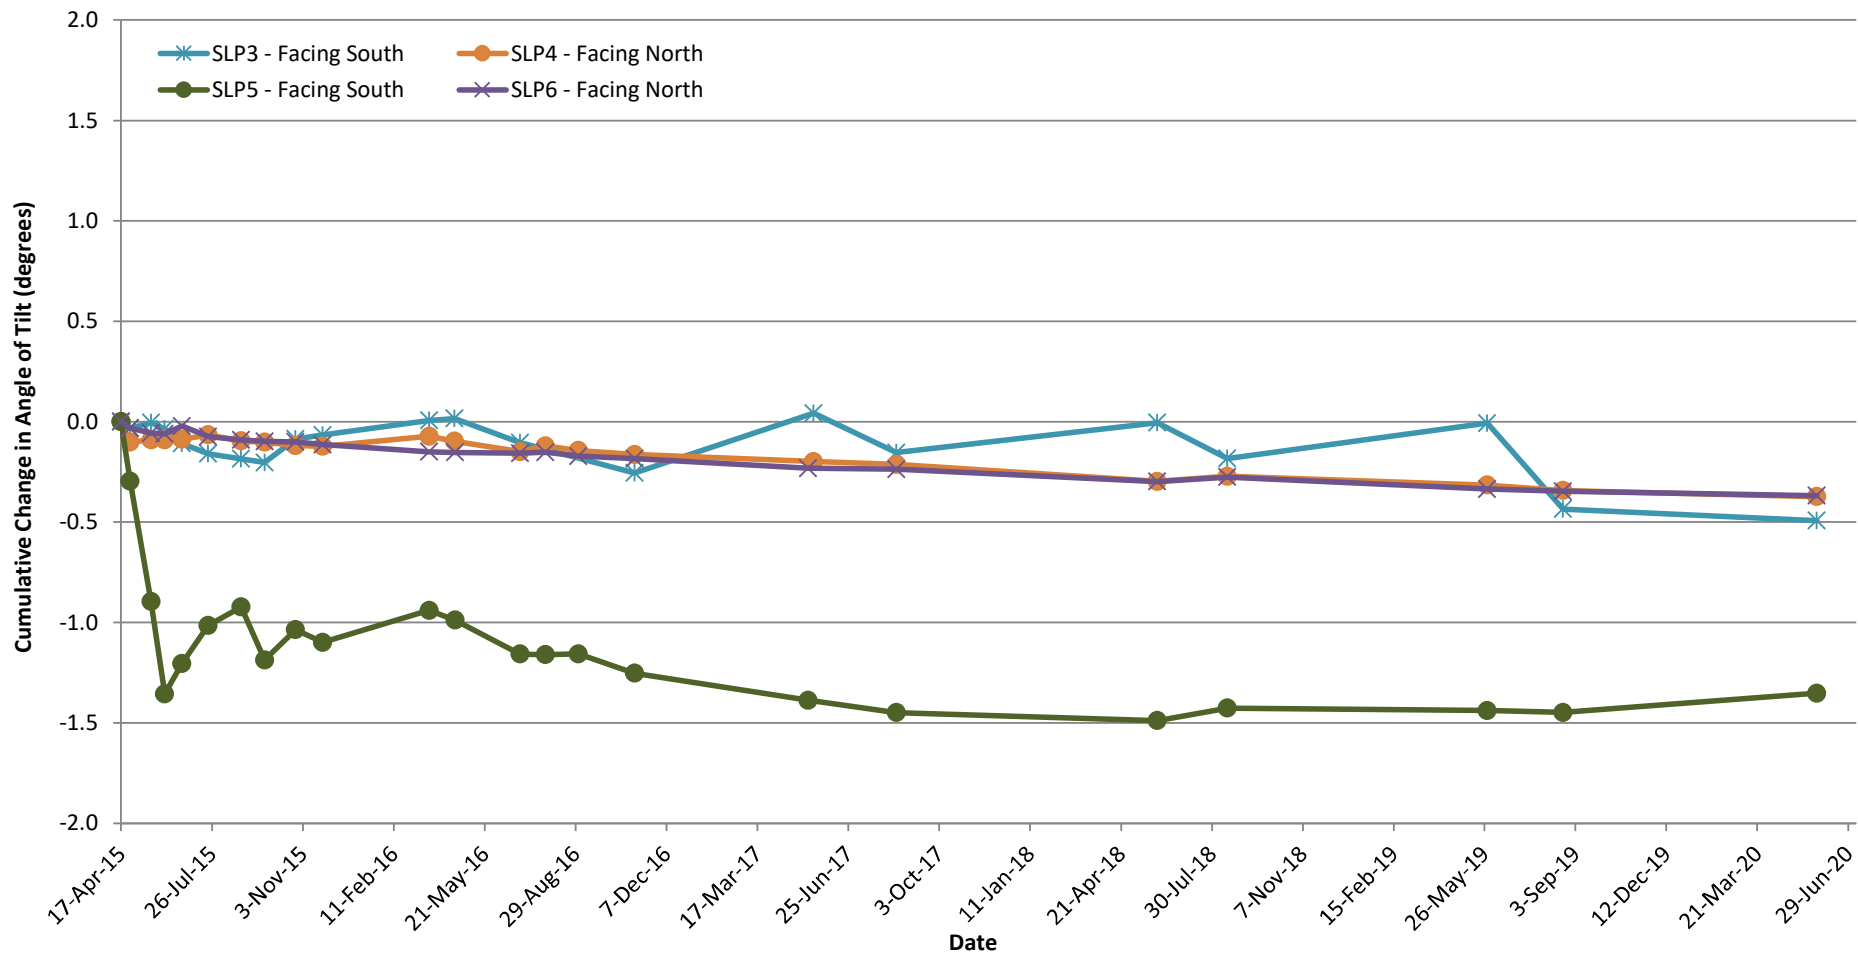
| | CHECK | | <b>FIGURE: 5</b> | |

- Tilt plates installed on SLP4 and SLP 6 indicated insignificant changes in angle of tilt (less than 0.05 degrees) between August 20, 2019 and May 25, 2020.

- Tilt plate installed on SLP3 indicates a change in angle of tilt of approximately 0.06 degrees, towards the south, between August 20, 2019 and May 25, 2020. Seasonal movements/shifting has been measured at his power pole since the tilt plate was installed in 2015.

- Tilt plate installed on SLP5 indicates a change in angle of tilt of approximately 0.1 degrees, towards the north, between August 20, 2019 and May 25, 2020.

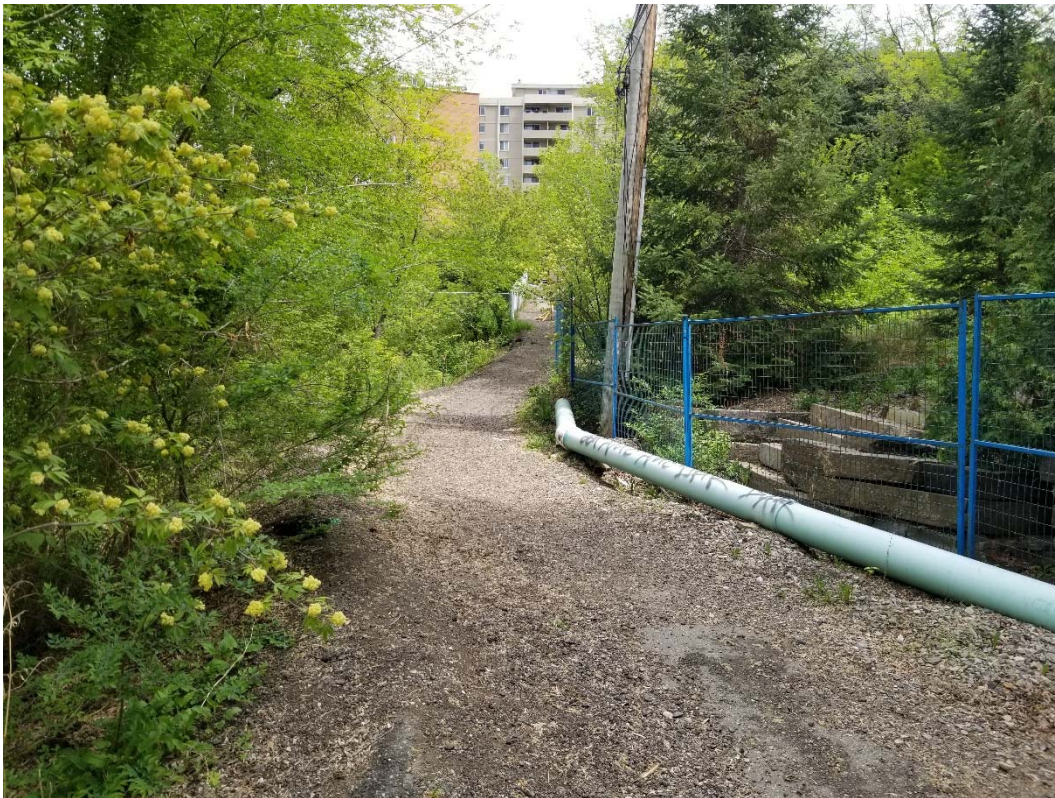
**Photograph 1: Looking east down the back alley at the East Failure (May 26, 2020)**

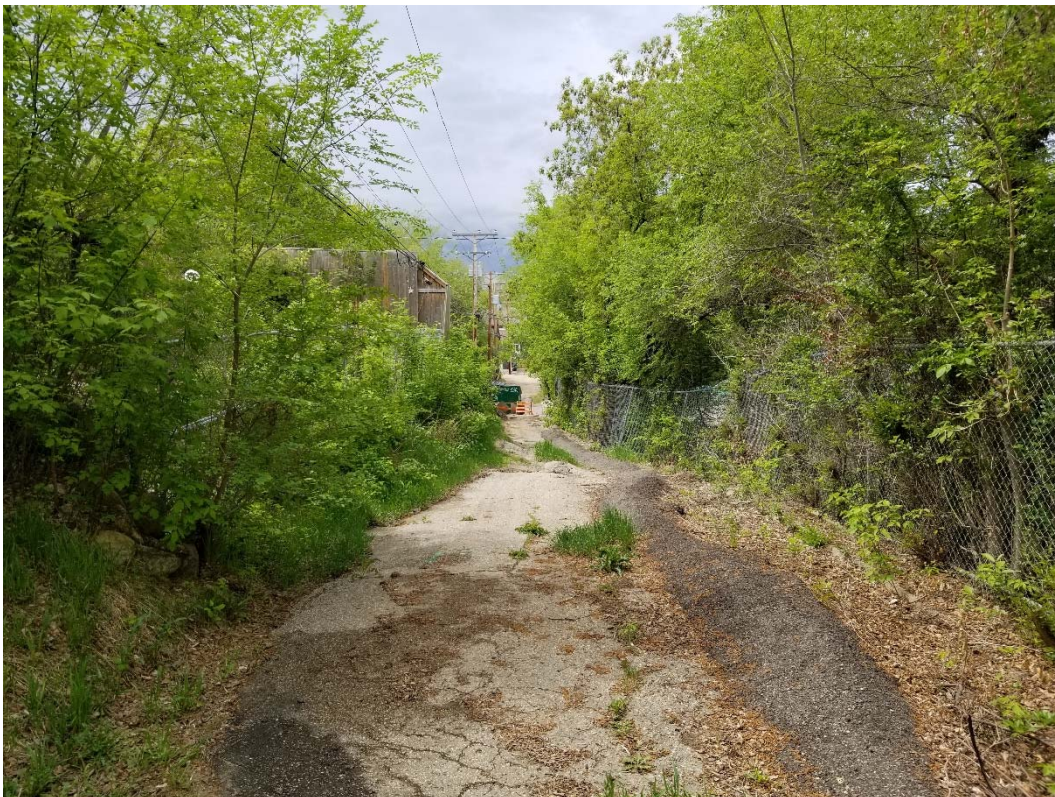
**Photograph 2: Looking west down the back alley at the West Failure (May 26, 2020)**
