## TECHNICAL MEMORANDUM

**Project No.** 20138294

### NUTANA SLOPE INSTABILITY UPDATE – AUGUST 2021

NUTANA SLOPE INSTABILITY

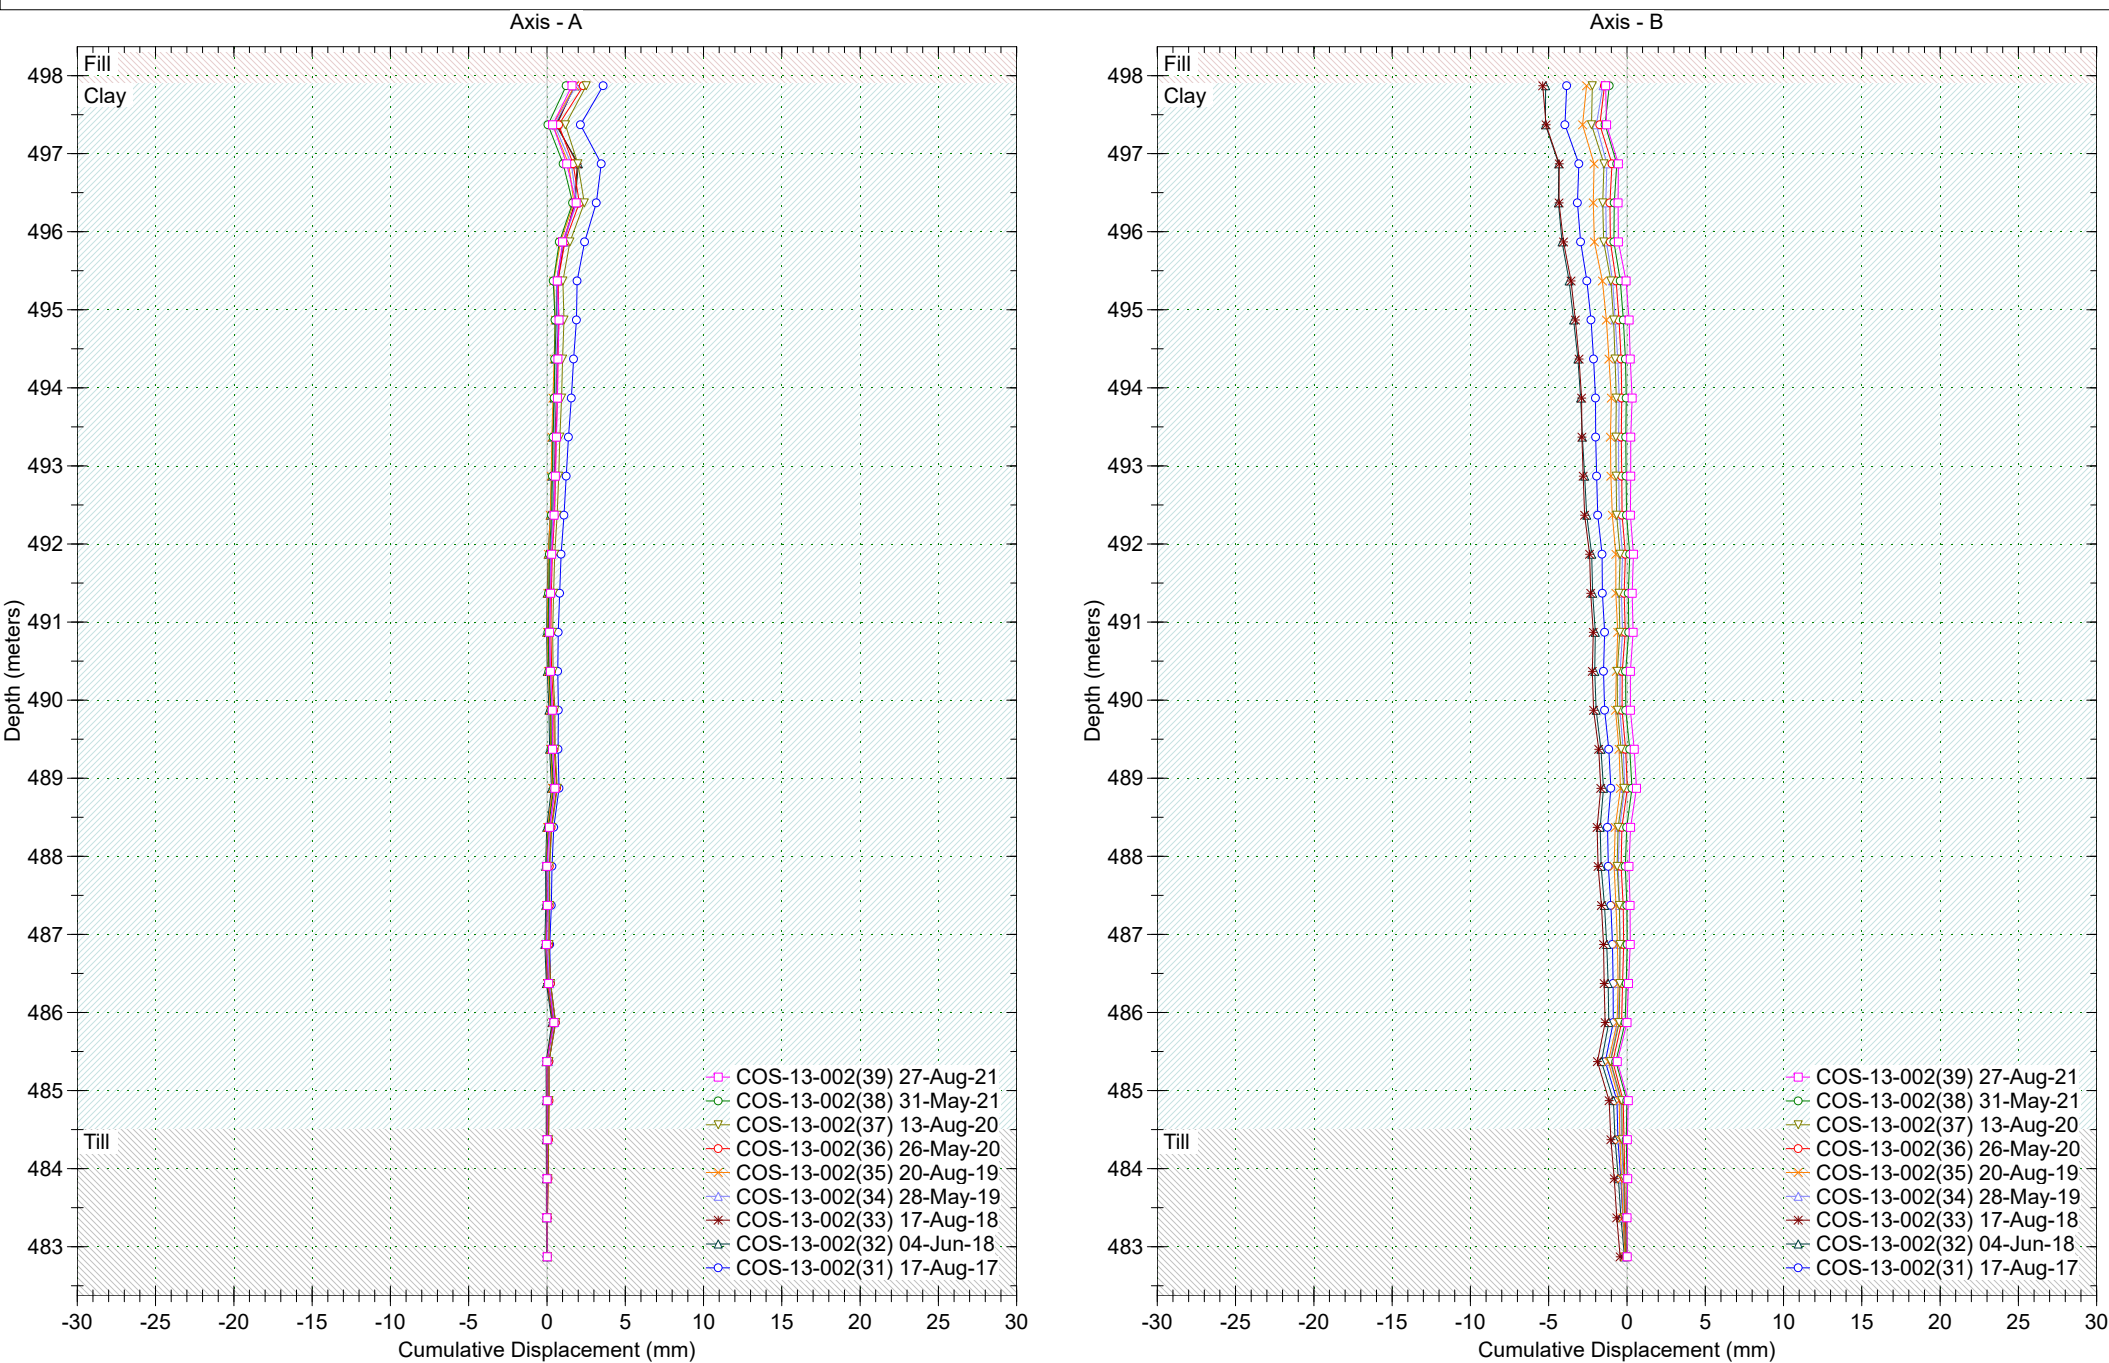
Borehole : COS-13-002  
Project : Nutana Slope  
Location : 307 11th St. E. (Front)  
Northing : 5775567.41  
Easting : 386043.54  
Collar : -0.113

- Inclinometer COS-13-002 indicated insignificant movement (less than 2 mm or 0.08 in) between May 31, 2021 and August 27, 2021.
- Inclinometer COS-13-004 indicated insignificant movement (less than 2 mm or 0.08 in) between June 3, 2021 and August 27, 2021.
- Inclinometer COS-13-005 indicated between 1.5 mm to 2.5 mm (0.06 in to 0.10 in) between May 31, 2021 and August 27, 2021.
- Inclinometer 20-109 indicated insignificant cumulative surface movement (less than 2 mm or 0.08 in) between May 31, 2021 and August 27, 2021. However, some shifting is noted between 1.0 m and 2.5 m below ground surface (bgs).

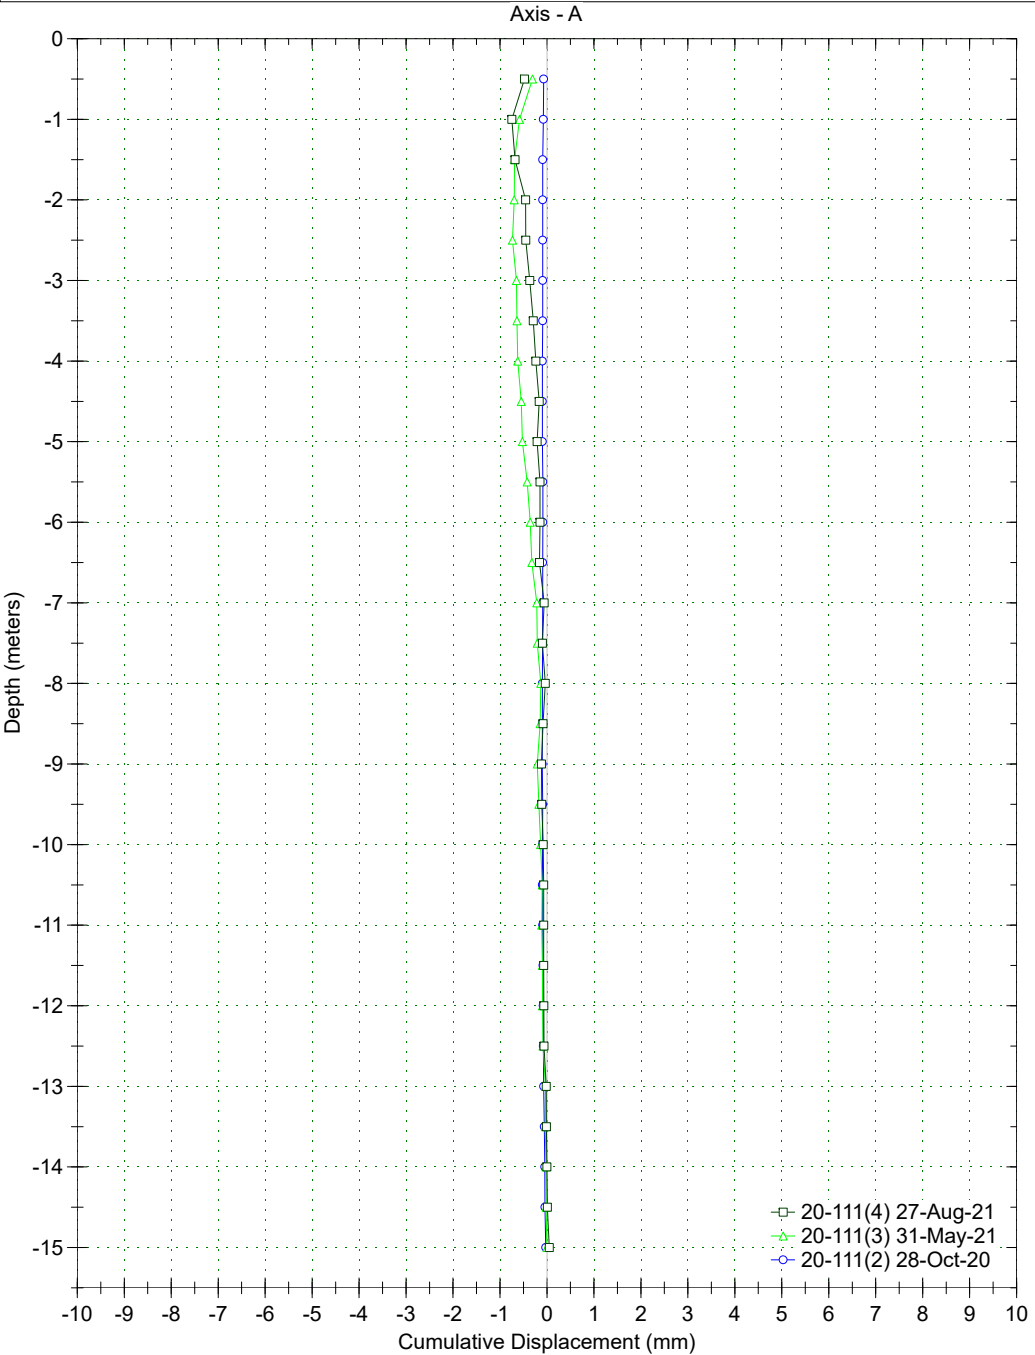
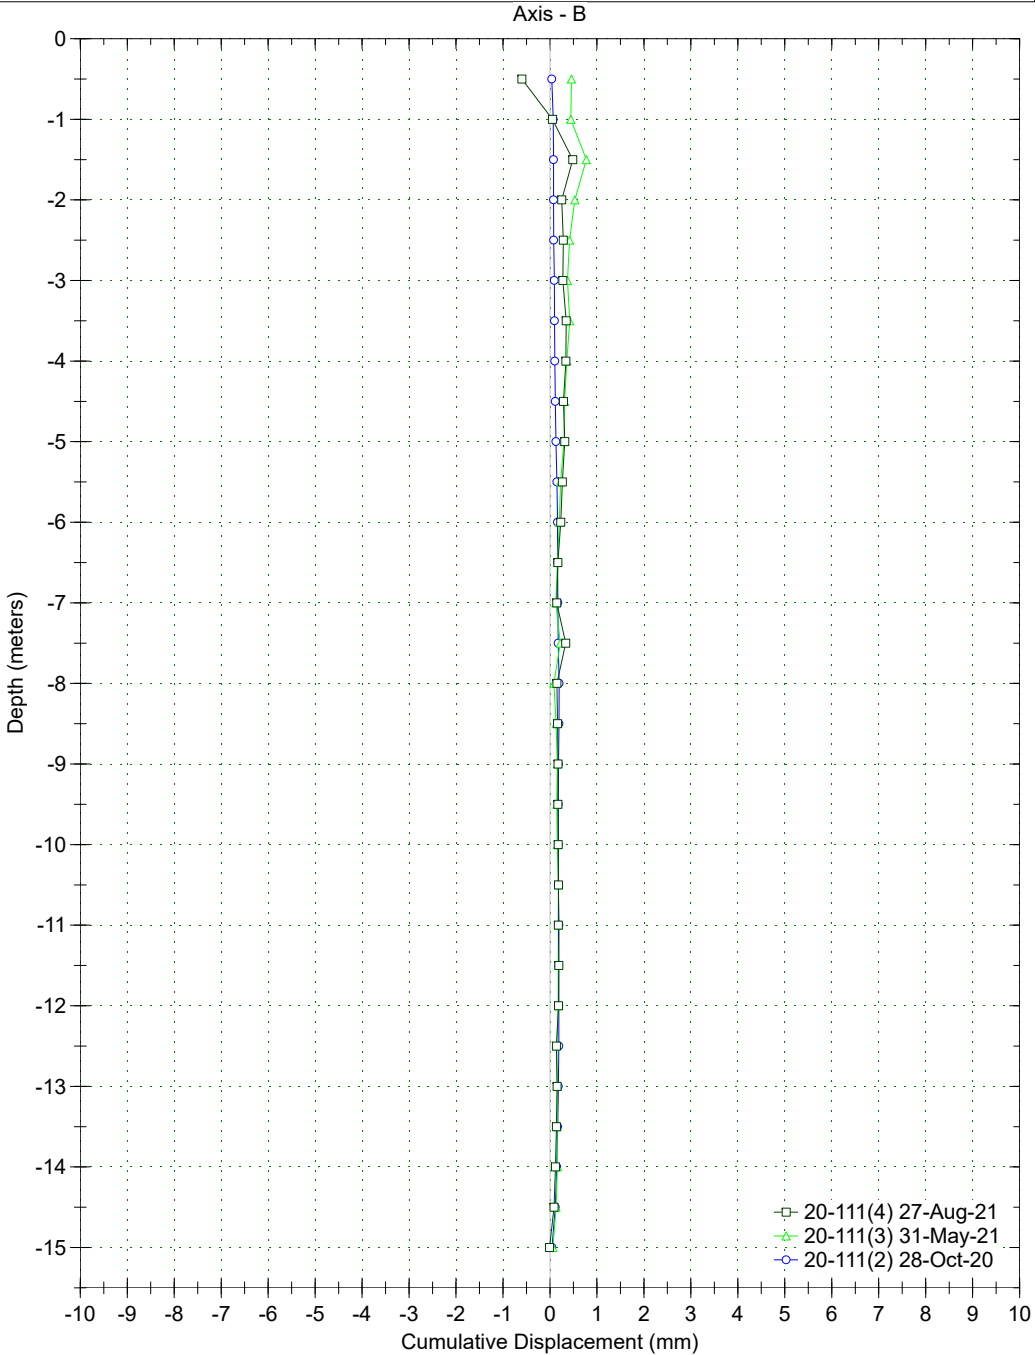
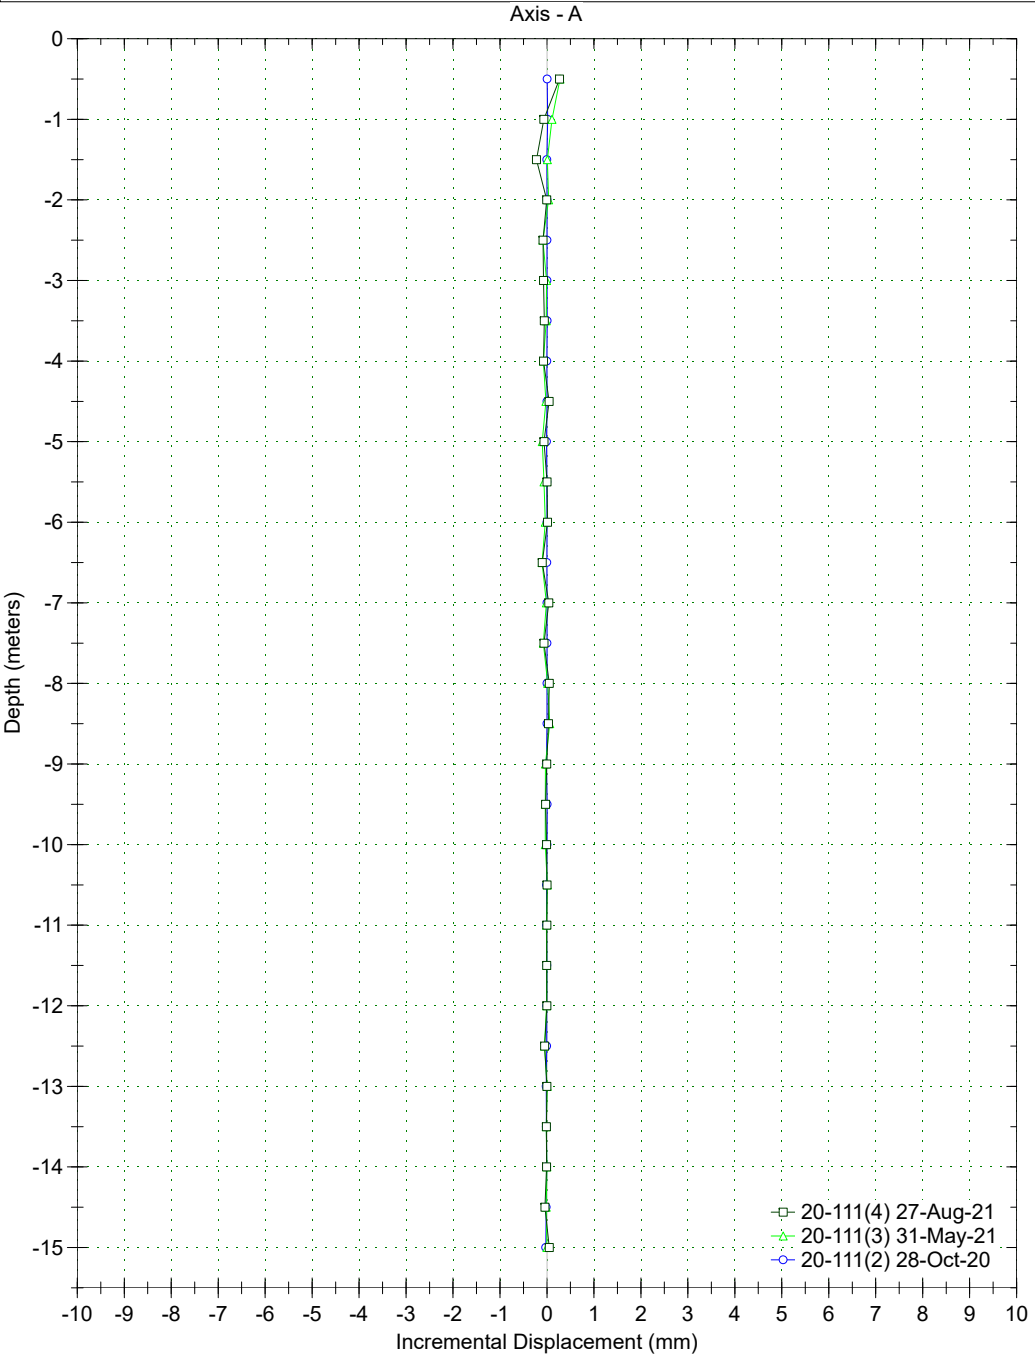
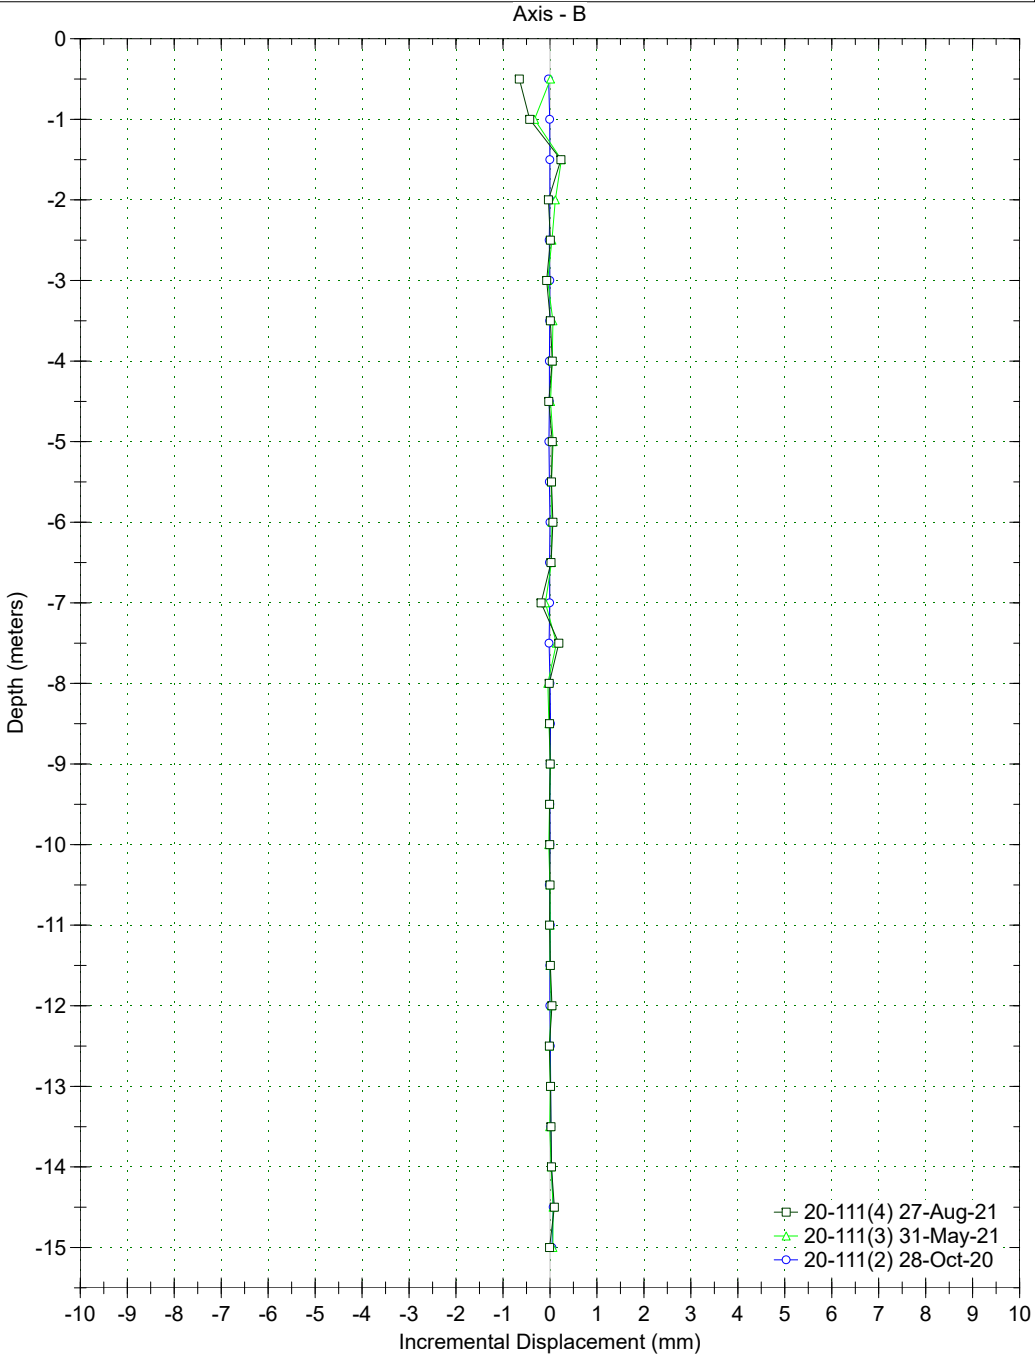
Borehole : 20-111  
Project : Nutana Slope  
Location :  
Northing : 5775568  
Easting : 385953  
Collar :

- Inclinometer 20-111 indicated approximately 2 mm of movement (0.08 in) along the B axis between May 31, 2021 and August 27, 2021.

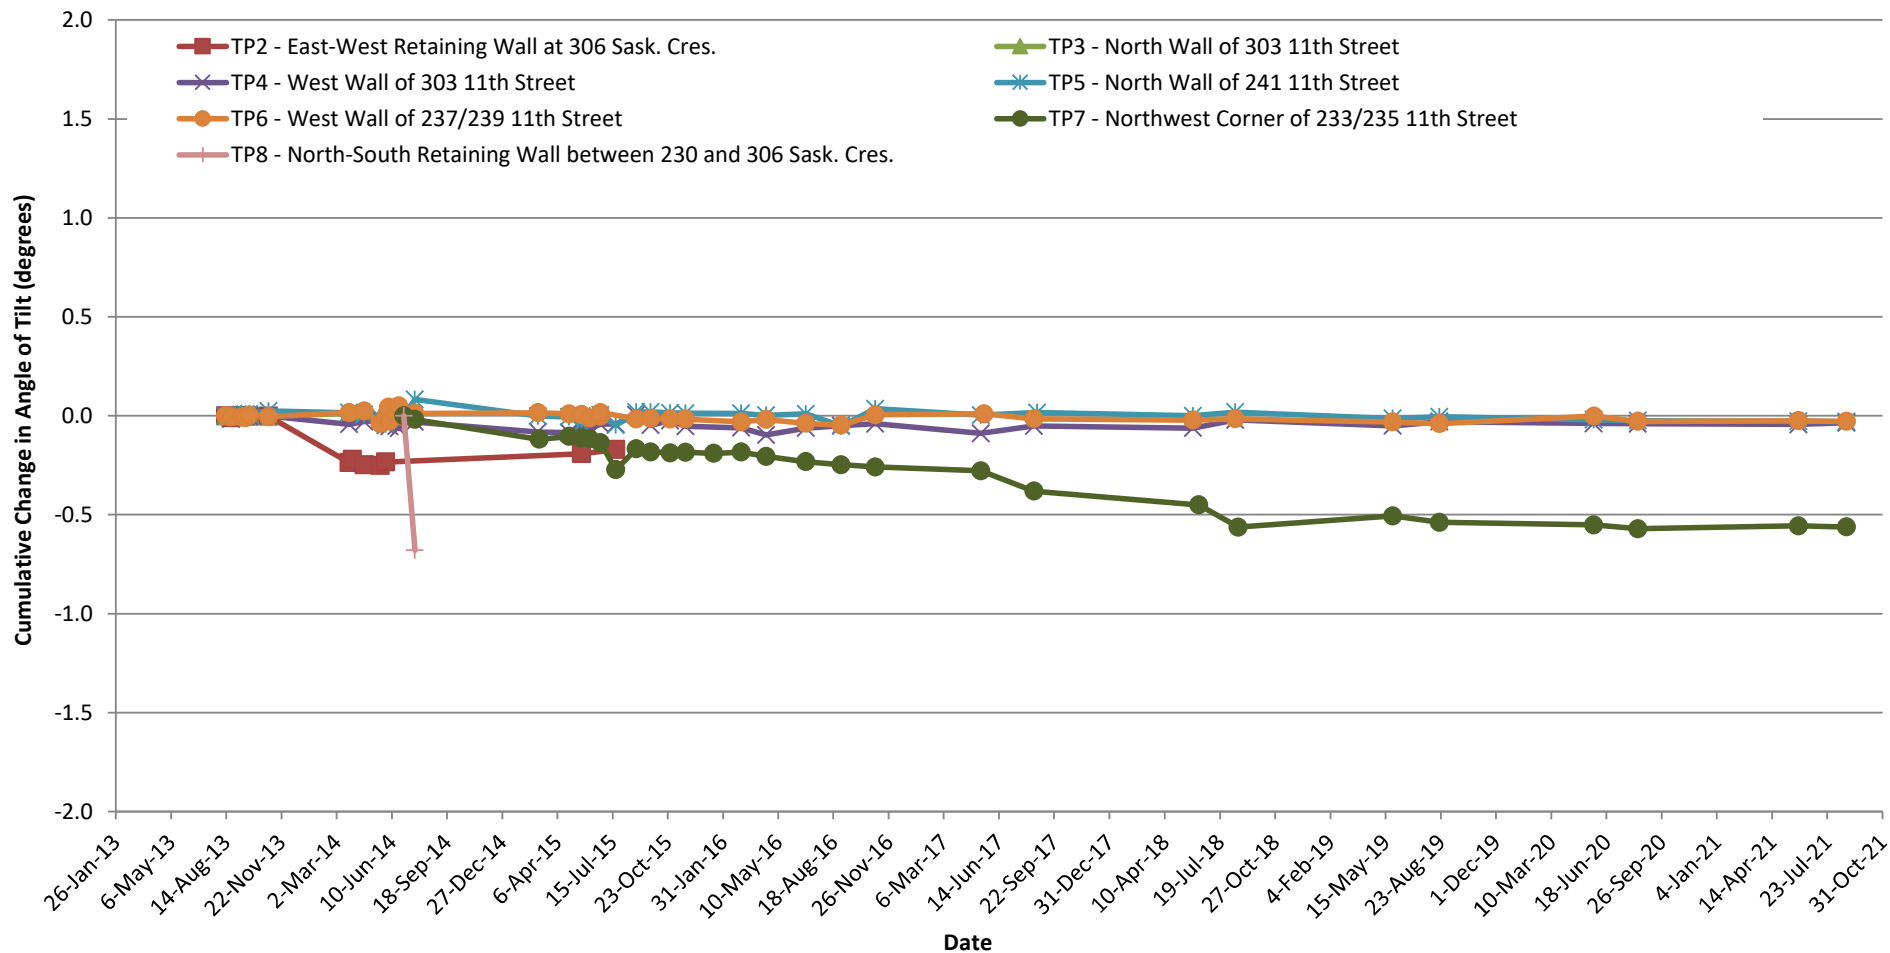
| | | | | | | FIGURE: 4 | | | |

- The results of tilt plate monitoring are shown on Figure 4 for the City of Saskatoon tilt plates, and in Figure 5 for the tilt plates installed on SL&P power poles.
- Tilt plates TP4, TP5, TP6, and TP7 indicate insignificant changes in angle of tilt (less than 0.05 degrees) between May 31, 2021 and August 27, 2021.
- Tilt plates SLP4, SLP5, and SLP 6 indicated insignificant changes in angle of tilt (less than 0.05 degrees) between May 31, 2021 and August 27, 2021.
- Tilt plate SLP3 indicated a change in angle of tilt of approximately 0.16 degrees, towards the south, between May 31, 2021 and August 27, 2021.

- 1) Positive changes in tilt indicate tilting toward the monitoring structure.
- 2) TP1, located on the retaining wall between 230 and 306 Sask. Cres., is not monitored for health and safety reasons; monitoring results for this tilt plate show a change in angle of tilt of approximately 9 degrees between August 2013 and June 2014.
- 3) TP3 and TP8 are destroyed, and TP2 is buried.

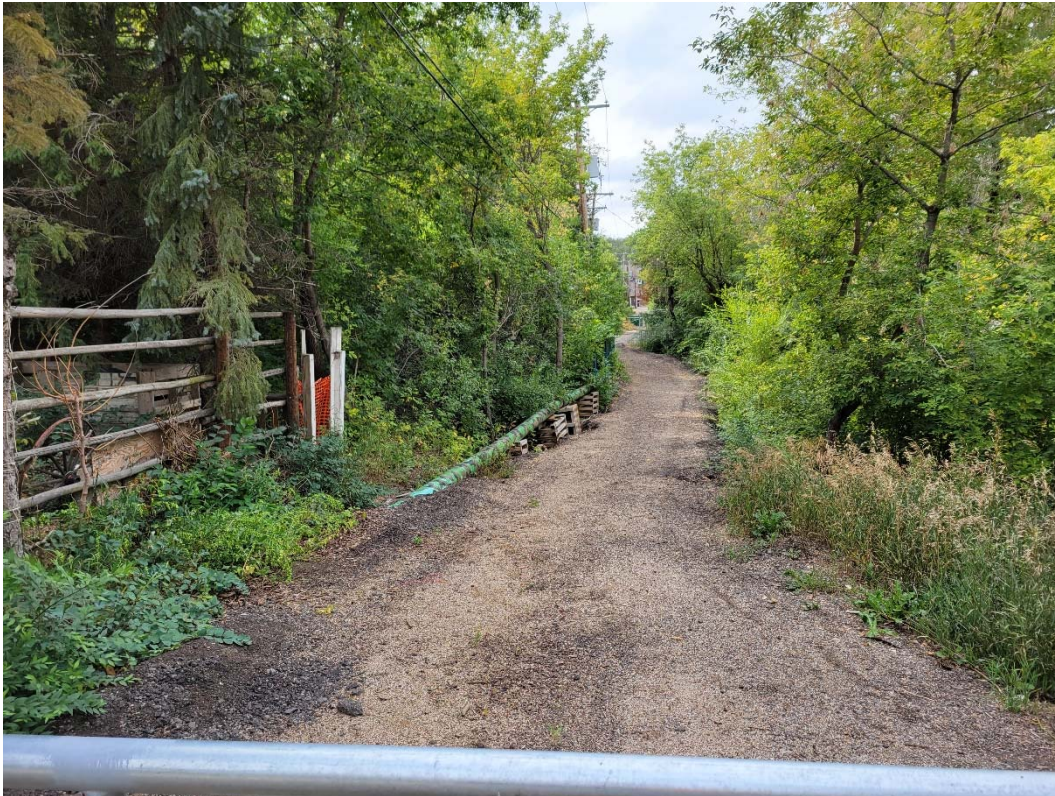
**Photograph 1: Looking west down the back alley at the East Failure (August 27, 2021)**

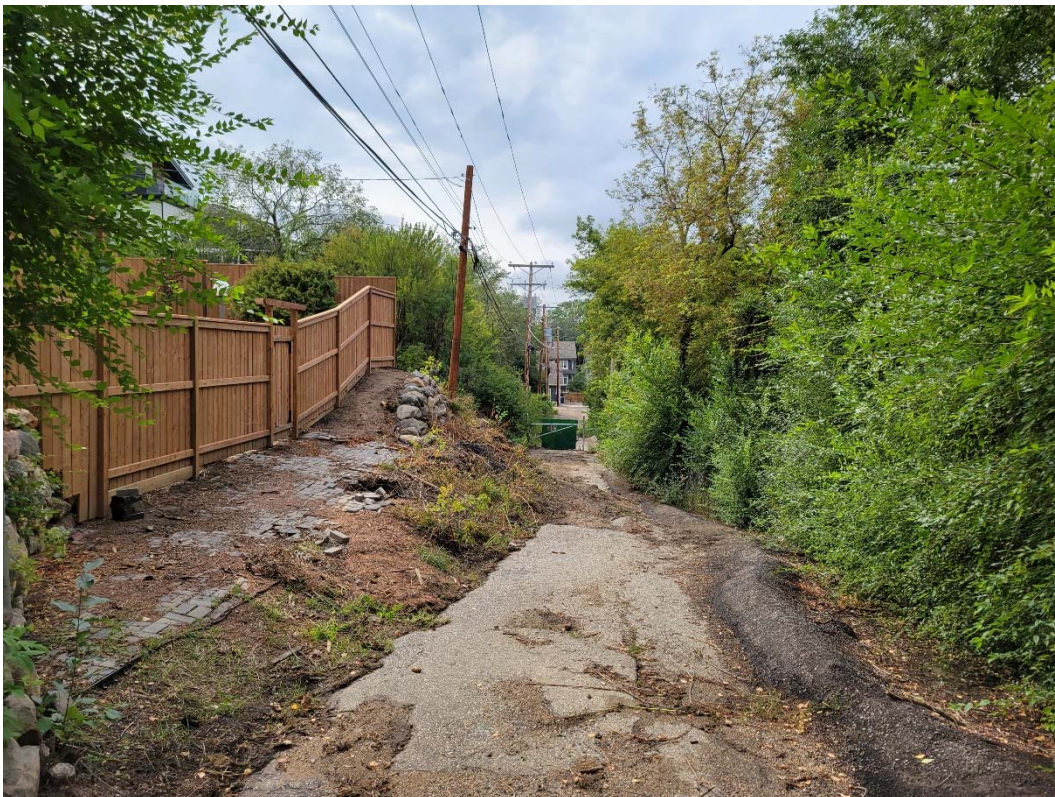
**Photograph 2: Looking west down the back alley at the West Failure (August 27, 2021)**
