Mendel Site Safety Audit Final Report

June 27, 2011 | Community Services Department, Planning & Development Branch

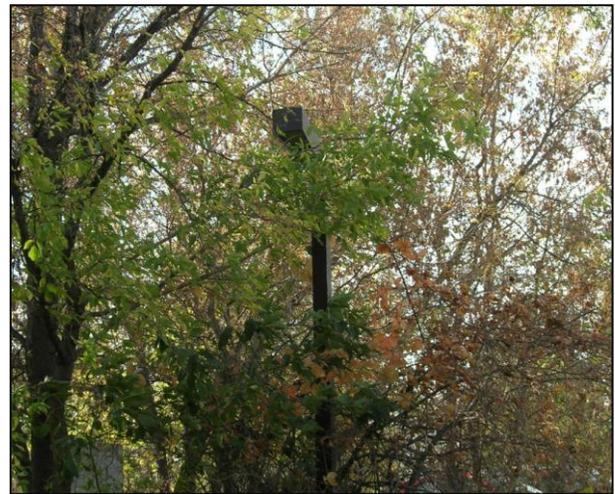
At the time of the Safety Audit, lighting conditions at the Mendel Site were observed to be inadequate as result of a number of lights being obscured by tree foliage. In addition, one or two lights in the parking lot and around the Mendel building were not working. A lack of consistent lighting throughout the site results in dark spots between lights and inconsistent path illumination. Creating a well lit area by increasing the number of lights, making necessary repairs, and trimming foliage around lighting will increase users’ perceptions of safety.

Foliage is obstructing lighting along a pathway near the parking lot.

Creating a well lit area by increasing the number of lights, making necessary repairs, and trimming foliage around lighting will increase users’ perceptions of safety

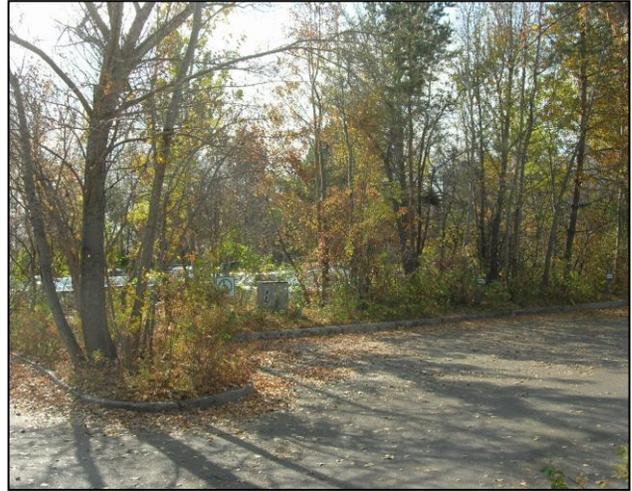
Although used for aesthetic and screening purposes, the number and density of trees, shrubs and bushes at the Mendel Site makes it difficult to clearly see into neighbouring parking lots or pathways. Heavy foliage along Spadina Crescent East further hampers visibility to and from nearby roadways. A higher standard of maintenance for mature shrubbery and bushes around the site will provide users with improved sightlines into and out of the area, and enhance personal perceptions of safety.

Boundary of trees, bushes and shrubs, separate the parking lots and reduce sightlines.

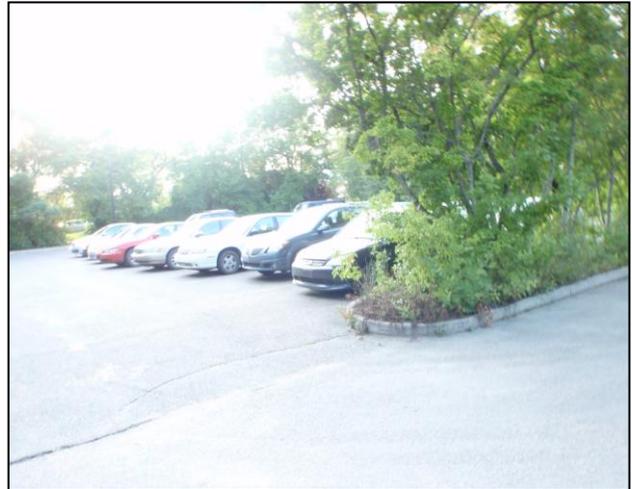
Surface pavement within the parking lots and along the pathways is cracked, indented and/or uneven in certain locations. Loose gravel and stones can also be found. These inconsistencies create physical safety issues for pedestrians and cyclists, and can cause vehicular damage. Through maintenance and repair of surface pavement imperfections, the potential hazards they cause can be minimized if not prevented.

Surface pavement cracks and depressions.

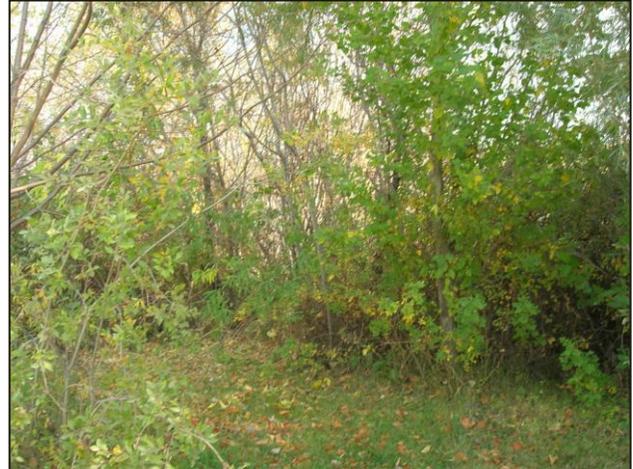
Potential hiding places exist throughout the Mendel Site. Examples include the east side area of the Mendel building (by the stairs) and in pockets of trees and brush along the pathways. These areas represent possible entrapment zones. Other areas of concern include the recessed doorway at the back of the Mendel Art Gallery and the Shearwater Boat Tours site.

Possible entrapment zone adjacent to one of the park pathways.

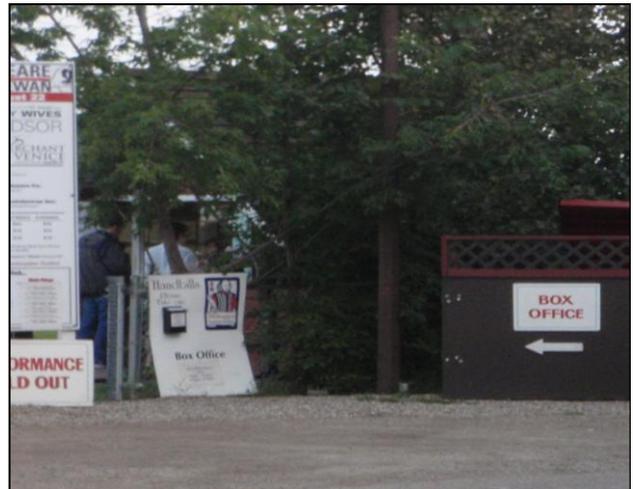
Signage present at the Mendel Site is limited. There is no permanent signage that establishes what the site is and what it is used for. There are also no maps or directions to the riverbank pathways, Shakespeare site or boat dock. There is also no emergency or maintenance contact information displayed on site. Increased signage in the area would help to define the space and provide valuable information to users.

One of the few signage examples at the Park, located outside of the Shakespeare Site.

Increased signage in the area would help to define the space and provide valuable information to users

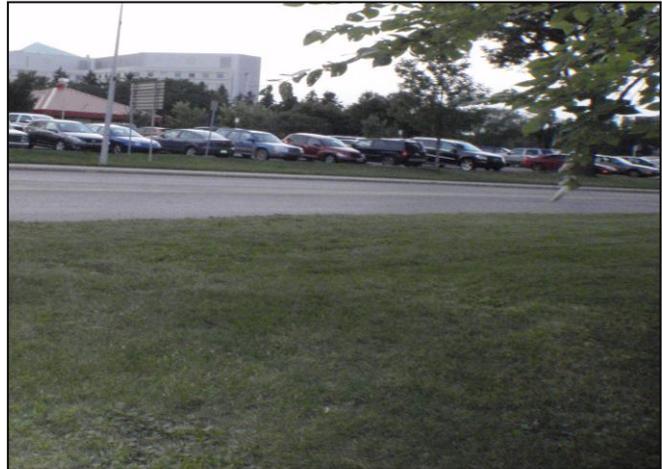
There is no continuous path or sidewalk that runs directly alongside Spadina Crescent East (across from Kinsmen Park). Pedestrians have no choice but to use the pathway through the Mendel Site. Developing an alternate route where pedestrians are able to continue along the road would give people a choice of paths. This would be of particular benefit during night time hours.

No path exists along Spadina Crescent adjacent to the Mendel Site. Users are directed into the Mendel Site.

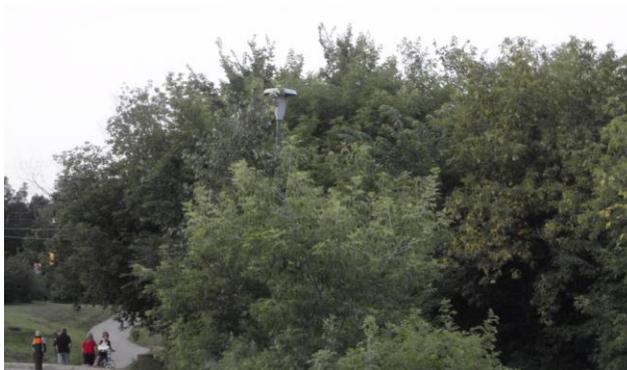
Finding:	The number and density of the trees, shrubs and bushes that are on the periphery of and in between each parking lot makes it difficult to maintain clear sightlines and limits natural surveillance. Heavy foliage along adjacent pathways and Spadina Crescent East further reduces visibility from neighbouring sites. Other areas with significant tree and shrub overgrowth include pathways behind the Mendel Art Gallery, around the boat dock area and the Shakespeare on the Saskatchewan site. The Parks Branch completed a pruning “clean up” in 2010; however, the site requires further maintenance of foliage to improve natural surveillance in the area.
Recommendation:	That the Planning and Development Branch, Community Services Department, the Parks Branch, Infrastructure Services Department and the Meewasin Valley Authority identify an appropriate maintenance strategy of the trees and shrubs at the Mendel Site to allow increased natural surveillance whilst retaining an acceptable level of screening for the area.

Left: South east of the Mendel Art Gallery and Civic Conservatory building: trees along the pathway are encroaching on pathways and obstructing views.

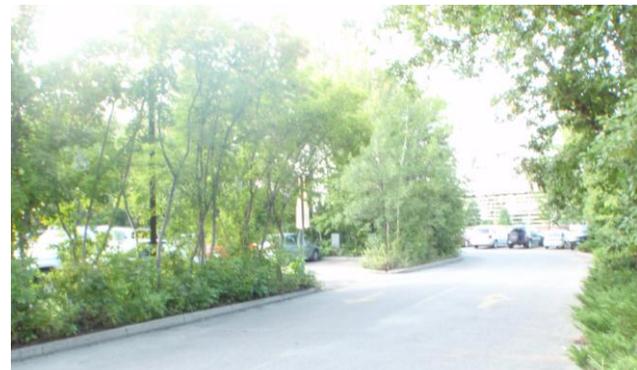
Right: Mendel Site Road looking north towards the Mendel Art Gallery: overgrown trees and bushes on the periphery of the parking lots reduce sightlines and natural surveillance

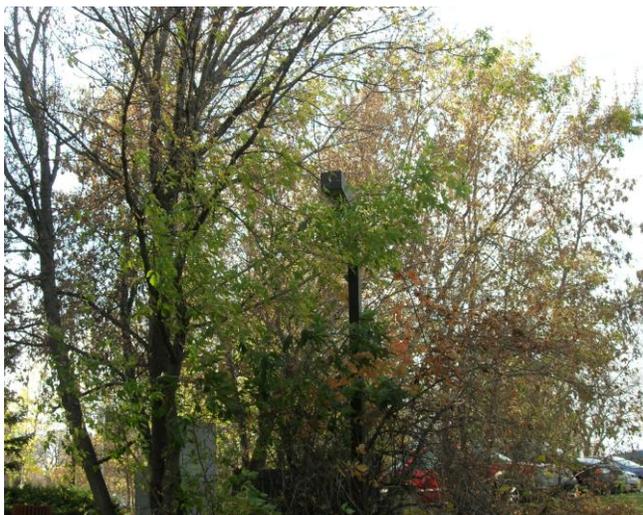
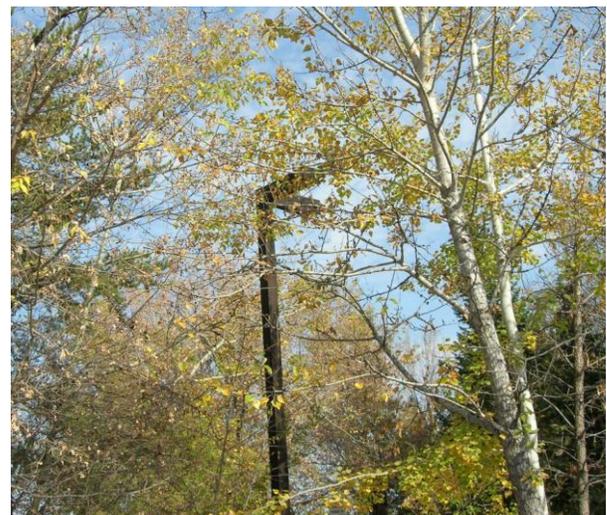
Finding:	Lighting conditions within Mendel Park are inadequate due to the obstruction of light fixtures by tree foliage, lights that are not working properly, and a lack of consistent lighting throughout the site. Roadway lighting in the south half of the Mendel Site is equally important, as it is often used as a pedestrian walkway.
Recommendation:	That the Planning and Development Branch, Community Services Department coordinate a meeting with Saskatoon Light & Power, Facilities Branch, Infrastructure Services Department, Parks Branch, Infrastructure Services Department and the Meewasin Valley Authority to review existing lighting in all of the parking lots, the pathway through the site, and the roadway lighting in the south half of the site, to ensure a consistent and uniform lighting level that allows users to recognize and respond to threats to their safety.
Justification:	<p>Creating a well lit area by increasing the number of lights, making necessary repairs, and trimming the foliage around the lights could act as a deterrent for illegal activity. An alternative option is to not light the Mendel Site after a certain time at night. This could deter people from entering into the site in the first place and in turn keep them on a safer pathway adjacent to the road. Currently there is no alternate route. All users are forced to use the pathway through the Mendel Site.</p> <p>Saskatoon Light and Power has recommended that only general security lighting be on from dusk until dawn, with consideration to scheduled higher level lighting depending on the activity in the area. Any new lighting should be designed to illuminate the intended task area and limit lighting spillage into adjacent areas. An increase in lighting levels on site would potentially require an expansion in electrical servicing.</p>

Some of the existing lighting is covered by overgrown foliage which reduces the amount of visibility on the parking lots and pathways.

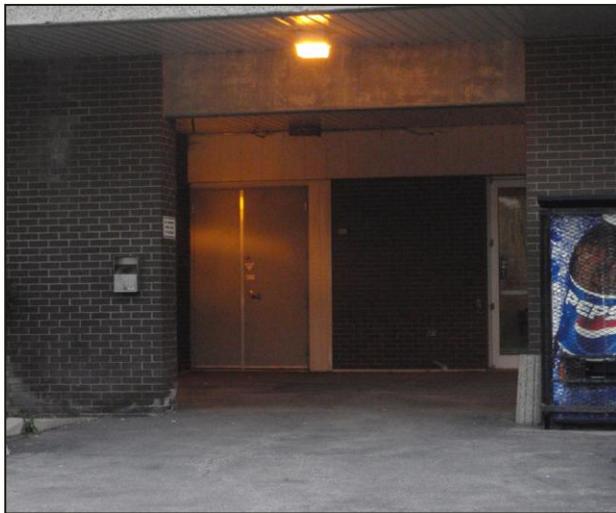
Finding:	Areas within the park were identified as potential hiding places that could be used for an illegitimate use. The recessed doorway at the back of the Mendel Art Gallery was one of the major sites of concern. Pockets of trees and brush along certain sections of the pathways at the Mendel Site create perfect hiding places, and represent possible entrapment zones. Encroachment of trees and shrubs onto Shearwater Boat Tours site and the Shakespeare on the Saskatchewan site were also sites of concern.
Recommendation:	That the Planning and Development Branch, Community Services Department meet with the Facilities Branch, Infrastructure Services Department, the Parks Branch, Infrastructure Services Department and the Meewasin Valley Authority to develop options to eliminate or mitigate the number of potential hiding places around the vicinity of the Mendel Art Gallery and Civic Conservatory building and the Mendel Site.

Left: Recessed doorway at back entrance of Mendel Art Gallery creates a haven for individuals to hide in the area and engage in illegal behaviour.

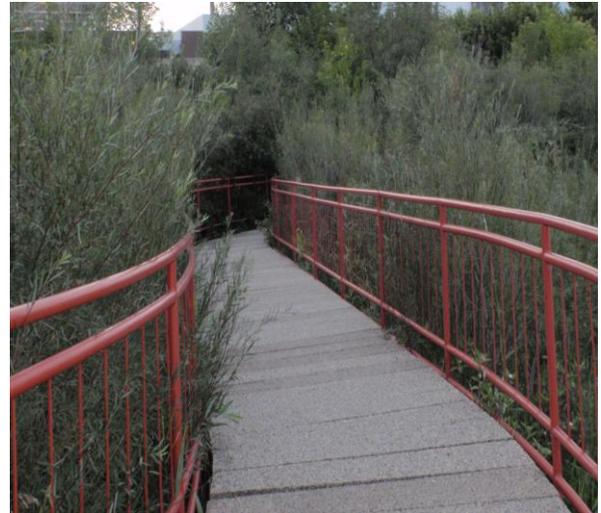
Right: Potential hiding place on one of the site's pathways near the boat dock.

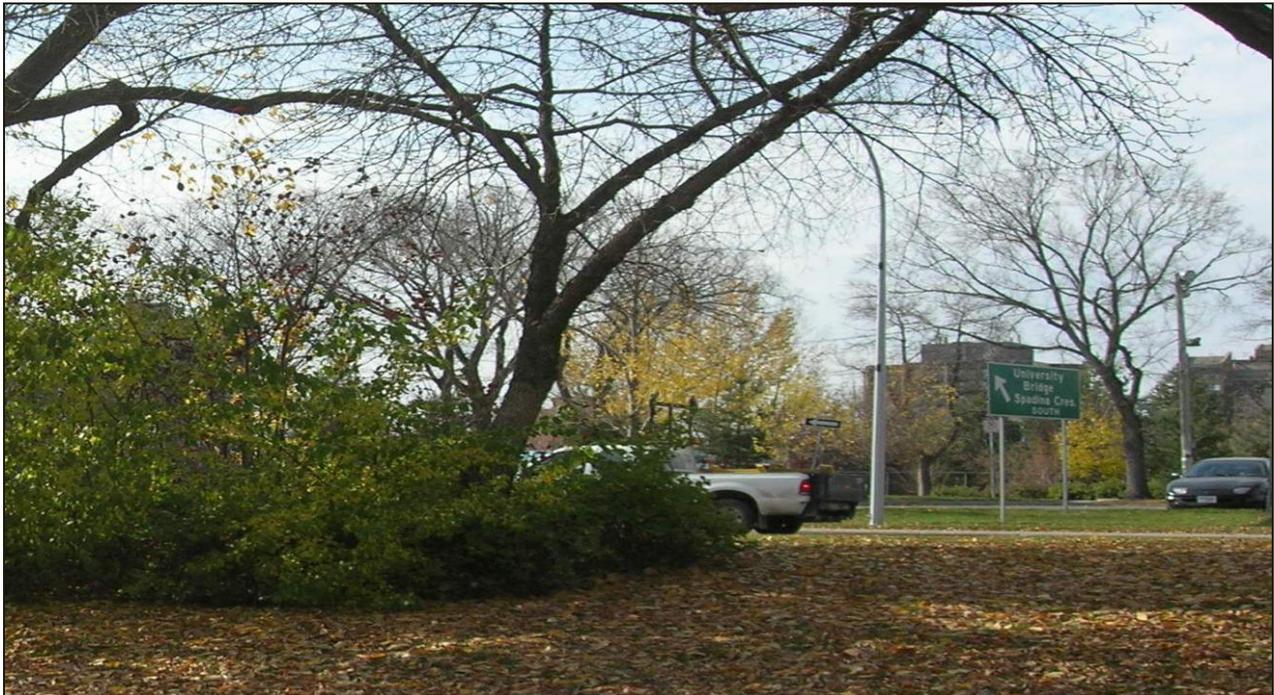
Finding:	There is no continuous path or sidewalk on the east side of Spadina Crescent East (across from Kinsmen Park). Pedestrians have no choice but to go through the Mendel Site. Appendix 4 of the City Park LAP identified the east side of Spadina Crescent East (25 th Street to 33 rd Street) in its City Park Missing Sidewalk Inventory.
Recommendation:	That the Planning and Development Branch, Community Services Department confirm with the Infrastructure Services Department, Transportation Branch that a sidewalk along the east side of Spadina Crescent East (25th Street to Queen Street) is included in its priority list, proceed with its installation, as defined in the City Park LAP, and report back to the City Park Community Association and Local Area Planning Committee following completion.
Justification:	Developing an alternative route where pedestrians are able to continue alongside the roadway would give people a safer option as opposed to entering The Mendel Site. A sidewalk in this area would be of particular benefit during night time hours.

No sidewalk exists along the east side of Spadina Crescent East adjacent to the Mendel Site. Pedestrians are directed into the site.

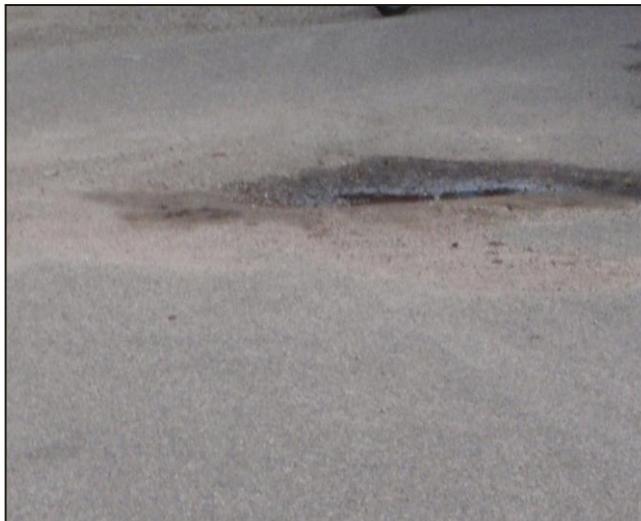
Finding:	Surface pavement within the parking lots and along the pathways is cracked, depressed and/or uneven in certain areas. Loose gravel and stones can be found along certain portions of the pathways.
Recommendation:	That the Parks Branch, Infrastructure Services Department and the Facilities Branch, Infrastructure Services Department review current practices for maintenance of surface pavement on pathways and parking lots at the Mendel Site. This review should identify the feasibility and expected timeframe for resolving the current deficiencies presently on site, determining the responsibilities of each Branch, and maintaining the parking lots to an acceptable level.
Justification:	Inconsistencies in surface pavement can lead to physical injuries for pedestrians and cyclists, as well as vehicular damage. General upkeep of the area also improves its appearance and image. It enhances the safety of users of the space and helps them feel that the area will be protected and maintained. Through maintenance and repair of surface pavement imperfections, the potential hazards they cause can be minimized if not prevented.

Left: A divot in the pavement and loose gravel located on the pathway near entrance to Shakespeare on the Saskatchewan.

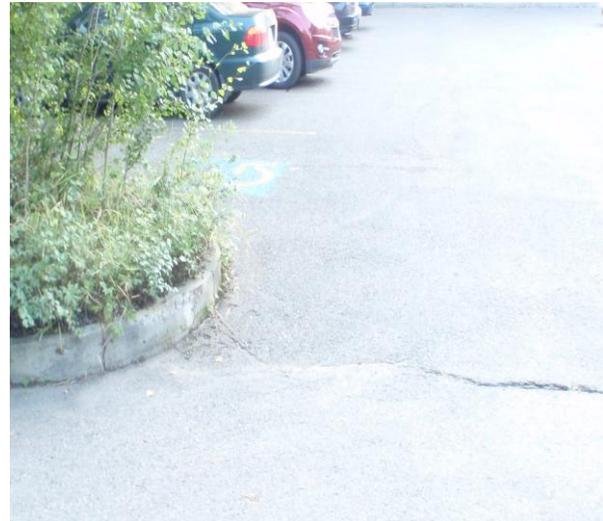
Right: Pavement cracks and depressions in the parking lot of the Mendel Site.

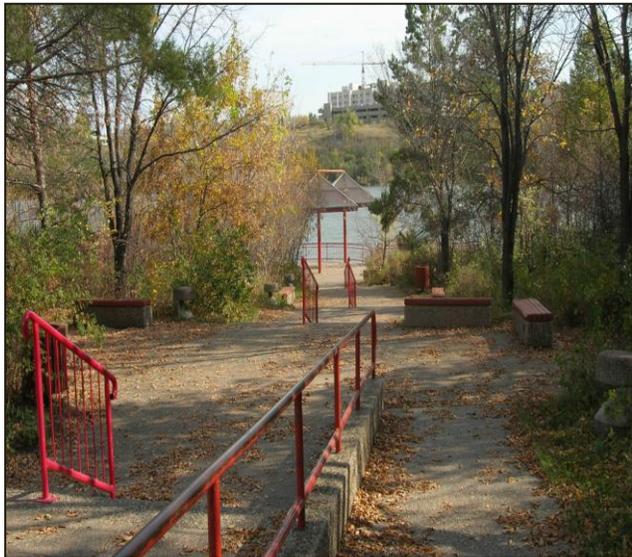
Finding:	The signage present at the Mendel Site is quite limited. There is no signage that establishes what the site is and what it is used for. There are also no maps or directions to the riverbank pathways, Shakespeare site, boat dock or neighbouring sites and attractions. There is also no emergency or maintenance contact information displayed on site.
Recommendation:	That the Planning and Development Branch, Community Services Department and the Meewasin Valley Authority, Shakespeare on the Saskatchewan, Shearwater Boat Tours and Parks Branch, Infrastructure Services Department develop signage that identifies park attractions, directions, hours of operation, and emergency and maintenance contact information.
Justification:	Signs are communication devices used to give public information and define the space. For visitors who are not familiar with the park, the proper signage can serve as an outreach tool to better inform them about the park.

Left: East side of the Mendel Site looking towards the river and boat dock area. There are no signs to help identify where the path goes, what the space is and what it is used for.

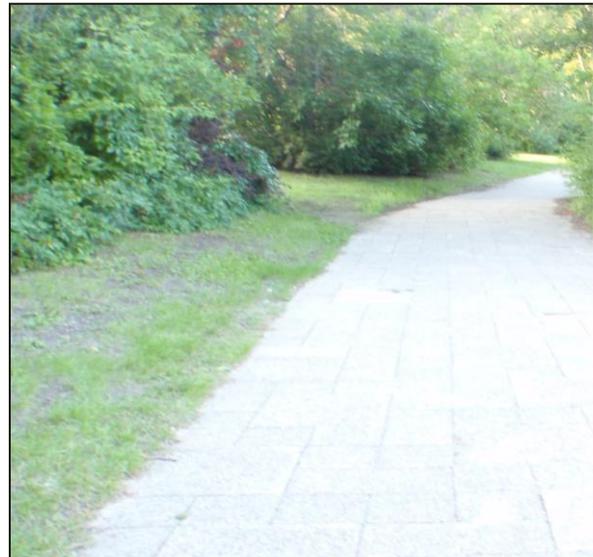
Right: Looking south towards Shakespeare on the Saskatchewan Site, on a pathway east of the parking lots. There are no signs that establish where the user is and what direction he or she should go in.
