## TECHNICAL MEMORANDUM

**Reference No.** CA0029692.2934-TM-06-Rev0

**TO** Vanessa Heilman, P.Eng.  
City of Saskatoon

### NUTANA SLOPE STABILITY UPDATE – SEPTEMBER 2025

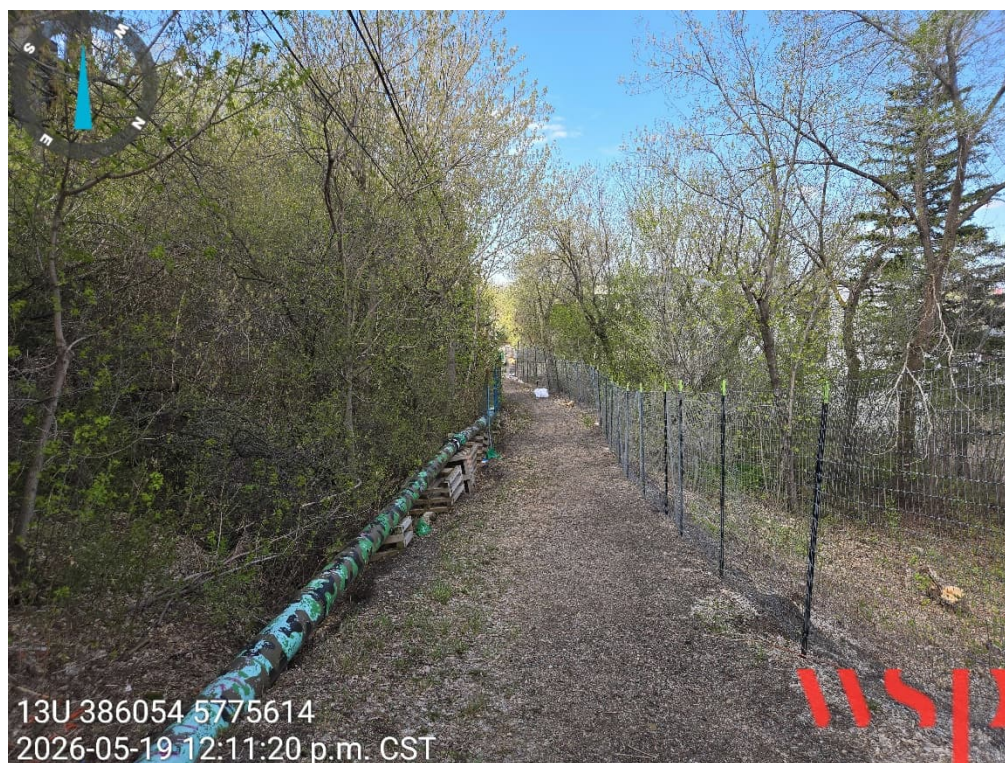
**Photograph 1: Looking west down the back alley at the East Failure (May 19, 2026)**

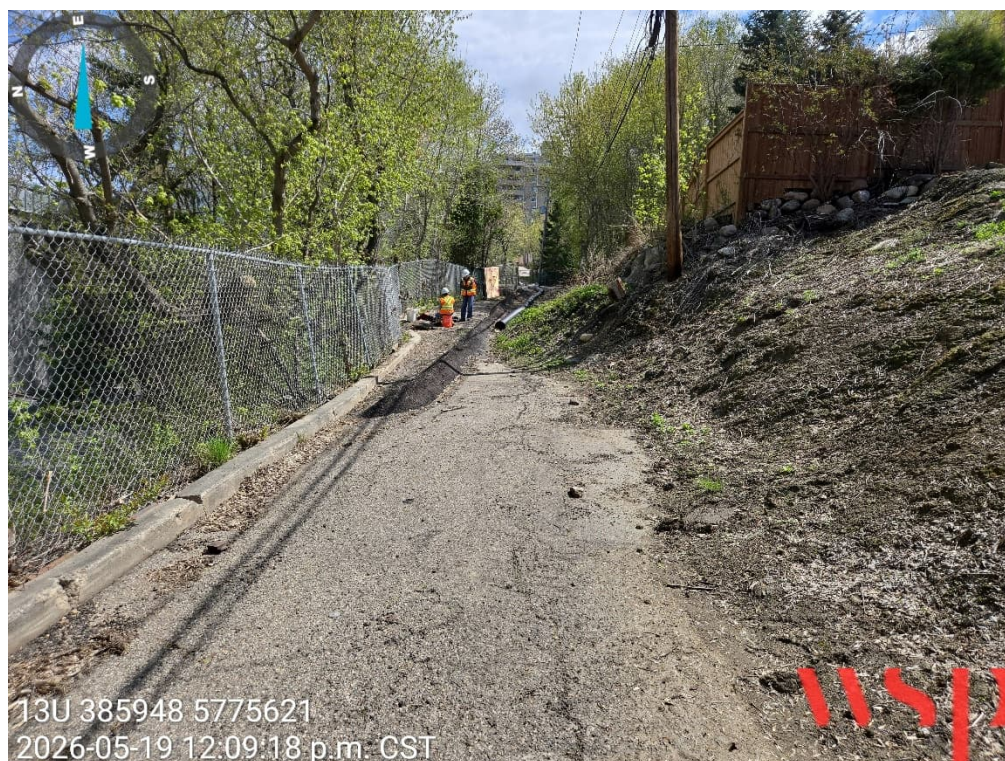
**Photograph 2: Looking east down the back alley at the West Failure (May 19, 2026)**

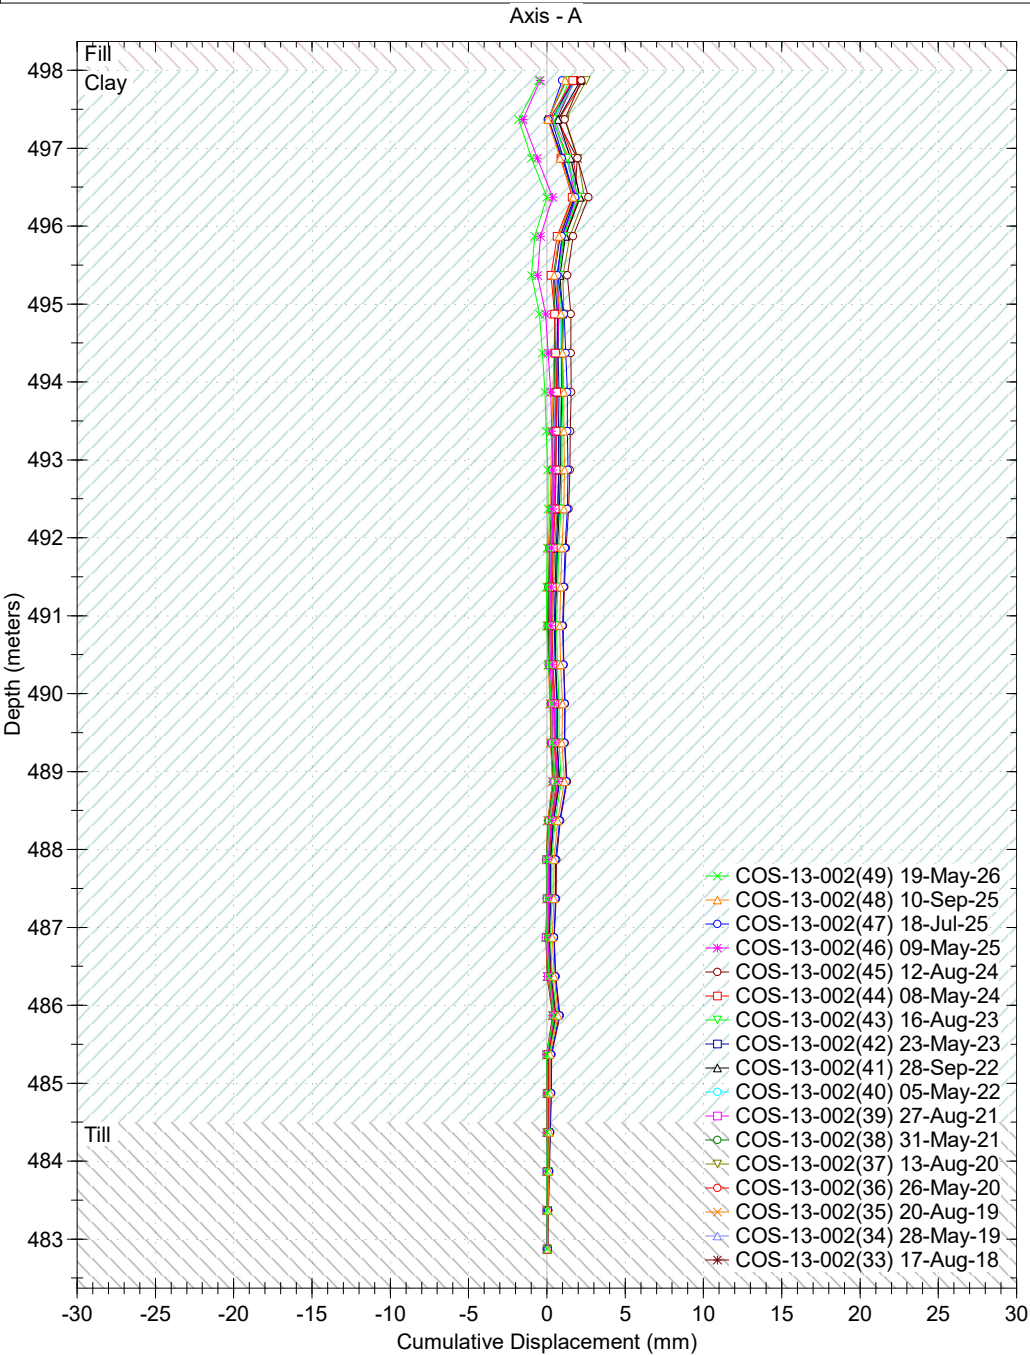
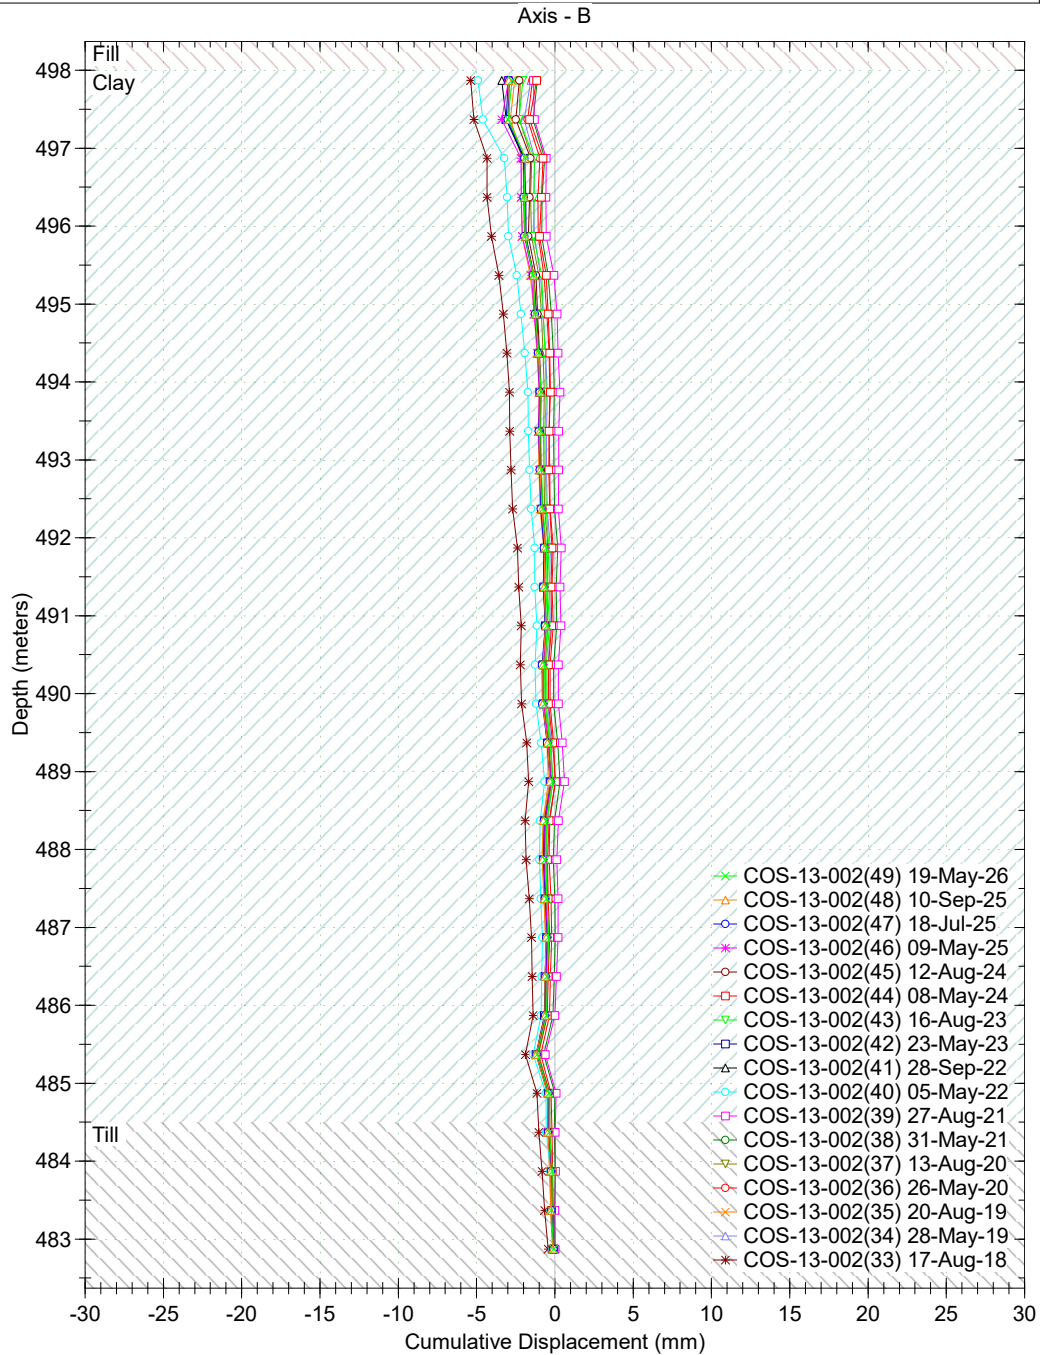
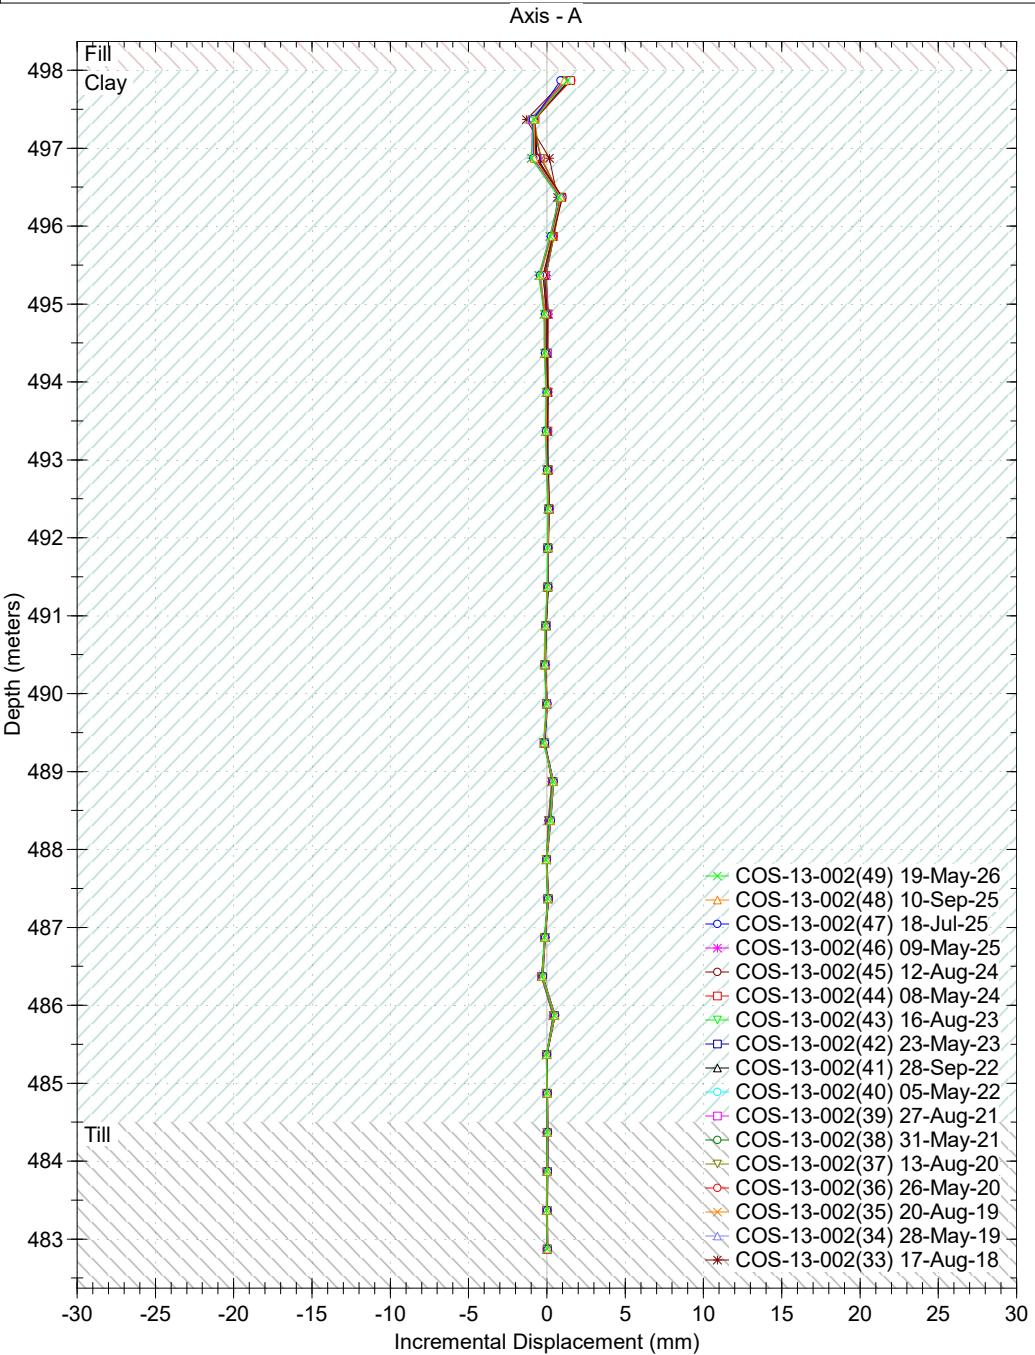
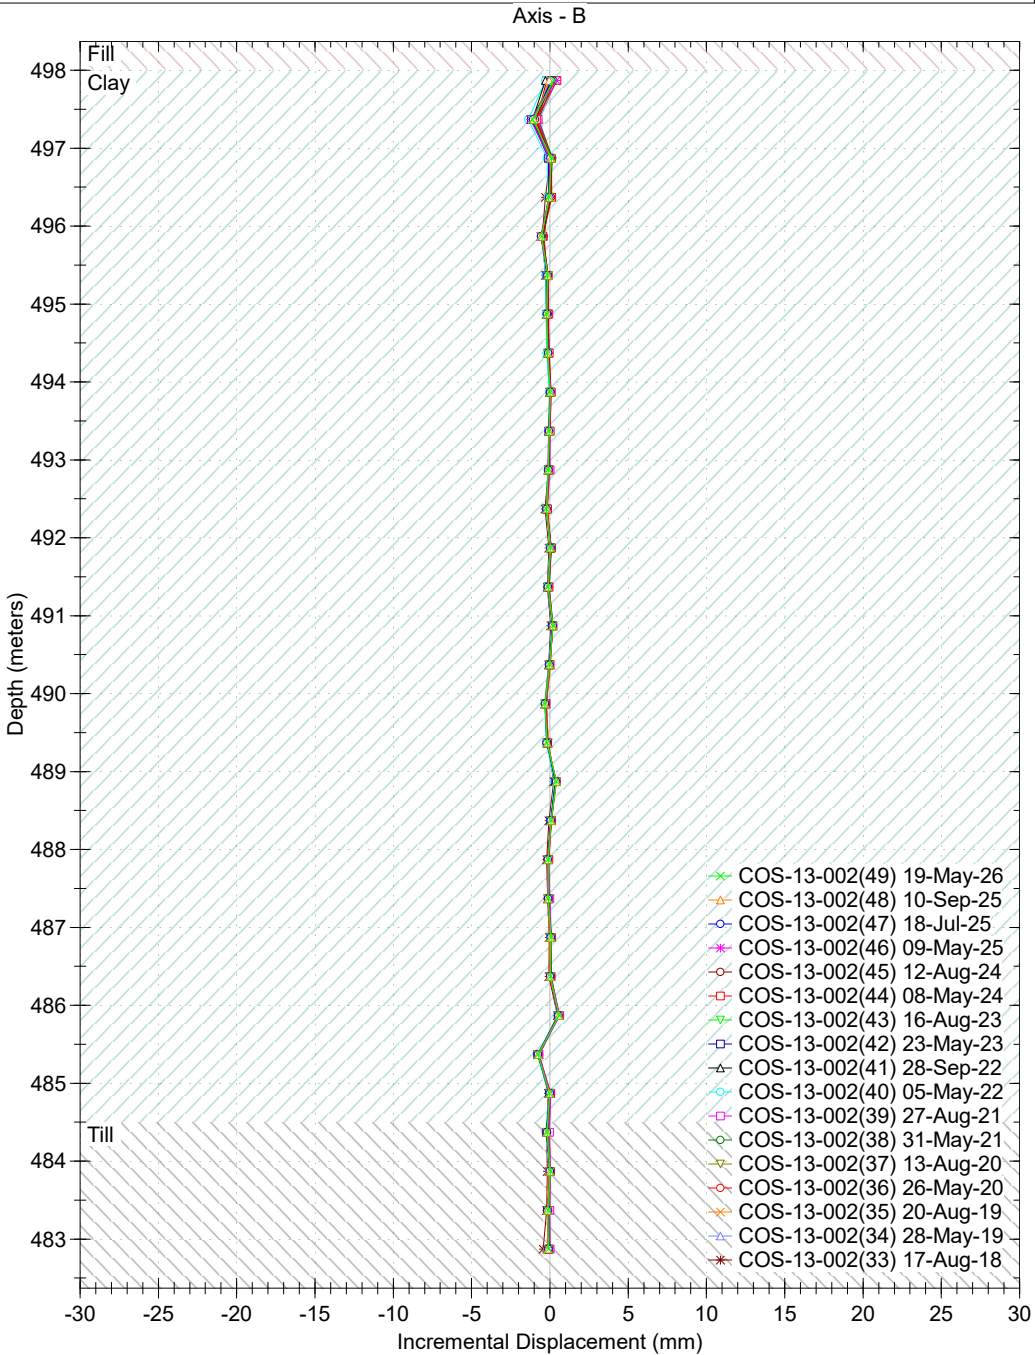
Borehole : COS-13-002  
Project : Nutana Slope  
Location : 307 11th St. E. (Front)  
Northing : 5775567.41  
Easting : 386043.54  
Collar : -0.113

- Inclinometer COS-13-002 plots continue to show a slight drift, with approximately 2.0 mm (0.08 in) of cumulative movement between August 17, 2018, and May 19, 2026, but overall insignificant movement since July 30, 2013.

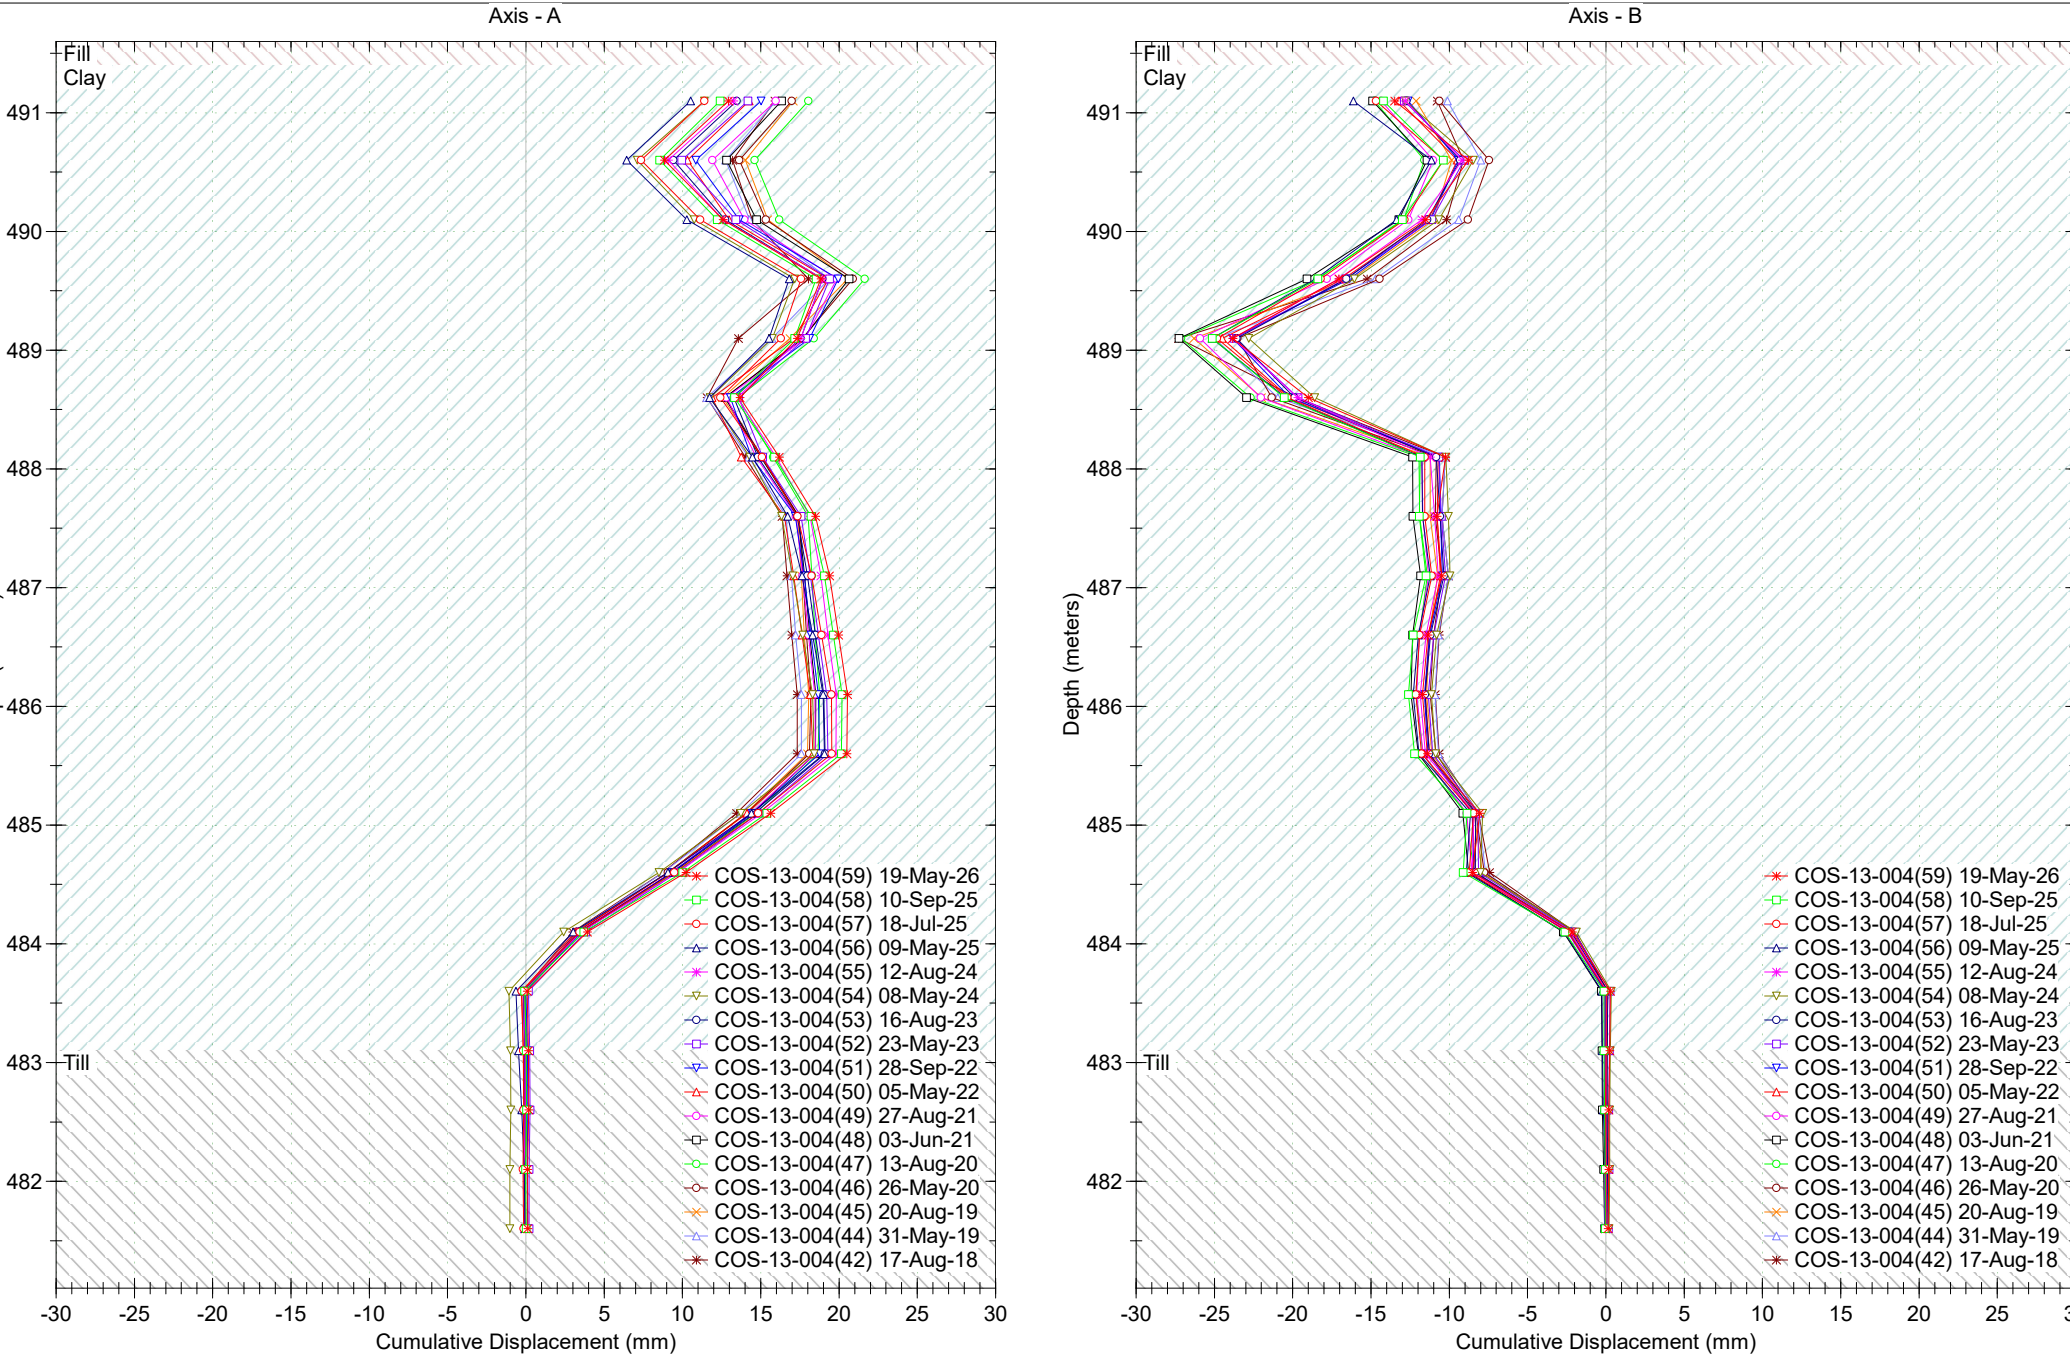
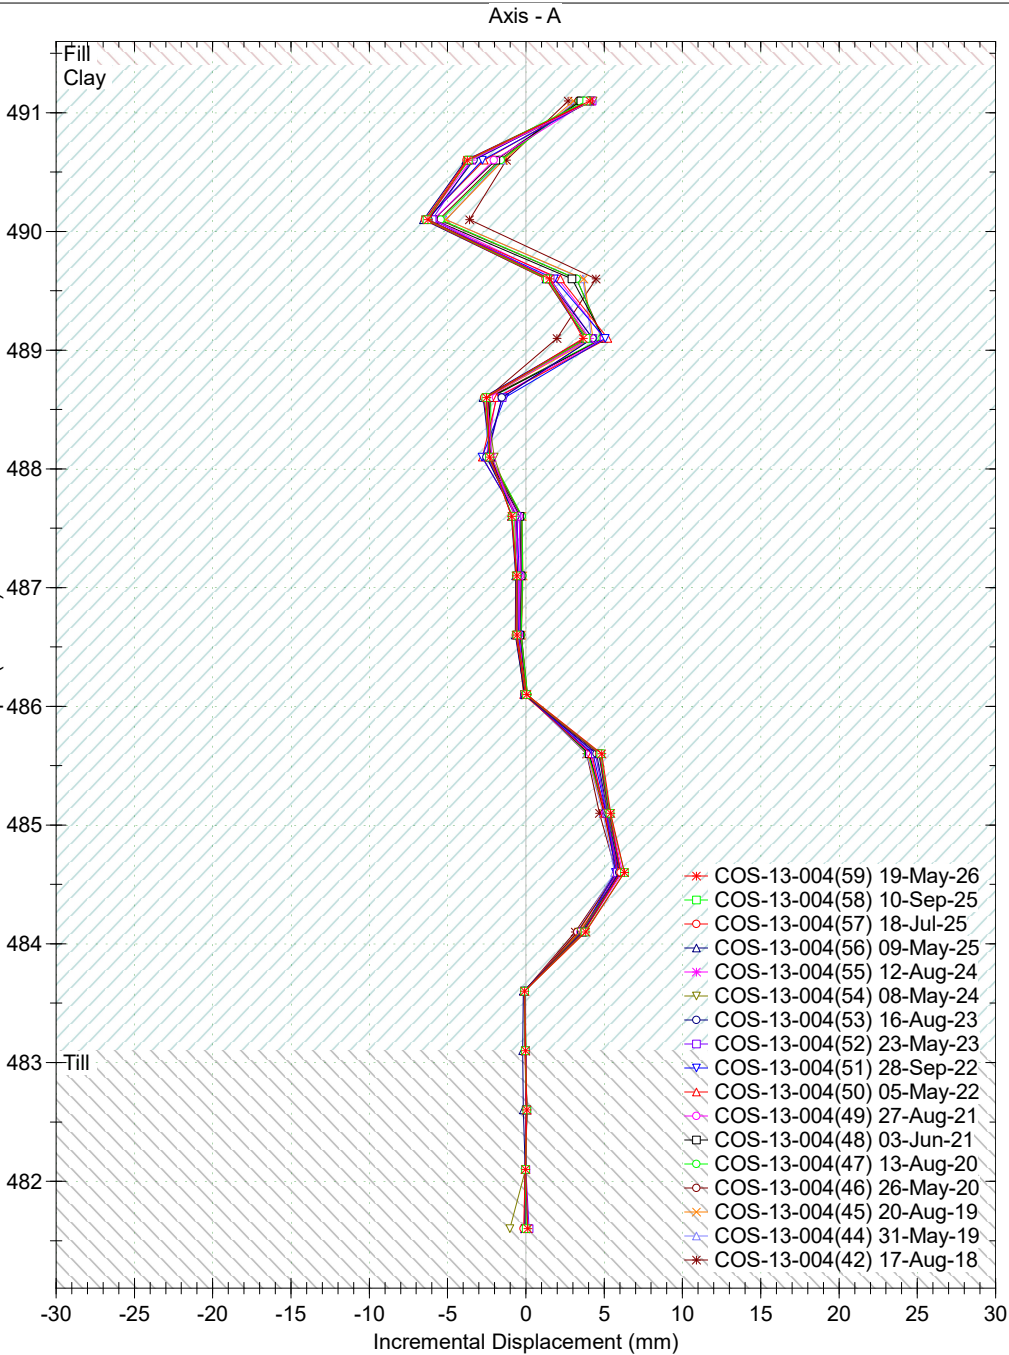
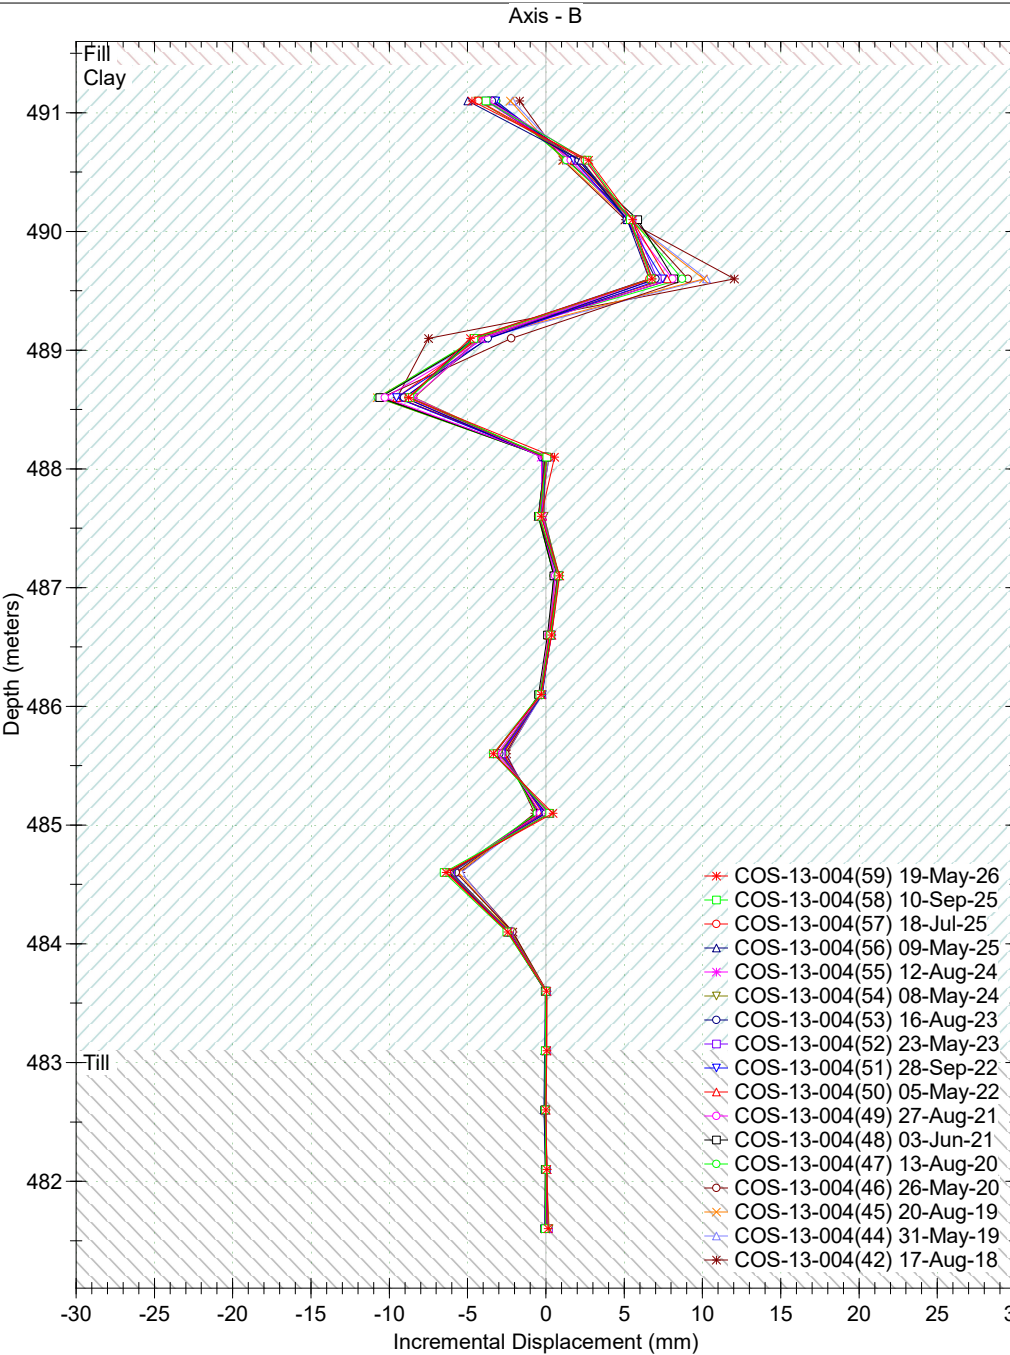
Borehole : COS-13-004  
Project : Nutana Slope  
Location : 307 11th. St. E. (back)  
Northing : 5775604.97  
Easting : 386050.63  
Collar : -0.677

- Inclinometer COS-13-004 has in recent years indicated drift in both the direction, perpendicular and parallel to the direction of the laneway. The inclinometer plots indicated insignificant movement (less than 2.0 mm or 0.08 in) between September 10, 2025 and May 19, 2026.

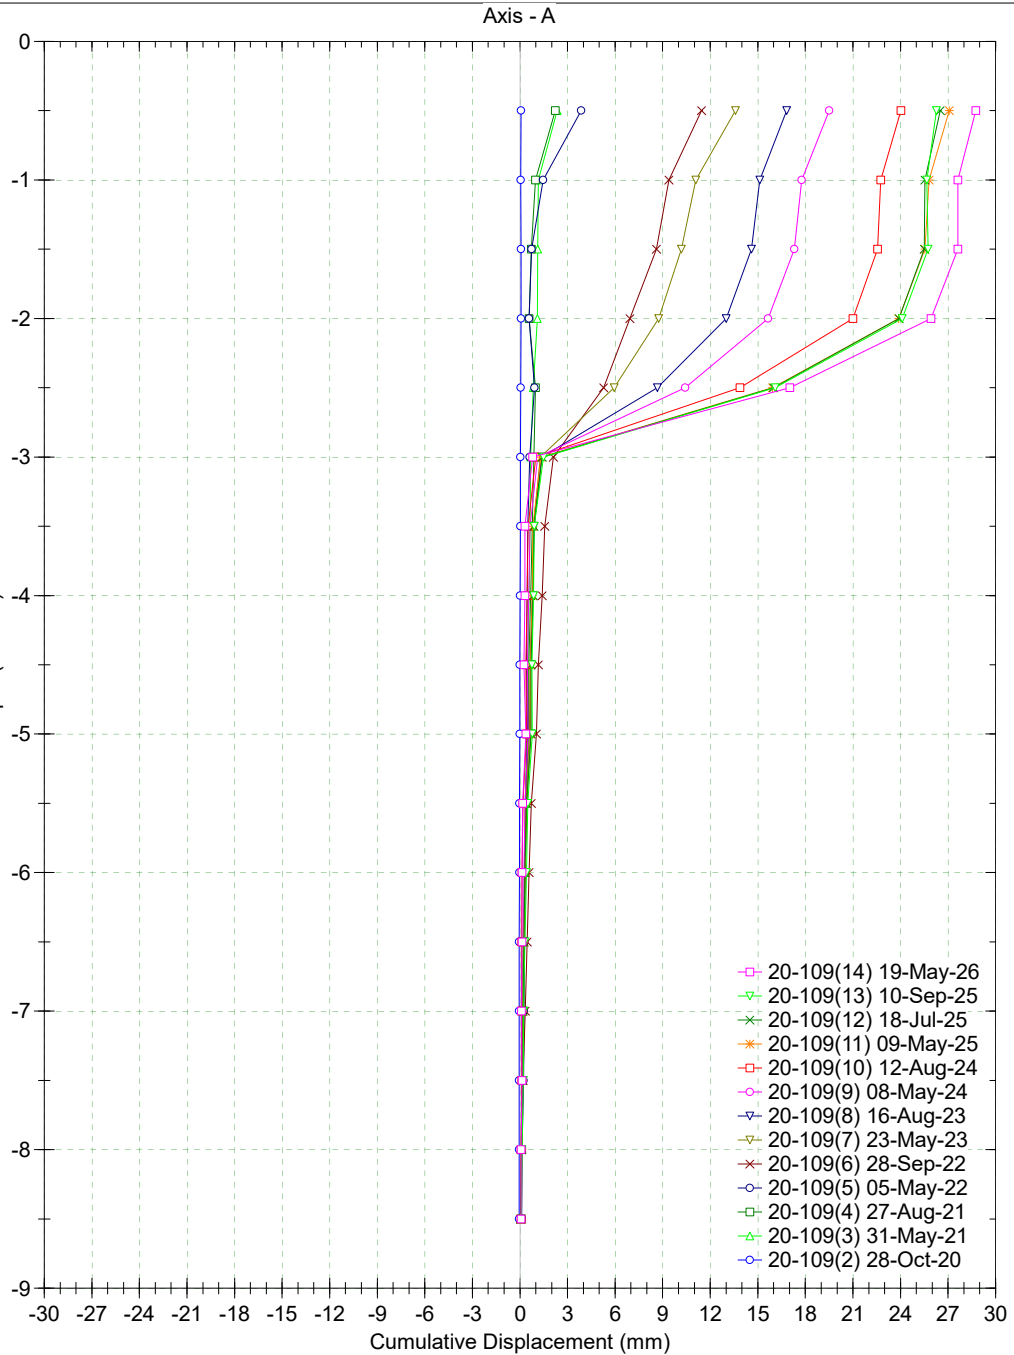
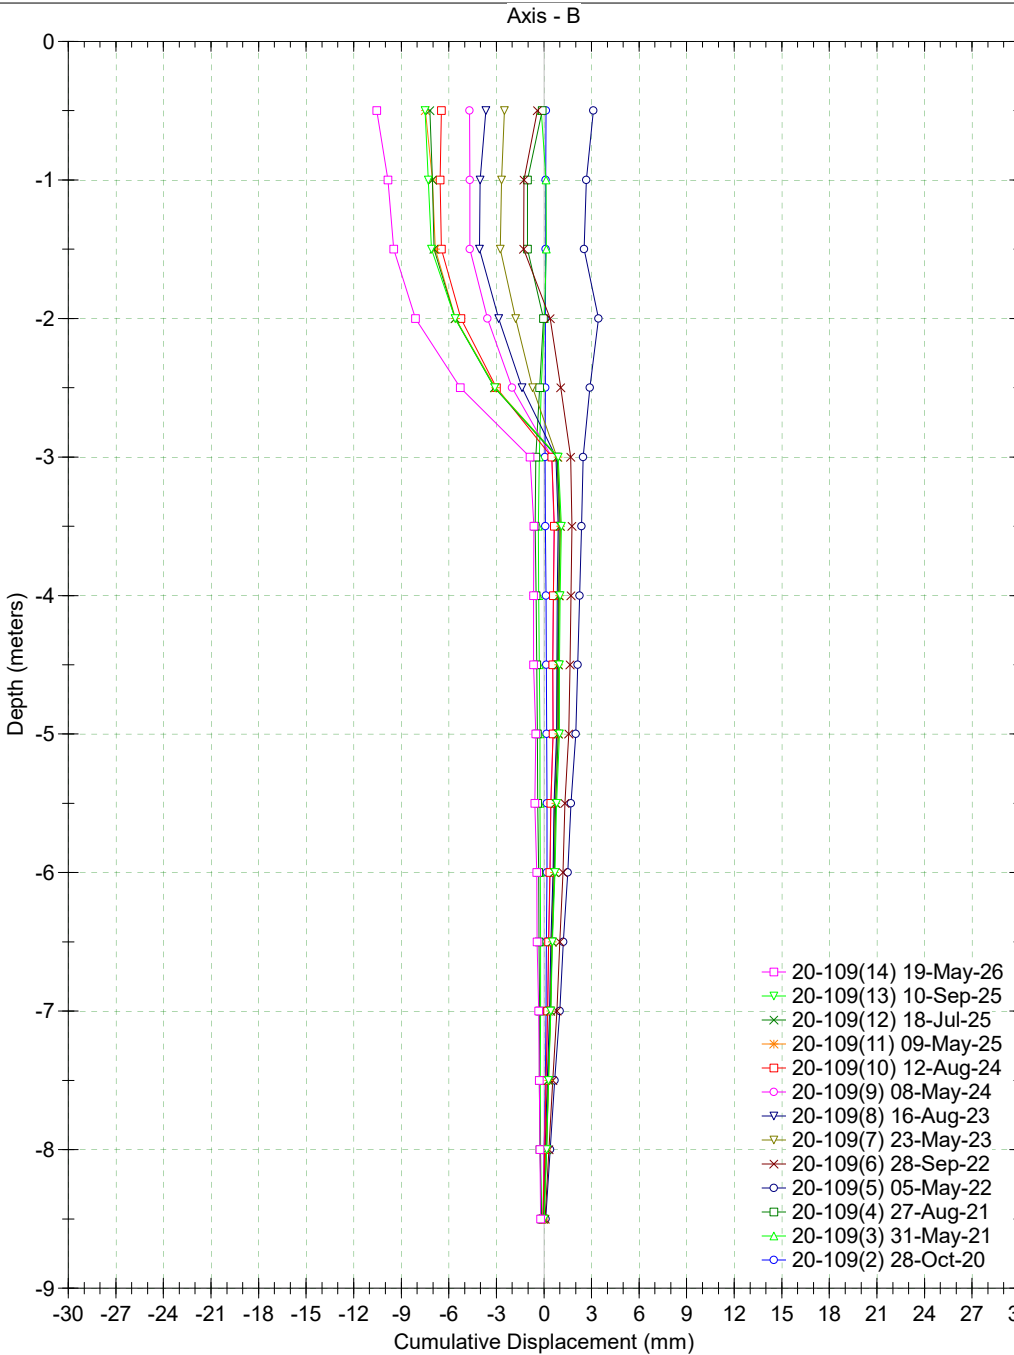
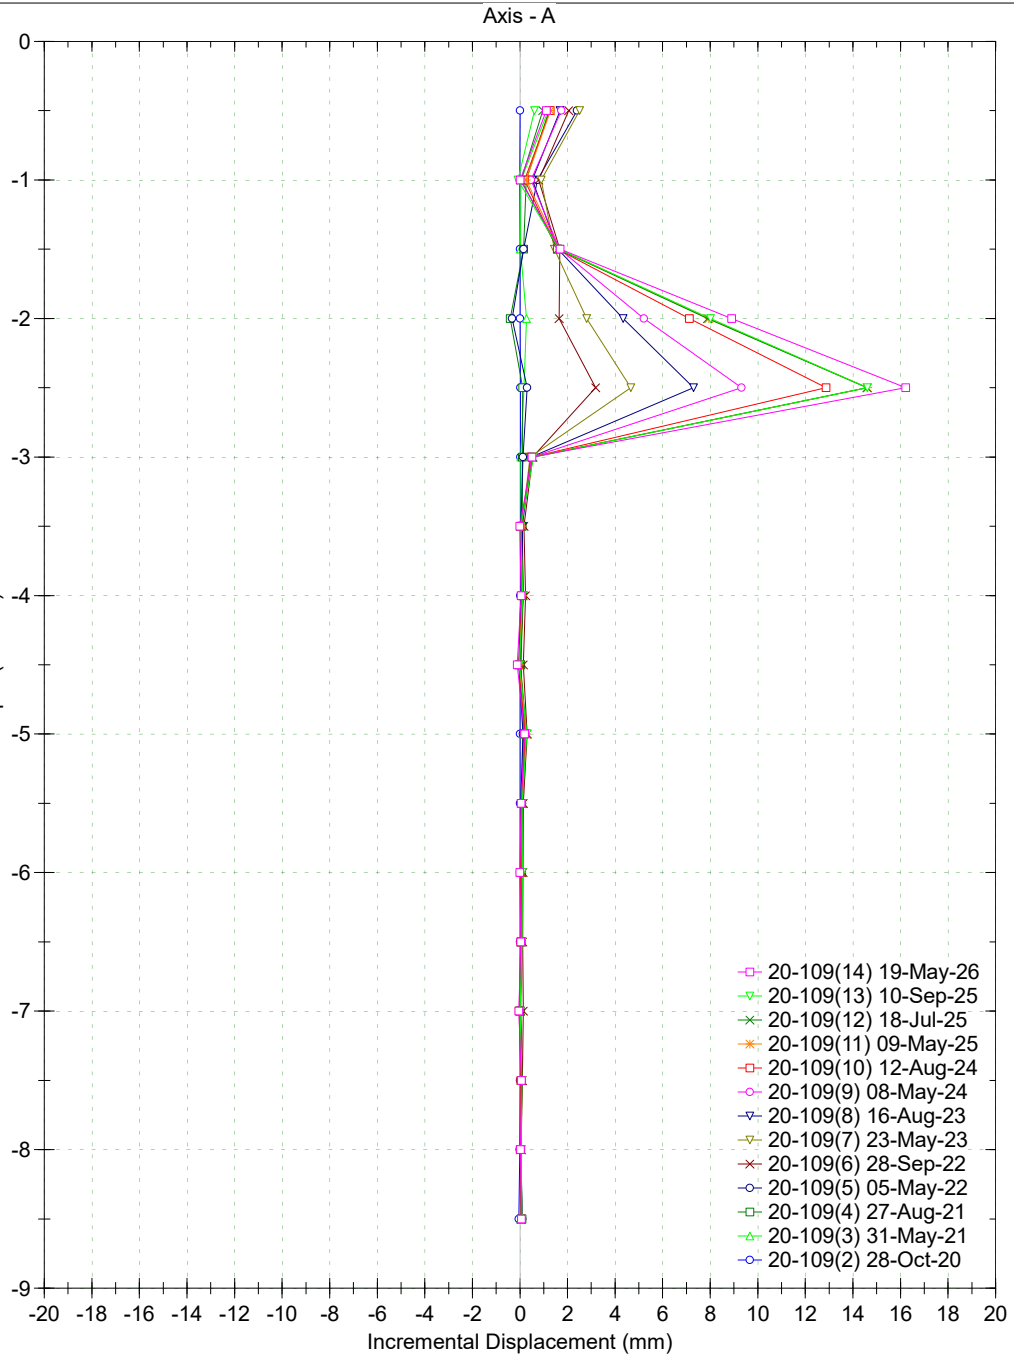
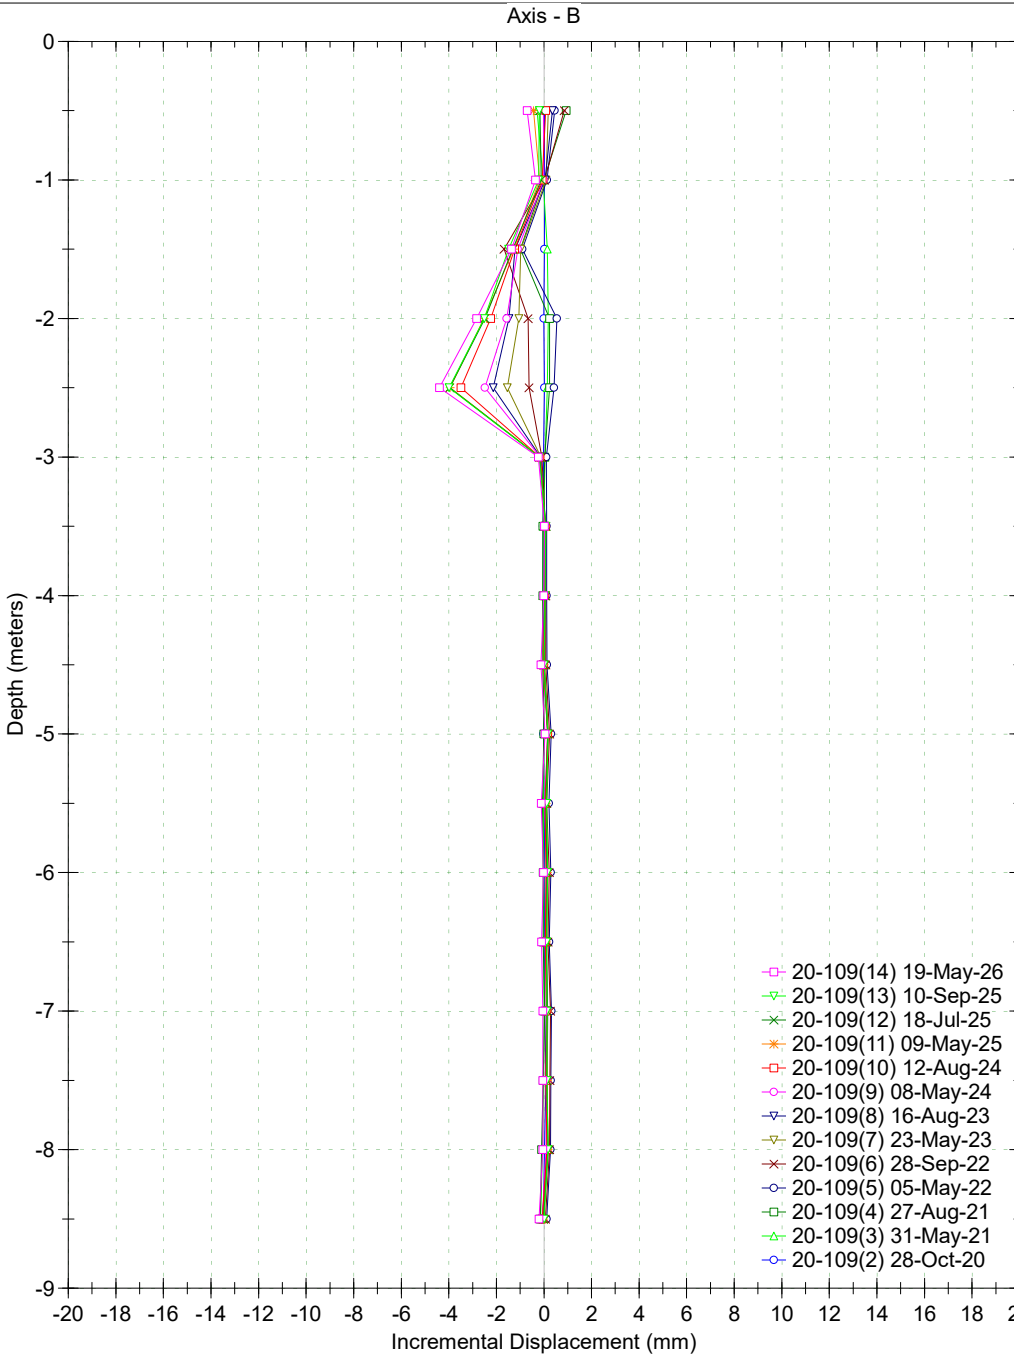
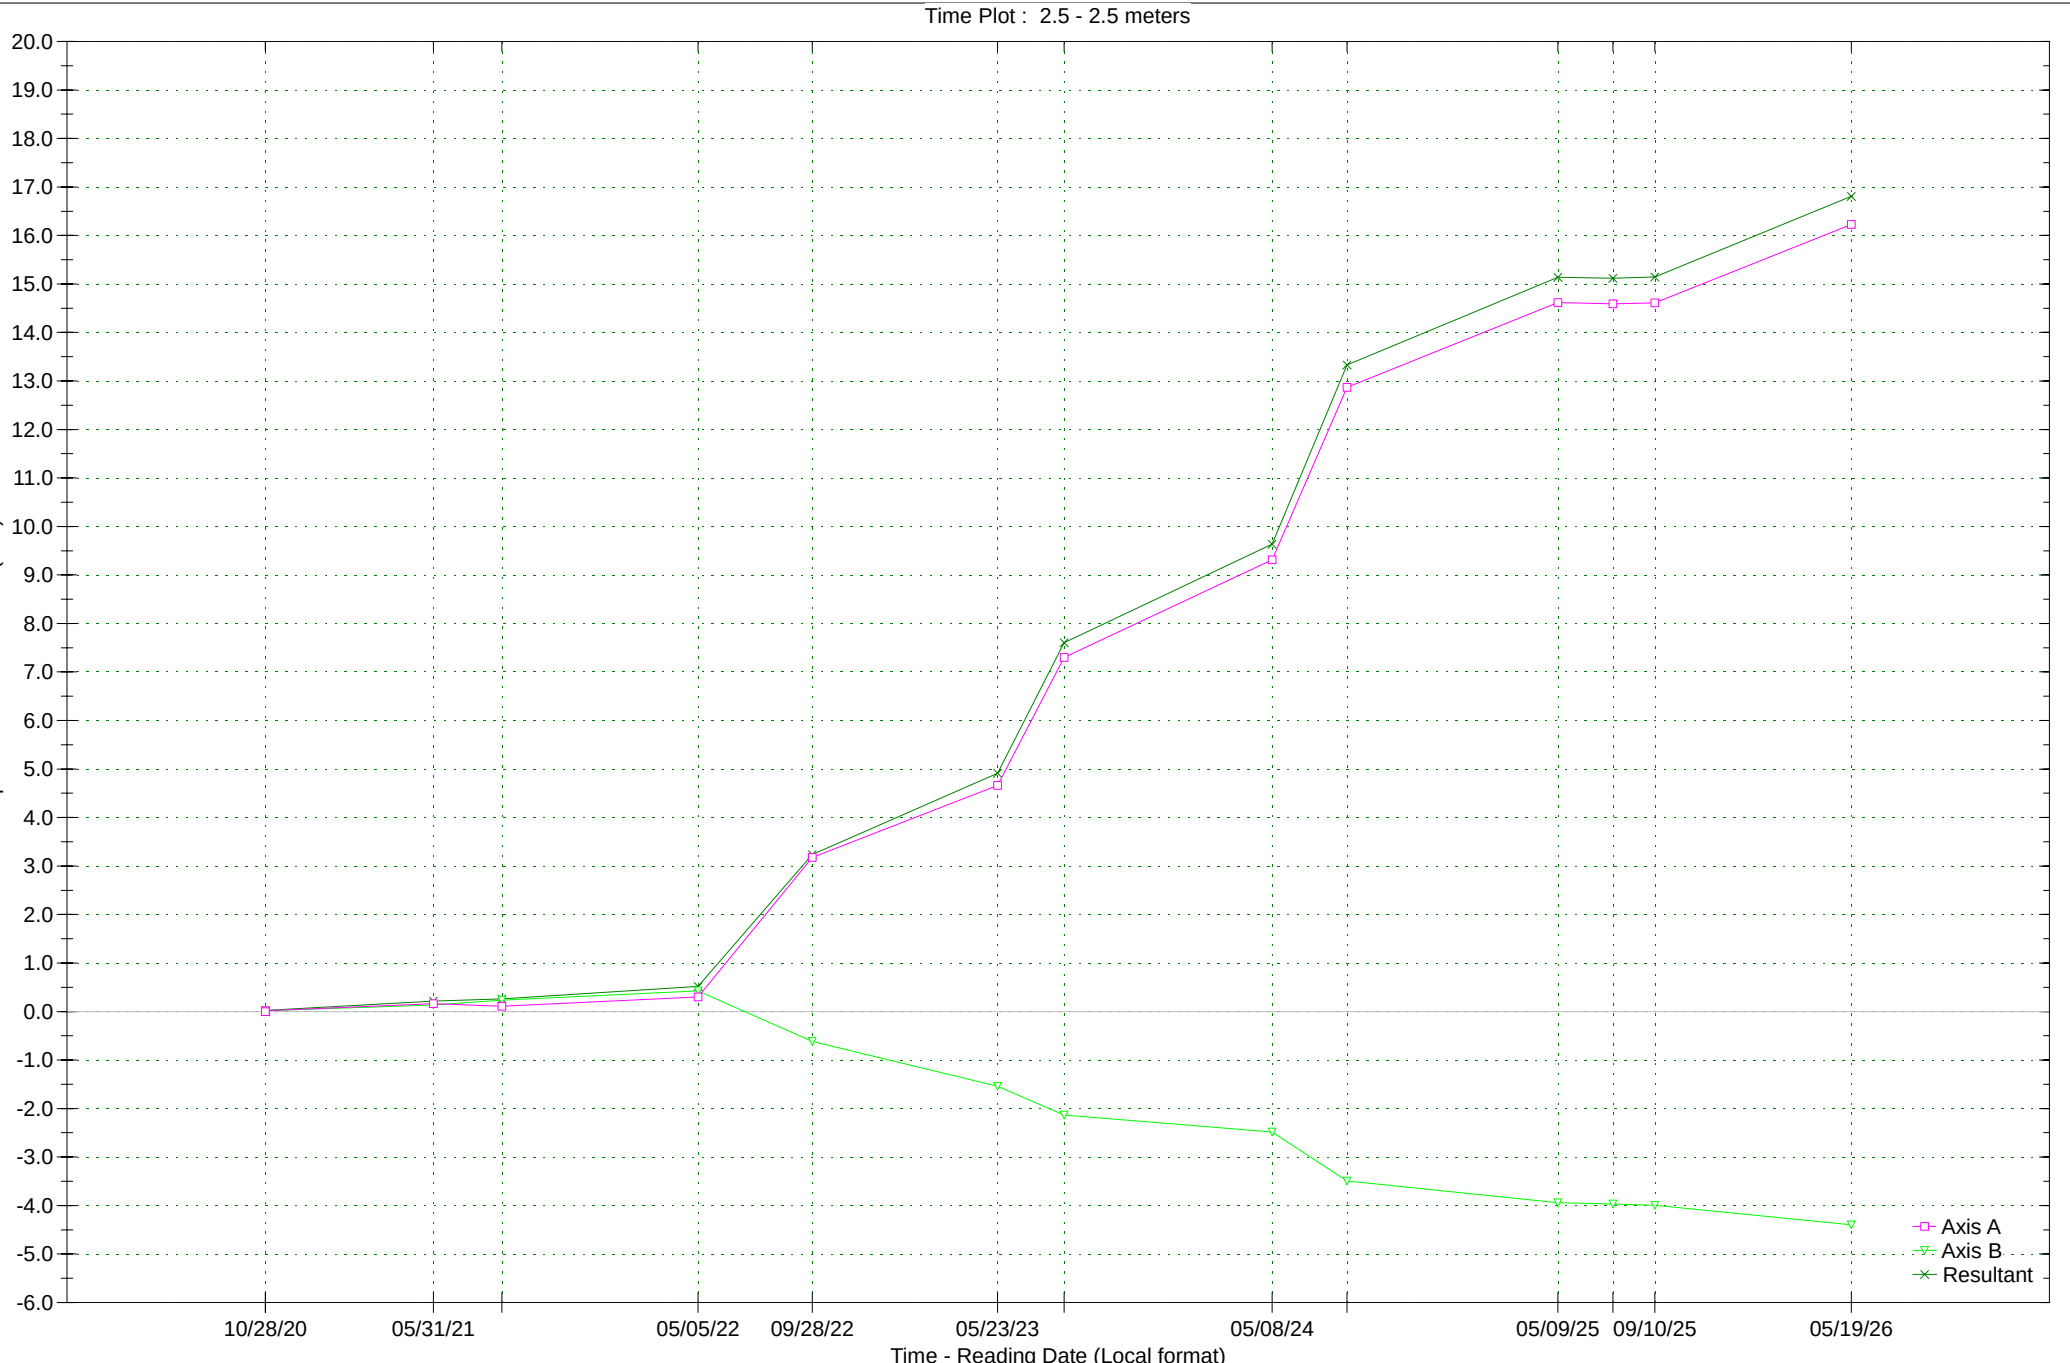
Borehole : 20-109  
Project : Nutana Slope  
Location :  
Northing : 5775622  
Easting : 385977  
Collar :

- Inclinometer 20-109 indicated approximately 29 mm of cumulative downslope movement between October 28, 2020, and May 19, 2026, with approximately 2.5 mm (0.10 in) of movement between September 10, 2025 and May 19, 2026. The zone of movement is approximately 2.5 m below the top of casing. The rate of slope movement has varied from:

- approximately 1.0 mm/yr between October 28, 2020 and May 5, 2022;
  - to approximately 5.3 mm/yr between May 5, 2022 and August 12, 2024; and
  - approximately 2.3 mm/yr between August 12, 2024 and May 19, 2026.

Slope inclinometer 20-109 indicated a zone of movement at a depth of approximately 2.5 m below the top of casing. The rate of movement has varied from approximately 1 mm/yr between October 28, 2020, and May 5, 2022; then increased to approximately 5.3 mm/yr between May 5, 2022 and August 12, 2024; but in more recent years has decreased to approximately 2.3 mm/yr between August 12, 2024 and May 19, 2026.

WSP recommends completing the remaining planning monitoring trips for summer and fall 2026.
