## TECHNICAL MEMORANDUM

**Reference No.** CA0029692.2934-TM-06-Rev0

**TO** Vanessa Heilman, P.Eng.  
City of Saskatoon

### NUTANA SLOPE STABILITY UPDATE – SEPTEMBER 2025

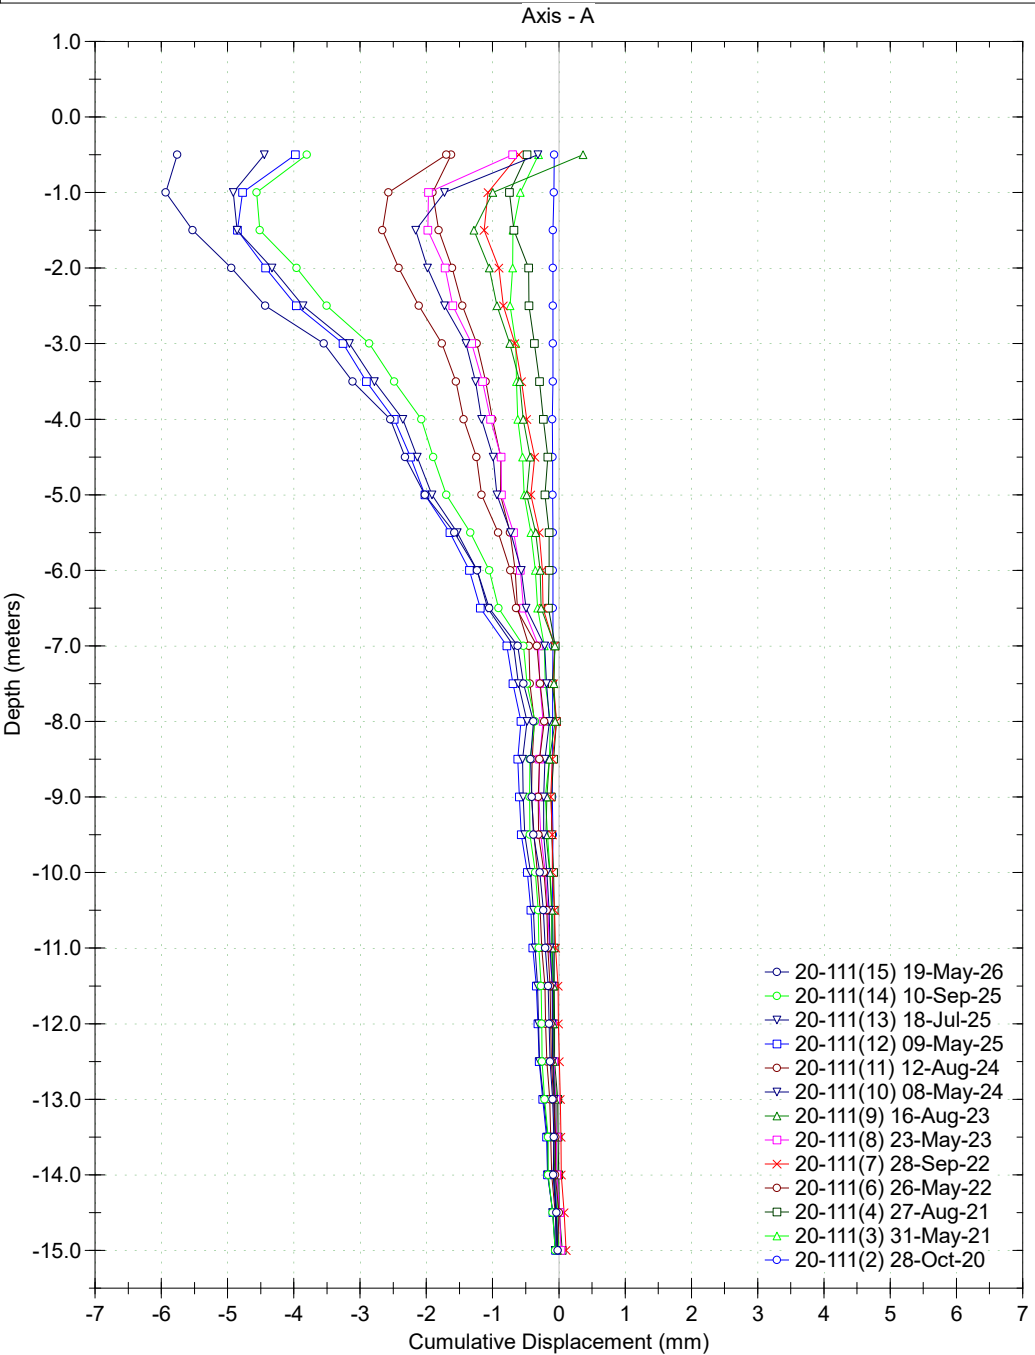
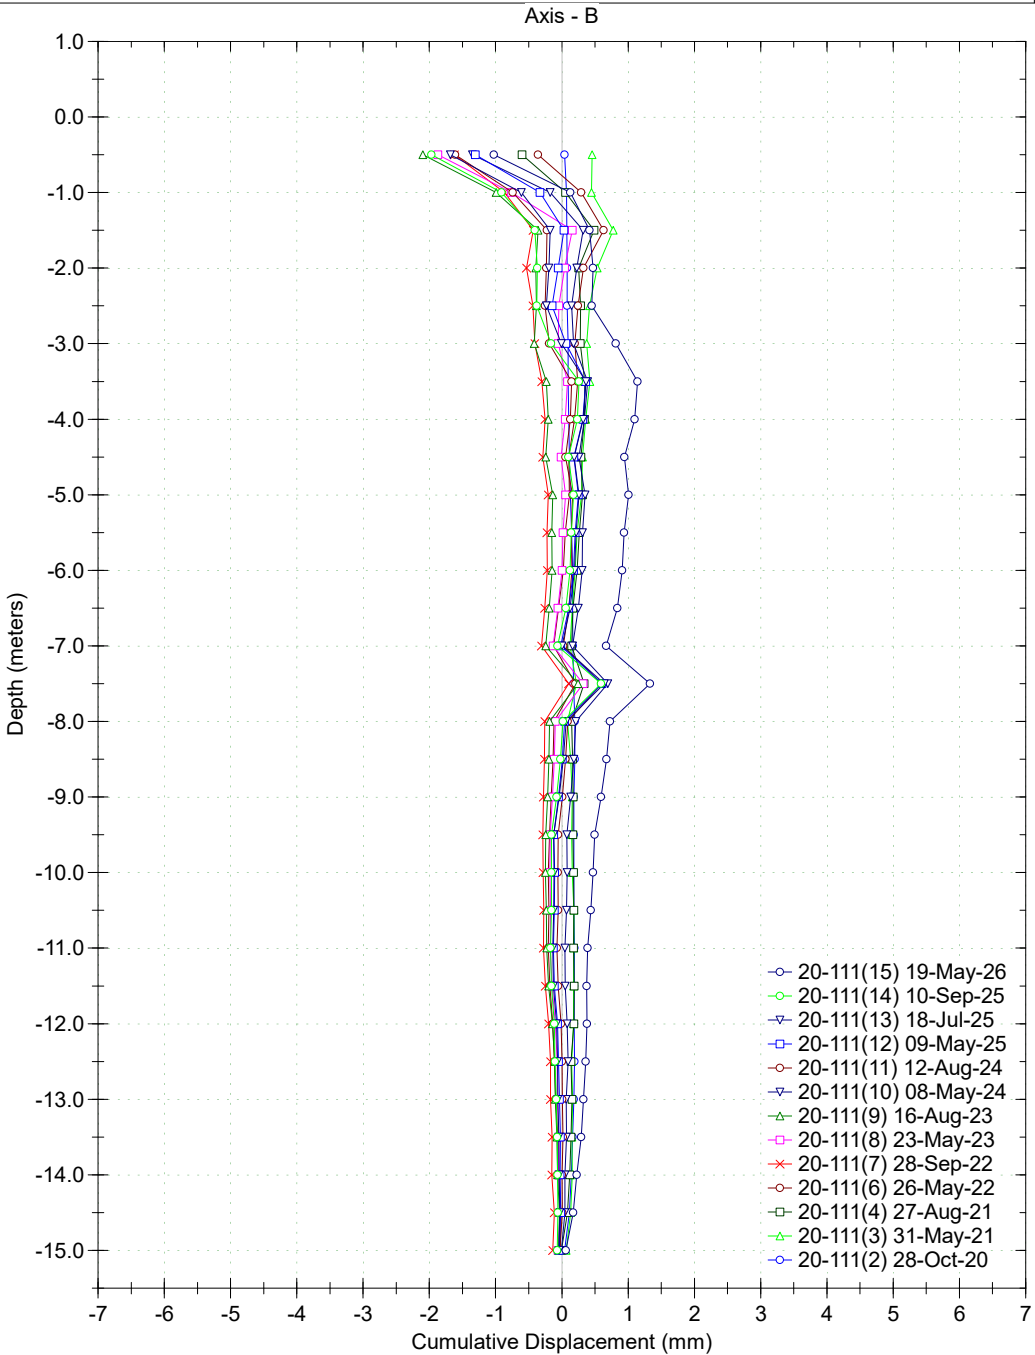
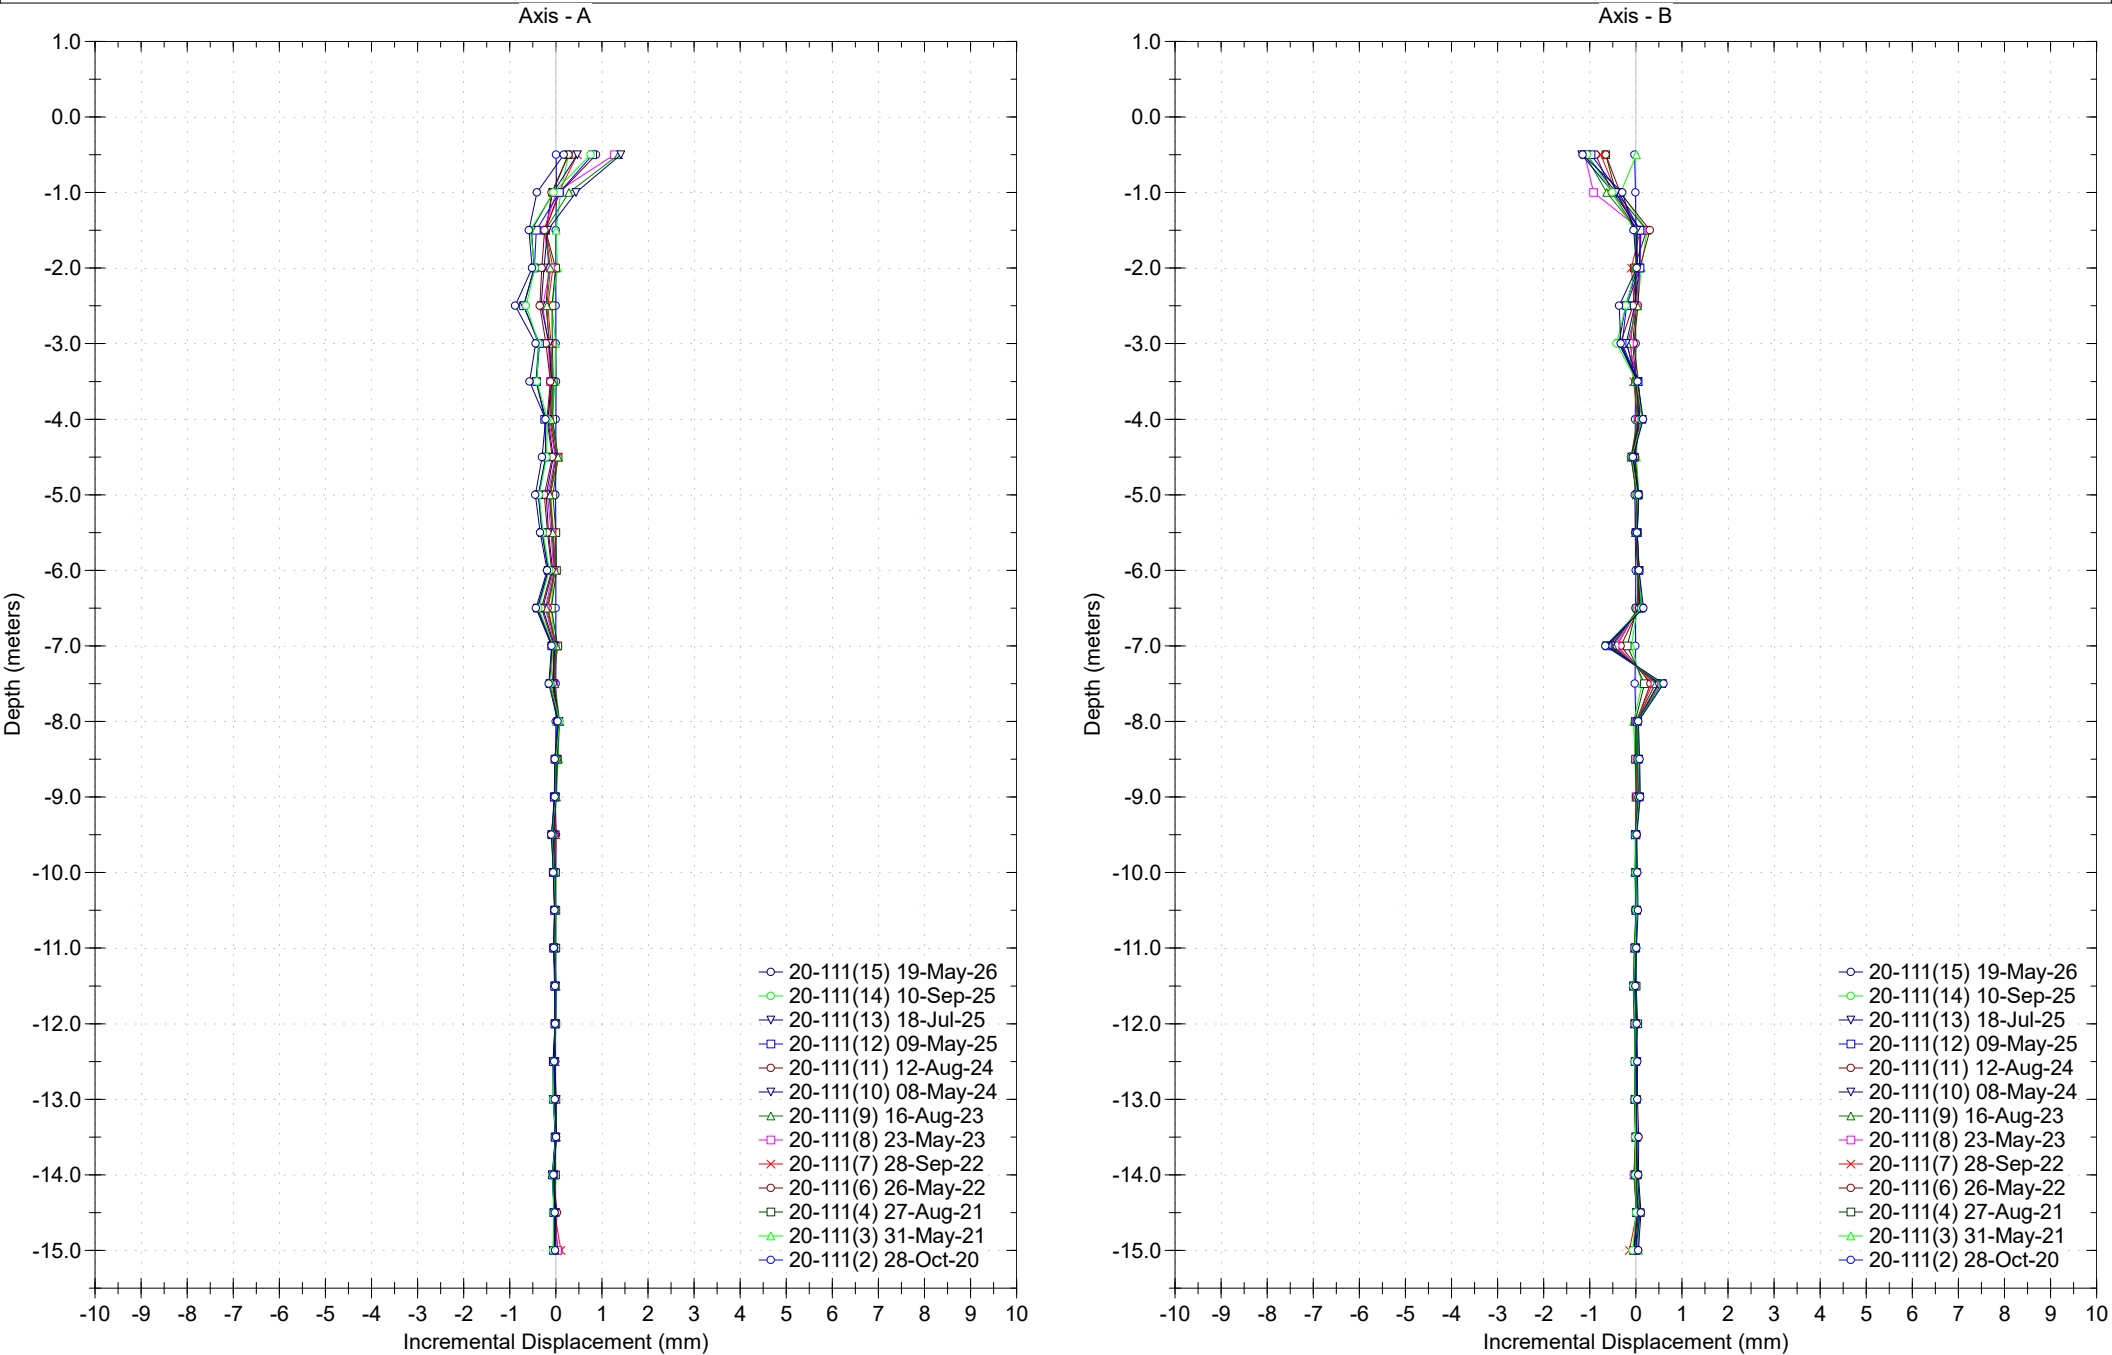
Borehole : 20-111  
Project : Nutana Slope  
Location :  
Northing : 5775568  
Easting : 385953  
Collar :

- Inclinometer 20-111 plots have historically shown minor drift in the upslope direction (with some downslope drift observed in September 2025), with approximately 6.0 mm (0.24 in) of cumulative movement observed between October 28, 2020, and May 19, 2026. Approximately 2.0 mm (0.08 in) of movement observed between September 10, 2025, and May 19, 2026 in the upslope direction.

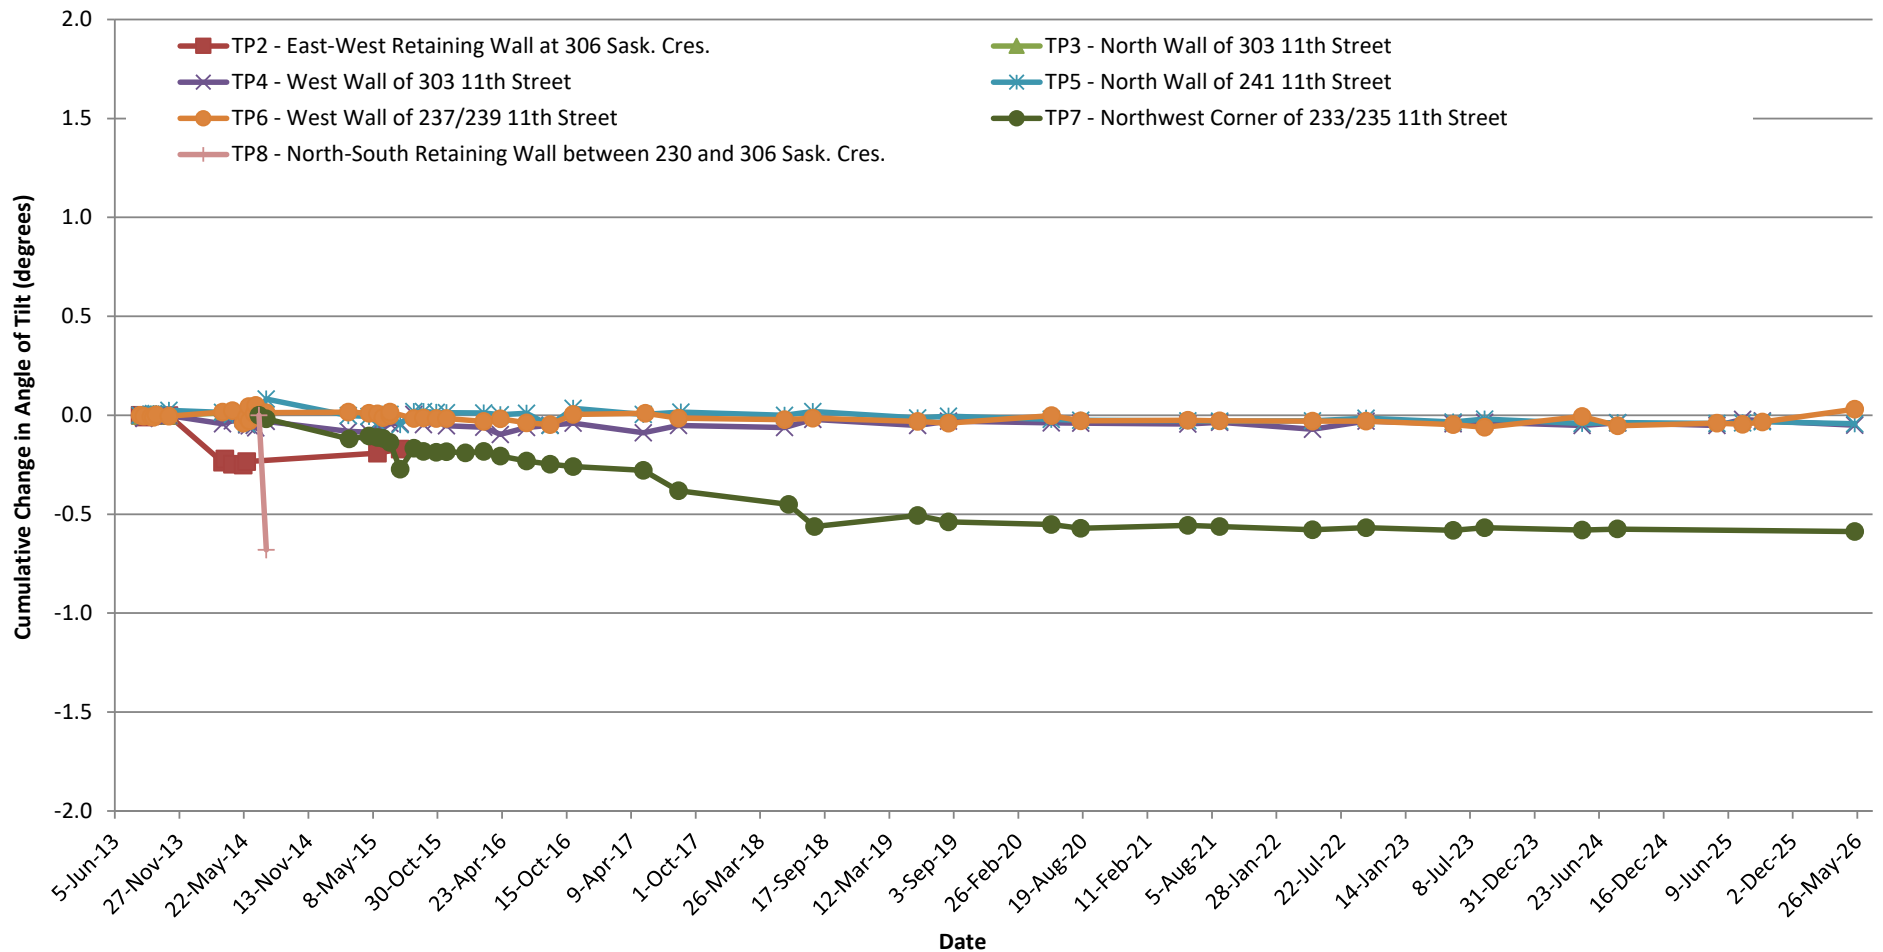
| | | | <b>FIGURE: B1</b> |

- Tilt plates TP4, TP5, TP6 indicated insignificant changes in angle of tilt (less than 0.05 degrees) between June 5, 2013, and May 19, 2026. Tilt plate TP7 indicates a change in angle of tilt of approximately 0.06 degrees between September 10, 2025 and May 19, 2026.

- 1) Positive changes in tilt indicate tilting toward the monitoring structure.
- 2) TP1, located on the retaining wall between 230 and 306 Sask. Cres., is not monitored for health and safety reasons; monitoring results for this tilt plate show a change in angle of tilt of approximately 9 degrees between August 2013 and June 2014.
- 3) TP3 and TP8 are destroyed, and TP2 is buried.

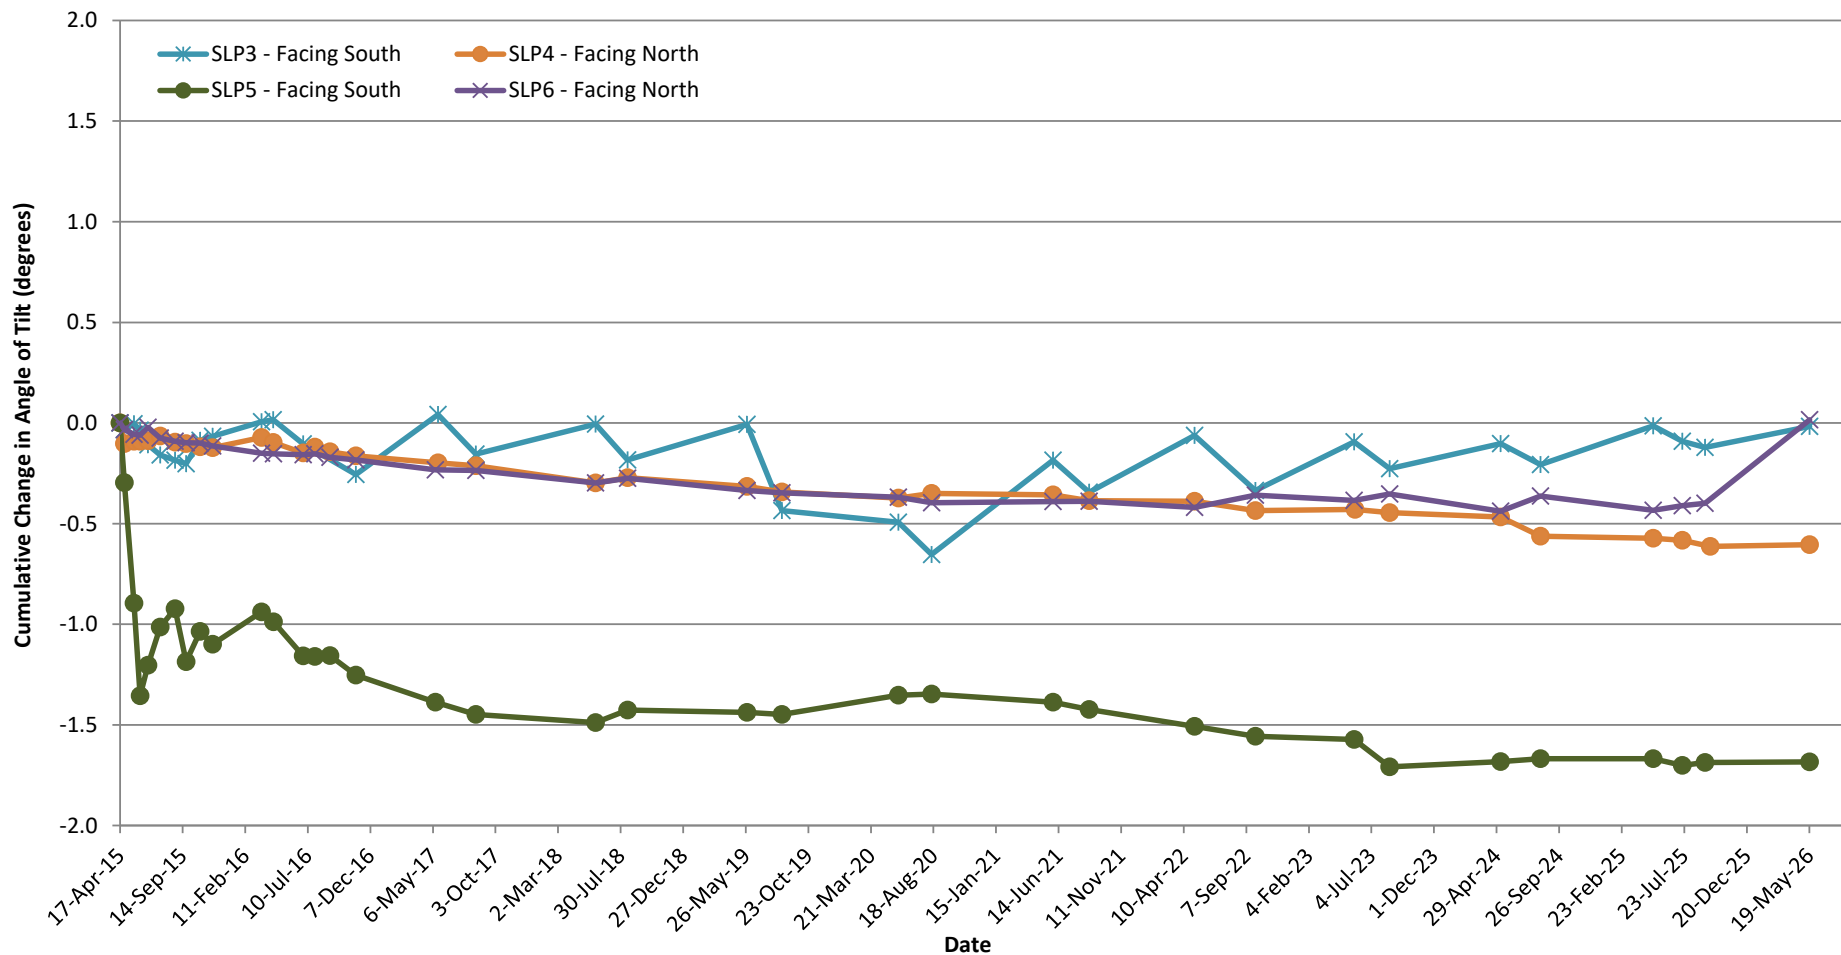
| | | | <b>FIGURE: B2</b> |

- Tilt plate SLP3 indicates a change in angle of tilt of approximately 0.10 degrees, towards the north, between September 10, 2025 and May 19, 2026. However, past readings for SLP3 have been erratic and appear to be affected by seasonal variations.

- Tilt plates SLP4 and SLP5 both indicated an insignificant change in angle of tilt (less than 0.05 degrees) between September 10, 2025 and May 19, 2026.

- Tilt plate SLP6 indicated a change in angle of tilt of approximately 0.42 degrees, toward the south, between September 10, 2025 and May 19, 2026. The results of this tilt plate are greater in magnitude than any historical results and were towards the south in direction, which is opposite of the historical direction of tilt. This reading from this tilt plate from this monitoring event is questionable, may be erroneous, and should be evaluated further compared to the results from the next monitoring update.

Tilt plate SLP6 indicated a greater magnitude of change in angle of tilt than has been observed in past events, which was also observed in the opposite direction of historical movement. The results for SLP6 are questionable, may be erroneous, and should be evaluated further following the next monitoring trip.
