Silverwood Golf Course Clubhouse

SHEET NAME	ASBUILT
Main Floor Base Plan

PROJECT TITLE
**814
Silverwood
Golf Clubhouse**

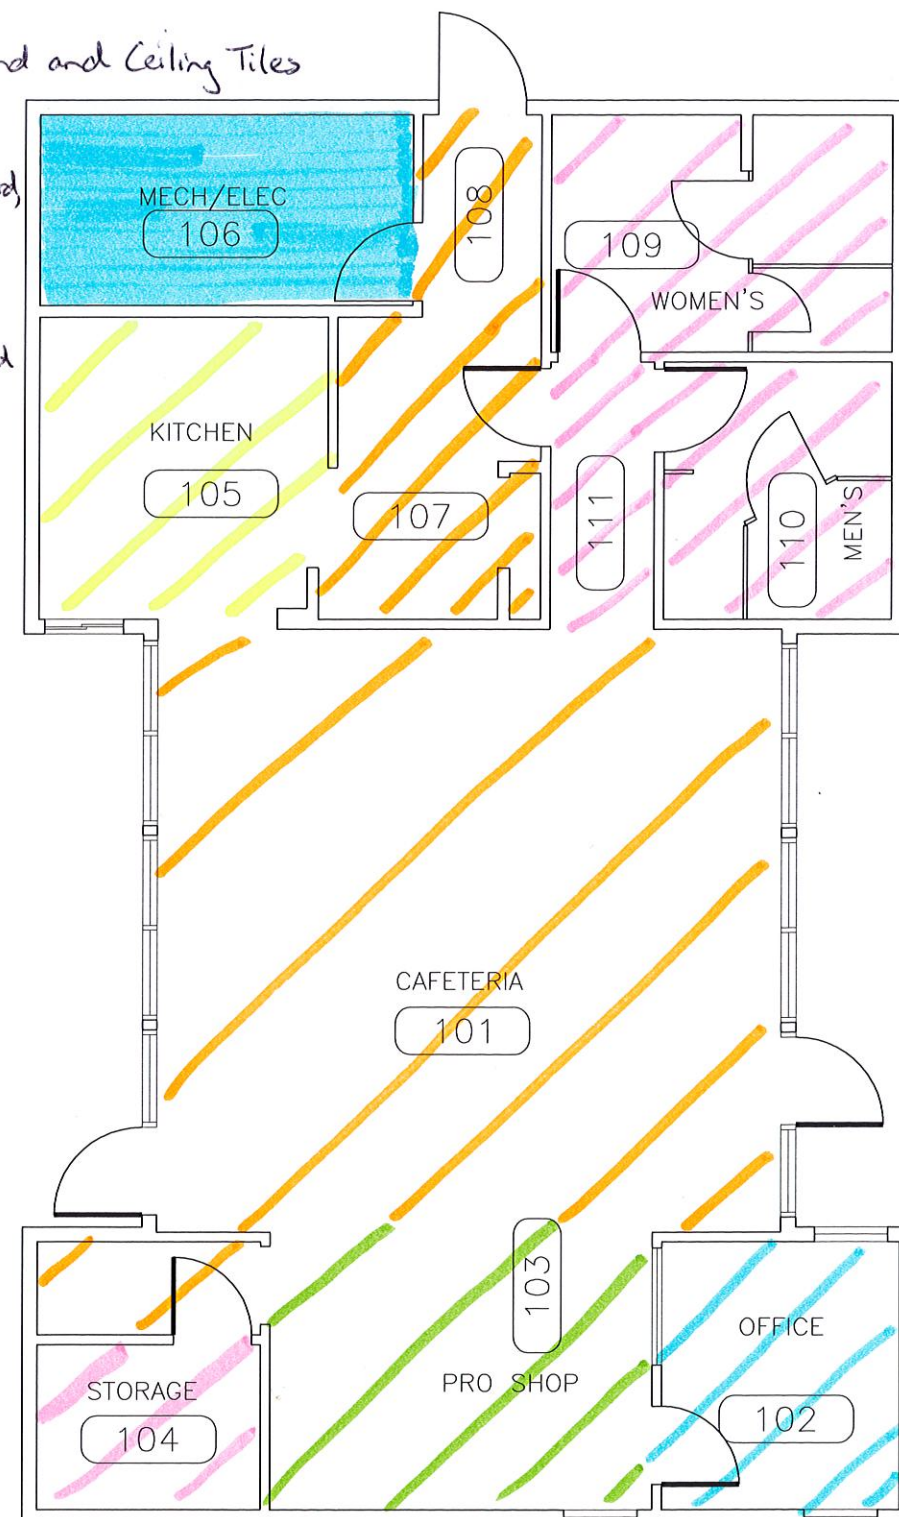
Asbestos-Containing Drywall Joint Compound

Asbestos-Containing Drywall Joint Compound and Caulking

Asbestos-Containing Drywall Joint Compound and Ceiling Tiles

Asbestos-Containing Drywall Joint Compound,
Ceiling Tiles, and Caulking

Asbestos-Containing Drywall Joint Compound
and Sink Undercoat

Asbestos-Containing Drywall Joint Compound,
Duct Mastic, Pipe-Fitting Insulation,
Caulking, and Firestop

Notes: 1) Asbestos is a carcinogen.
Avoid breathing dust.
2) Asbestos-containing caulking
and firestop are located
on the building exterior.
