CITY OF SASKATOON PARKS & AQUATIC UNITS ASBESTOS SURVEY REPORT

AUGUST 2013

Prepared By: Bersch & Associates Ltd. Project No. : B67.13

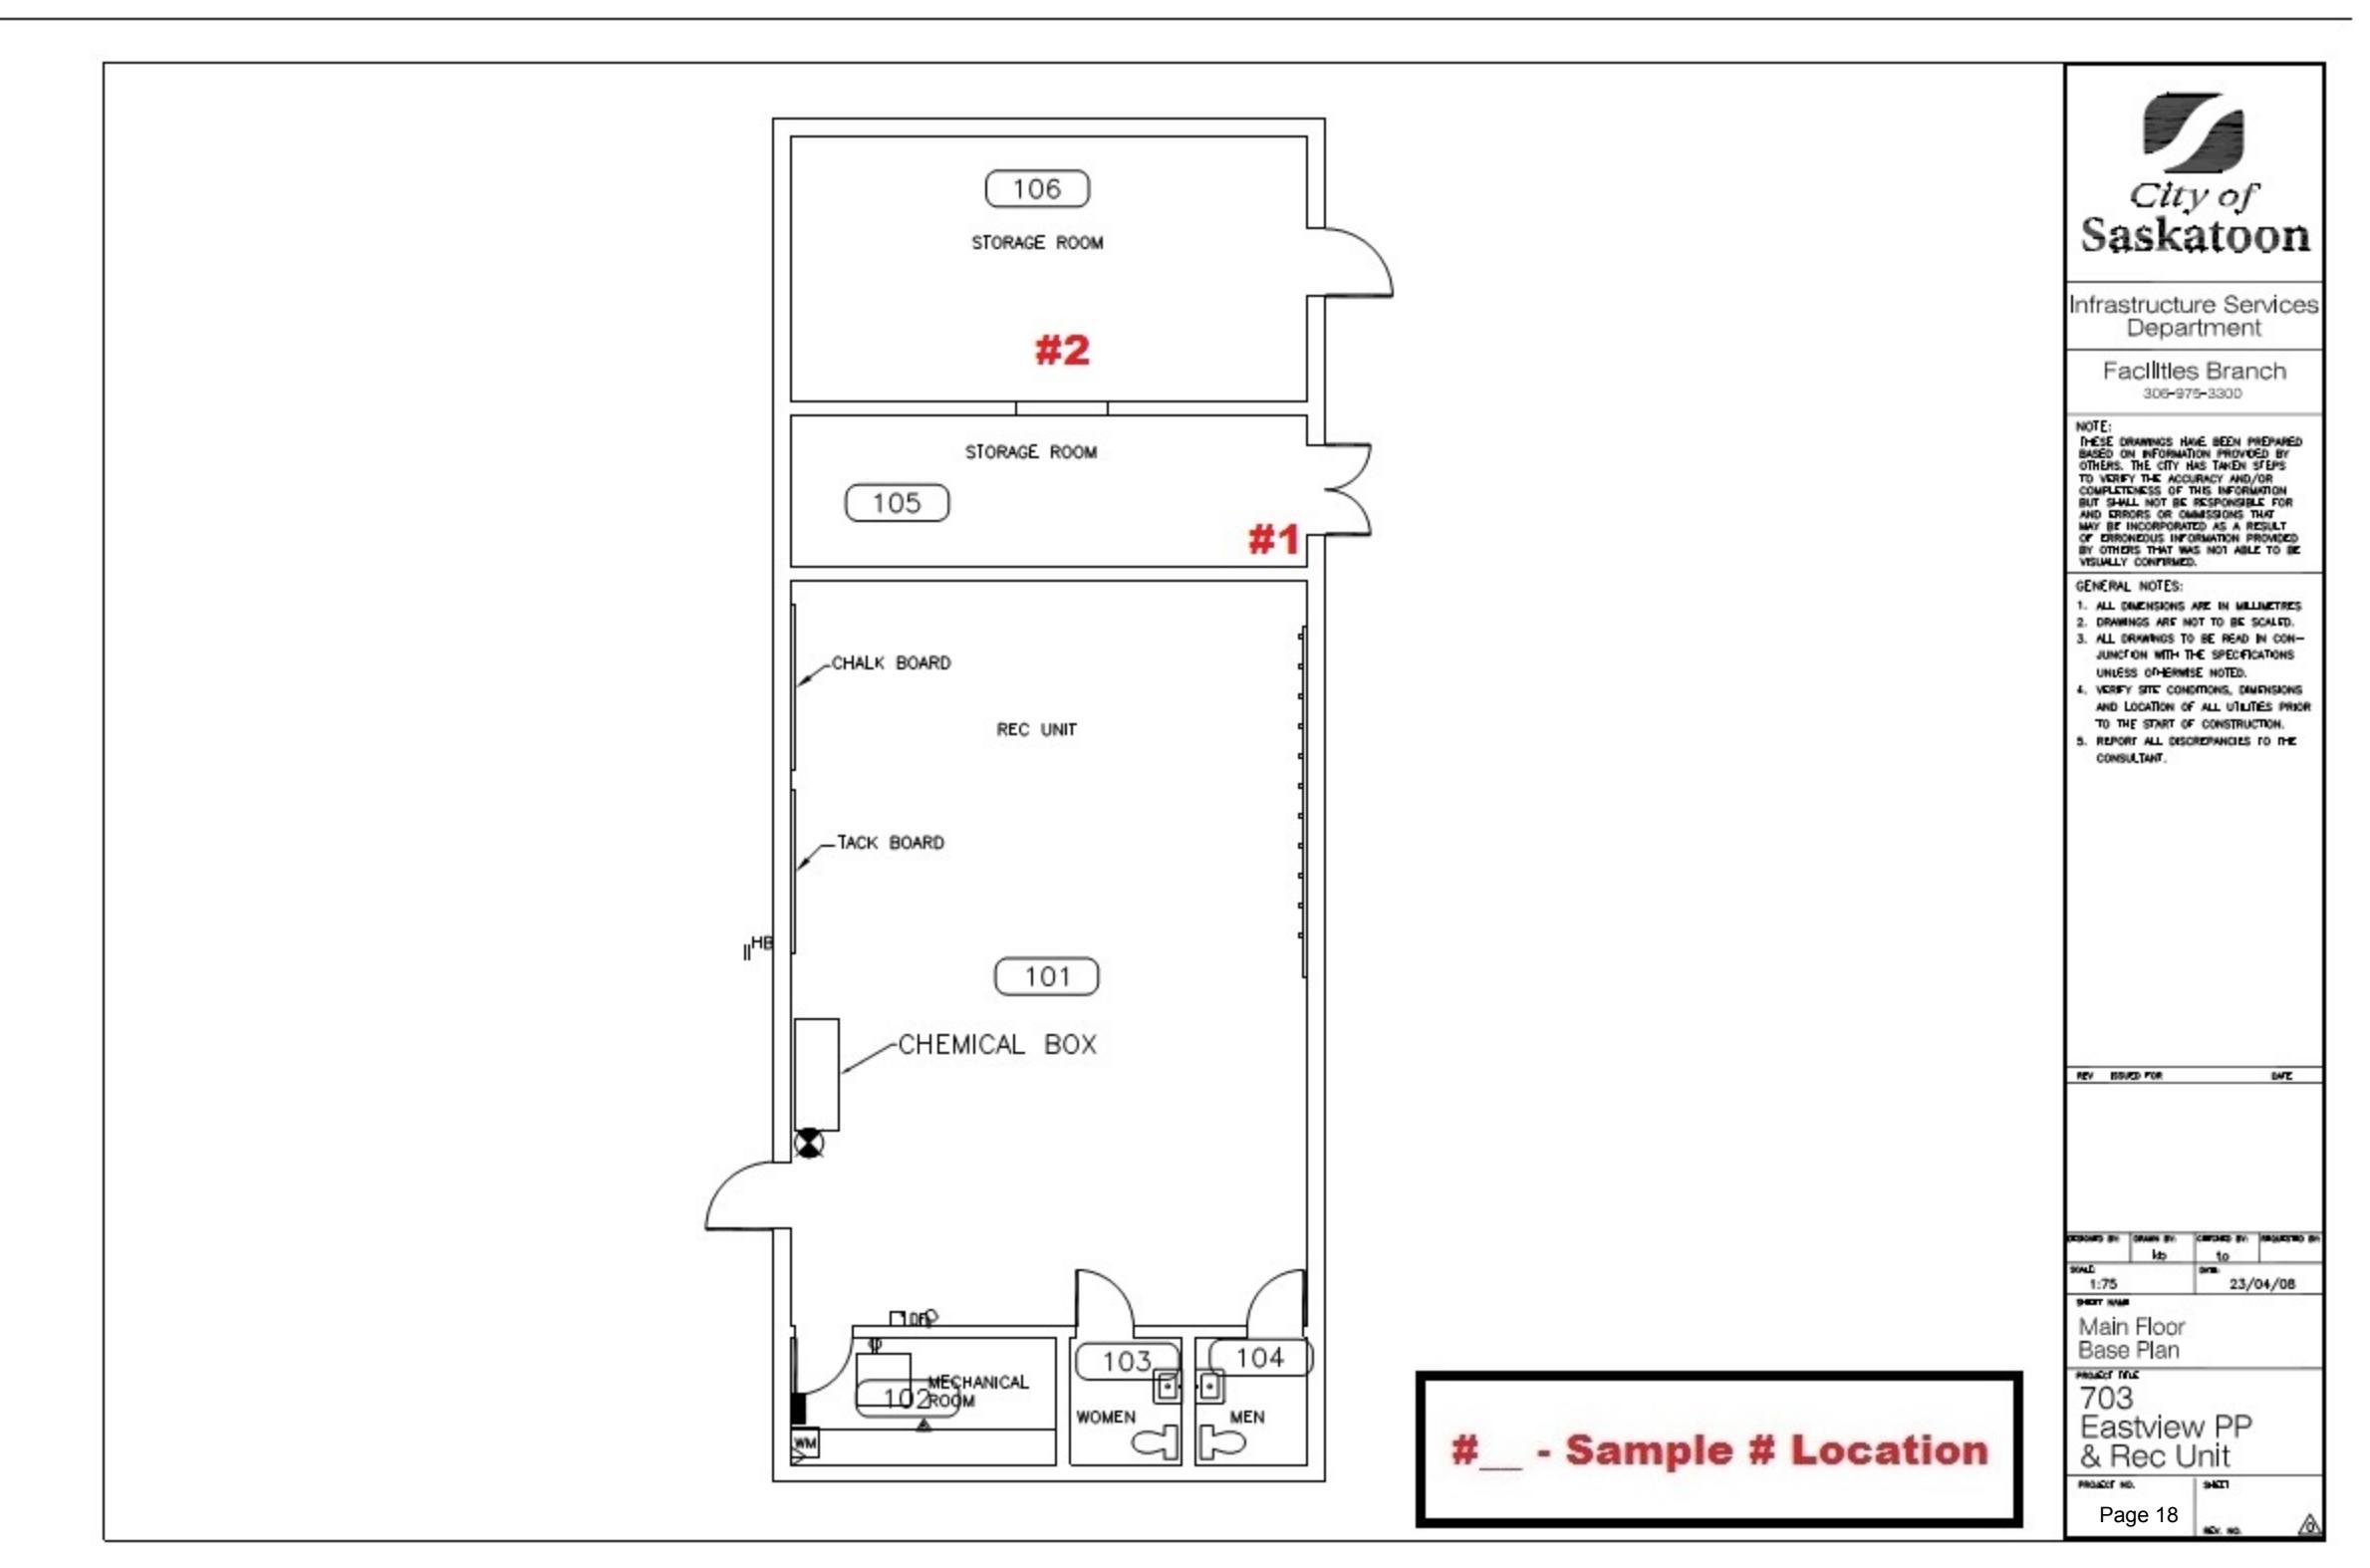
Vermiculite block wall fill insulation has been identified on the ground within room 105 of the Eastview/James Anderson Park Rec Unit. A cleanup of the vermiculite should be performed and the cause of the material spillage should be contained. Consider all material of this type to be asbestos containing.

PRIORITY:	ONE
CONDITION:	POOR/ MODERATE
POTENTIAL FOR DISTURBANCE:	LOW
ACTION:	CLEANUP & MANAGE

Bersch	h & Asso	ciates Ltd.			B67BAH08
Box 3568					
Humbold	t, Sask. S0K 2	2A0	BULK SAMPL	E ANAL	YSIS REPORT
PROJE	CT NO. Be	57.13			
CLIEN	T: City of S	Saskatoon			
	Infrastru	acture Services - Facilities Branch			
Contact	: Brent A	nderson			
Locatio	n: James A	Anderson Park - 1140 East Centre, Saskato	oon, SK.		
NO	DATE		AGDECTOG	0/	
NO.	DATE	SAMPLE INFORMATION	ASBESTOS	%0	ANALYSI
1	8-Aug-13	Exterior Storage- Zonolite Material	Actinolite/Tremolite	>0.1	WD
					WB

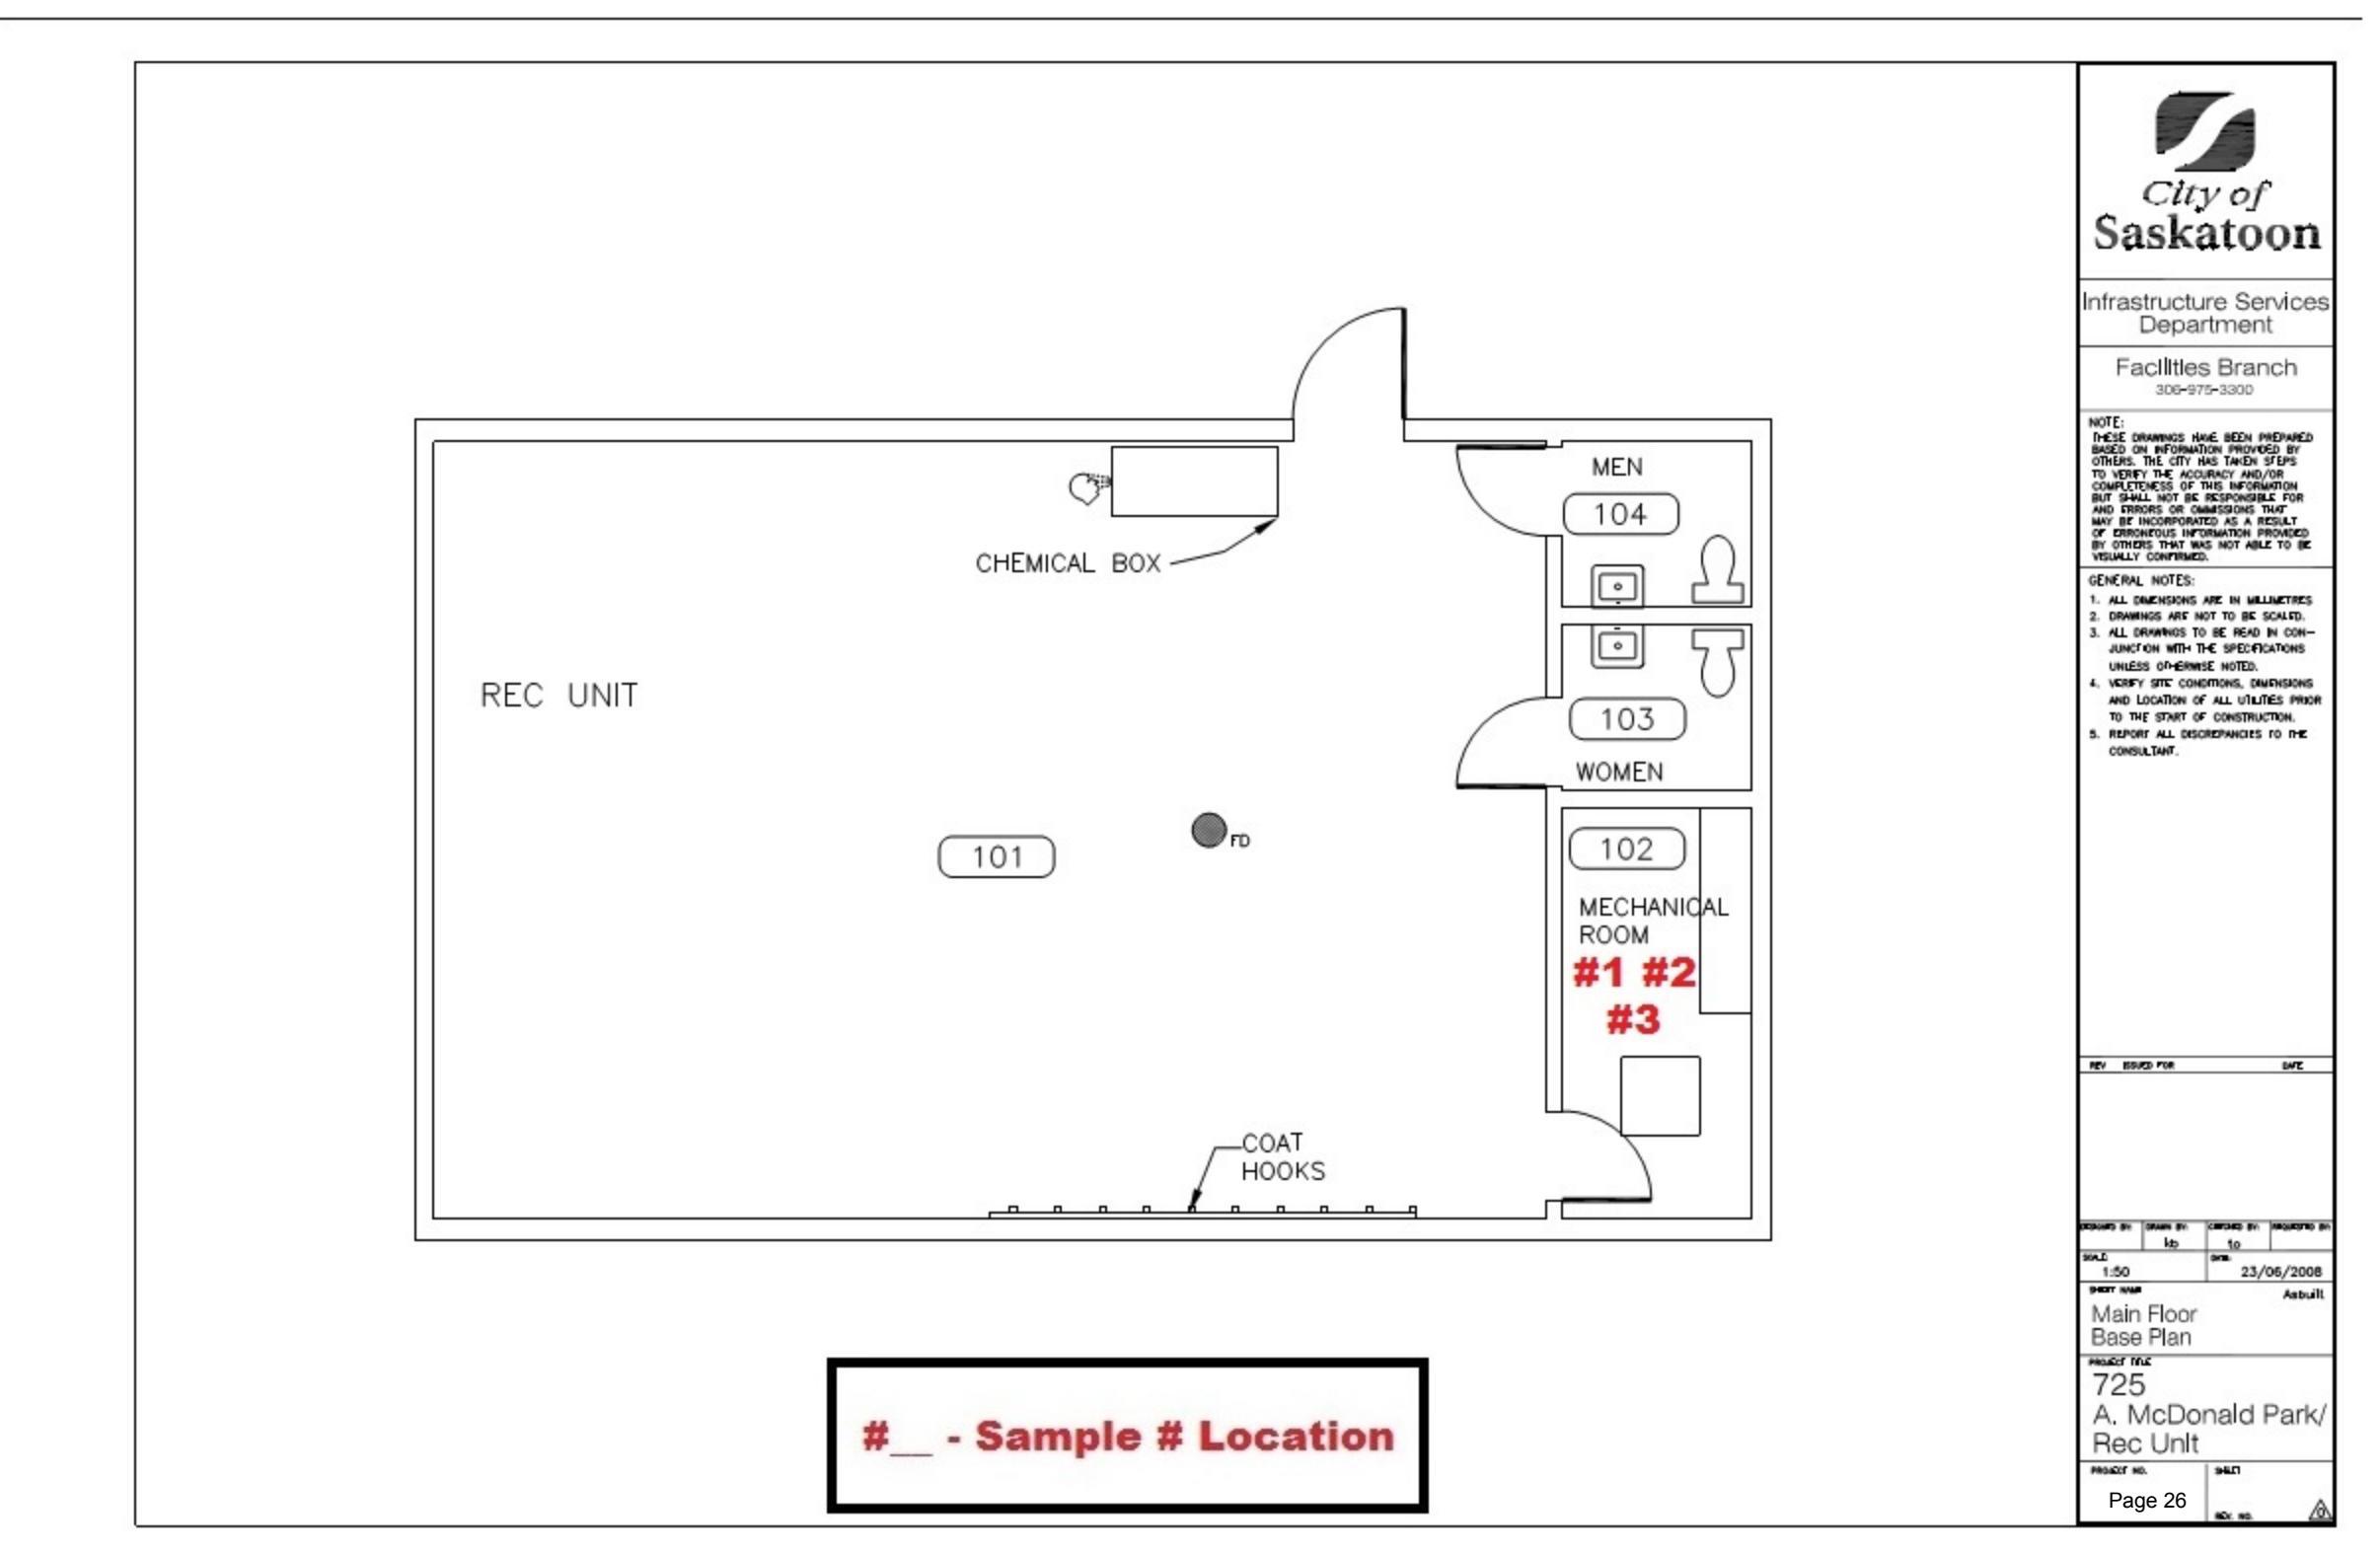
Asbestos containing Transite Boards are present within the facilities. This material is in good condition and may be managed in place. This material is located on the ceiling within the 102 mechanical rooms of the facilities. The board was identified with a red 'ASBESTOS' stencil.

PRIORITY:	THREE
CONDITION:	GOOD
POTENTIAL FOR DISTURBANCE:	LOW
ACTION:	MANAGE

Bersch	h & Asso	ciates Ltd.			B67BAH07
Box 3568 Humboldt	, Sask. S0K 2	2A0	BULK SAMPI	LE ANAI	LYSIS REPORT
PROJE CLIEN Contact Locatio	CT NO. BO F: City of S Infrastru : Brent Au n: Archiba	57.13 Saskatoon ucture Services - Facilities Branch nderson Id McDonald Park - 3110 Massey Drive, Saska	atoon, SK.		
NO.	DATE	SAMPLE INFORMATION	ASBESTOS	%	ANALYST
1	7-Aug-13	Electrical Room- Lineal pipe insulation on small line	None Detected		WB
2	7-Aug-13	Electrical Room- Transite cement board	Chrysotile	30	WB
3	7-Aug-13	Electrical Room- Wall parging	None Detected		WB

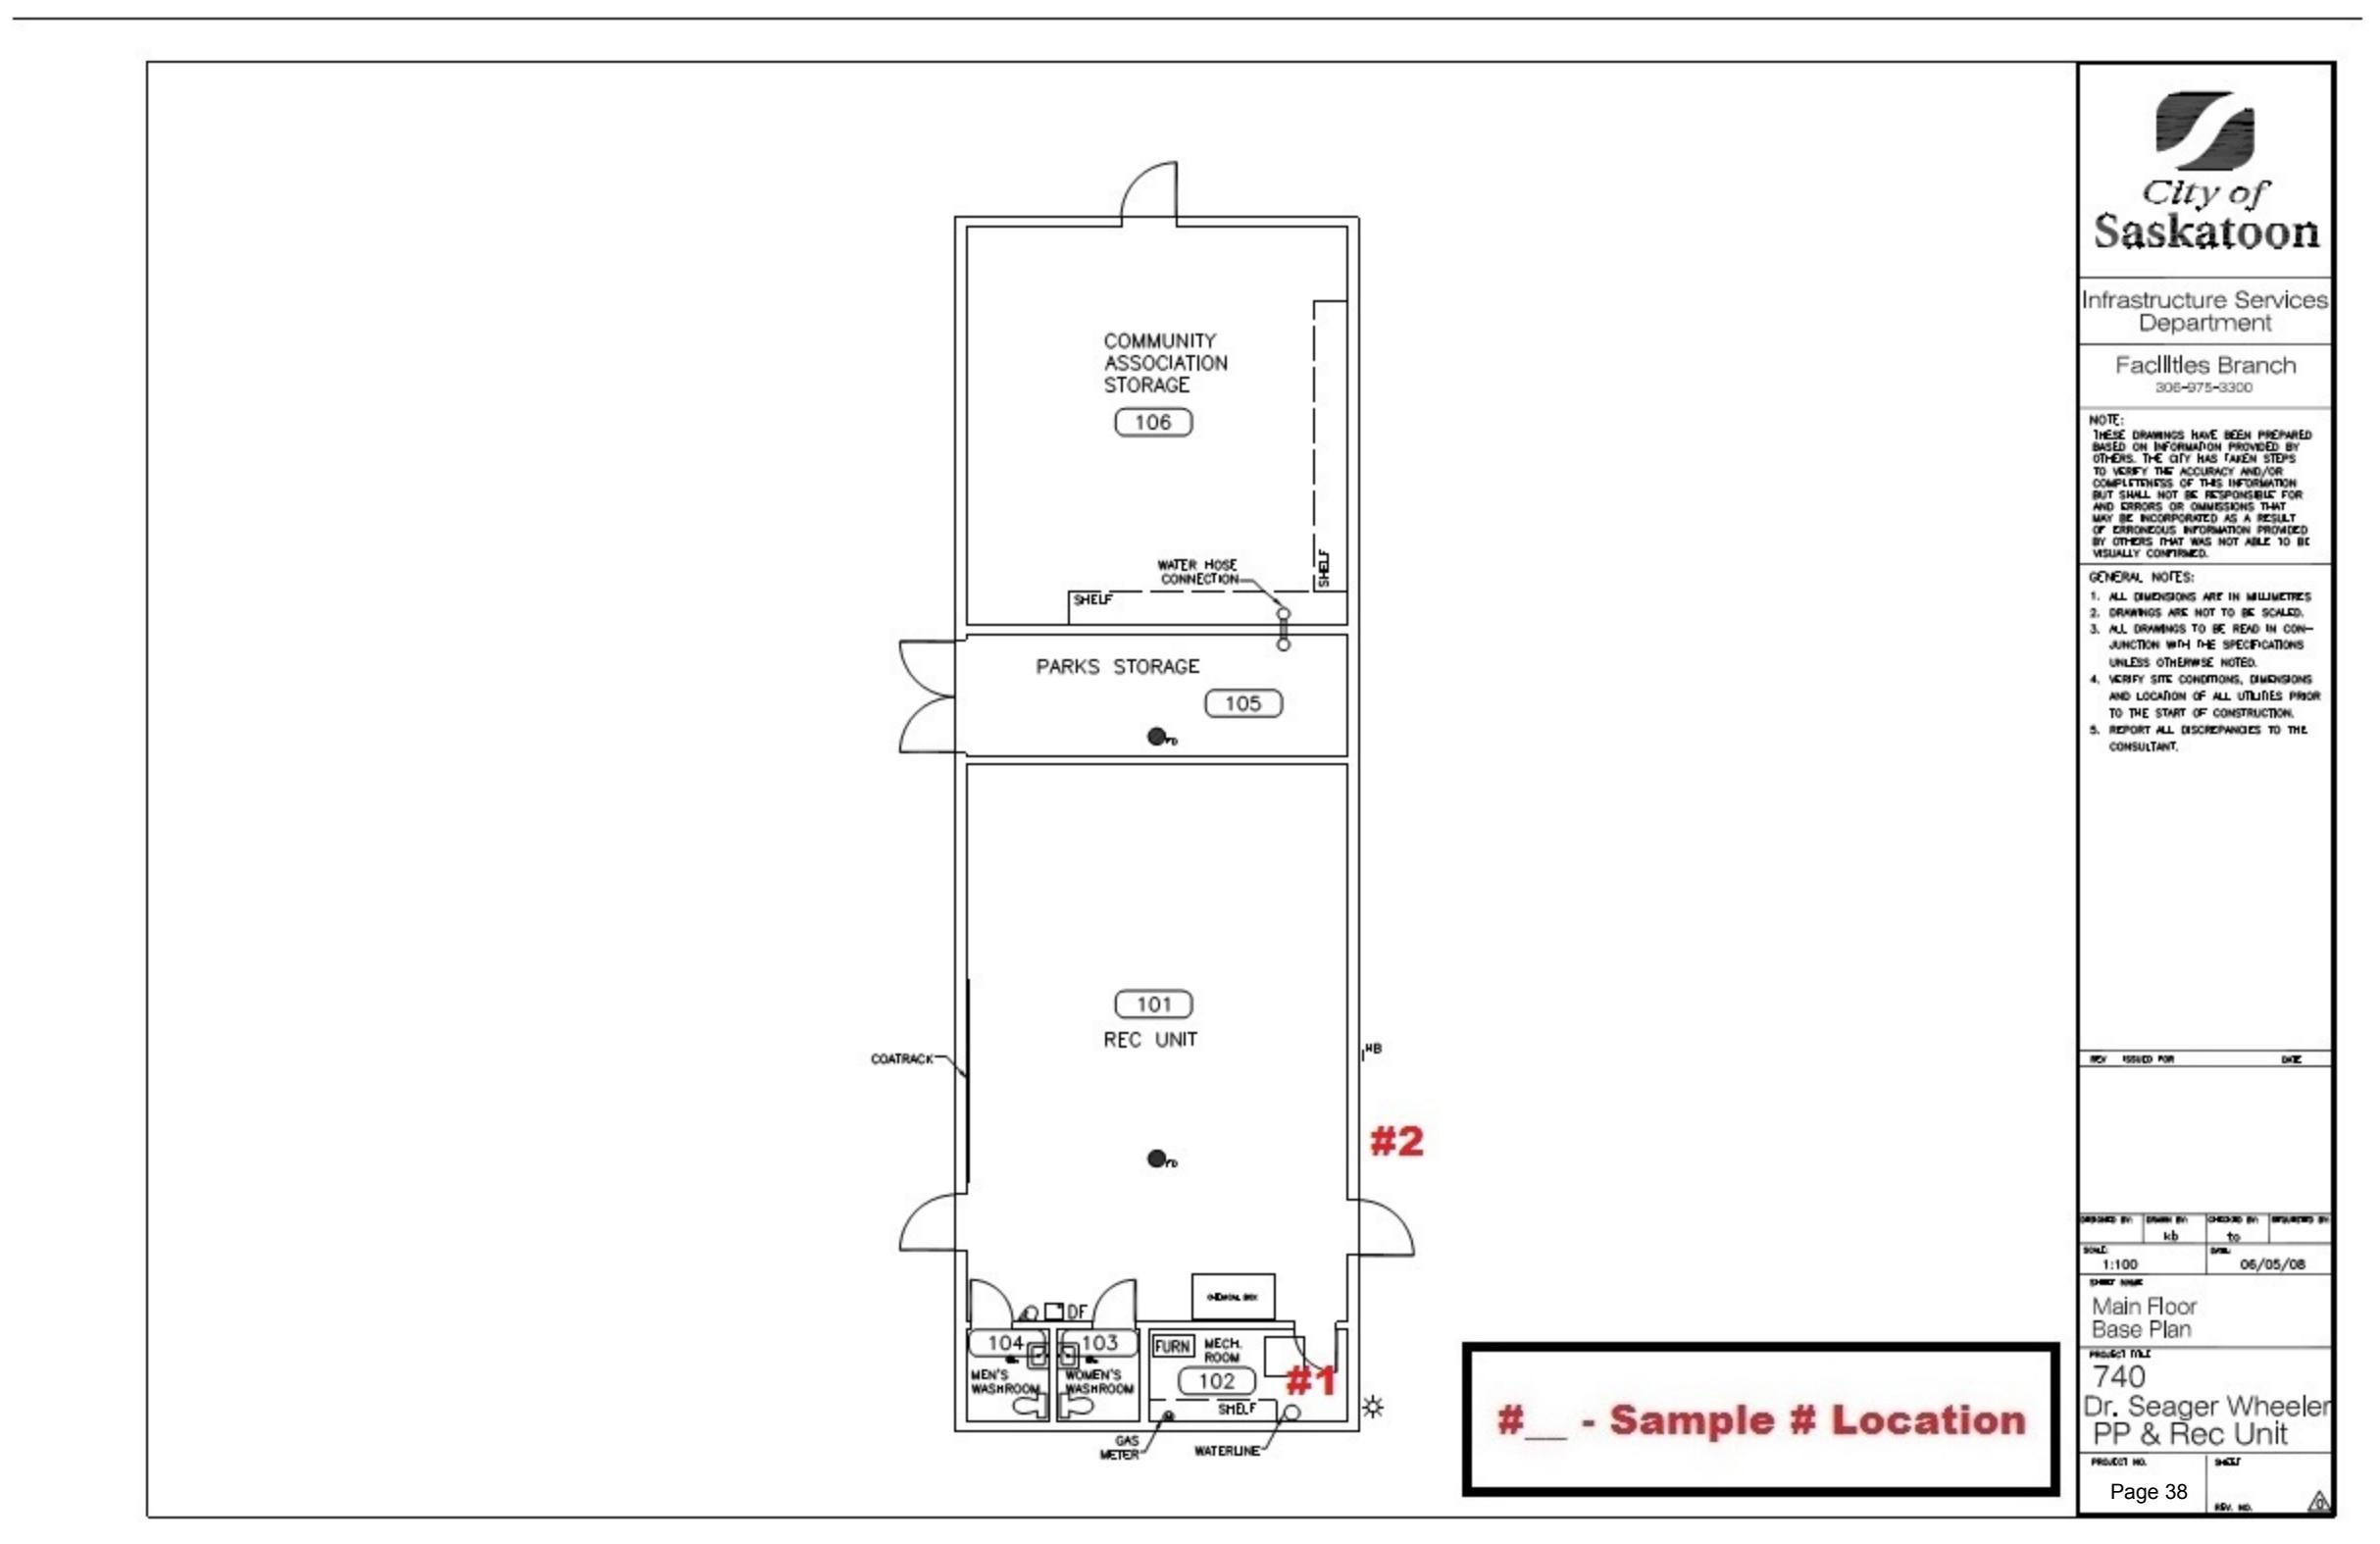
Bersch	h & Asso	ciates Ltd.			B67BAH07
Box 3568					
Humboldt	t, Sask. SOK 2	2A0	BULK SAMPI	LE ANAI	AYSIS REPORT
PROJE	CT NO. B(57.13			
CLIEN	F: City of S	Saskatoon			
	Infrastru	acture Services - Facilities Branch			
Contact	: Brent Ar	nderson			
Locatio	n: Dr. Seag	ger Wheeler Park - 2230 Richardson Ro	oad, Saskatoon, SK.		
NO.	DATE	SAMPLE INFORMATION	ASBESTOS	%	ANALYST
110.	DITL			/0	
+	7-Aug-13	Furnace Room- Transite cement board	BATEMENT OMPLETED ct 21, 2015	30	₩B
2	7-Aug-13	Exterior of Building- Wall parging	None Detected		WB
