EXISTING RIVERBANK CONDITIONS IN KINSMEN PARK

RESTORATION KINSMEN PARK / Saskatoon, SK NOVEMBER, 2011

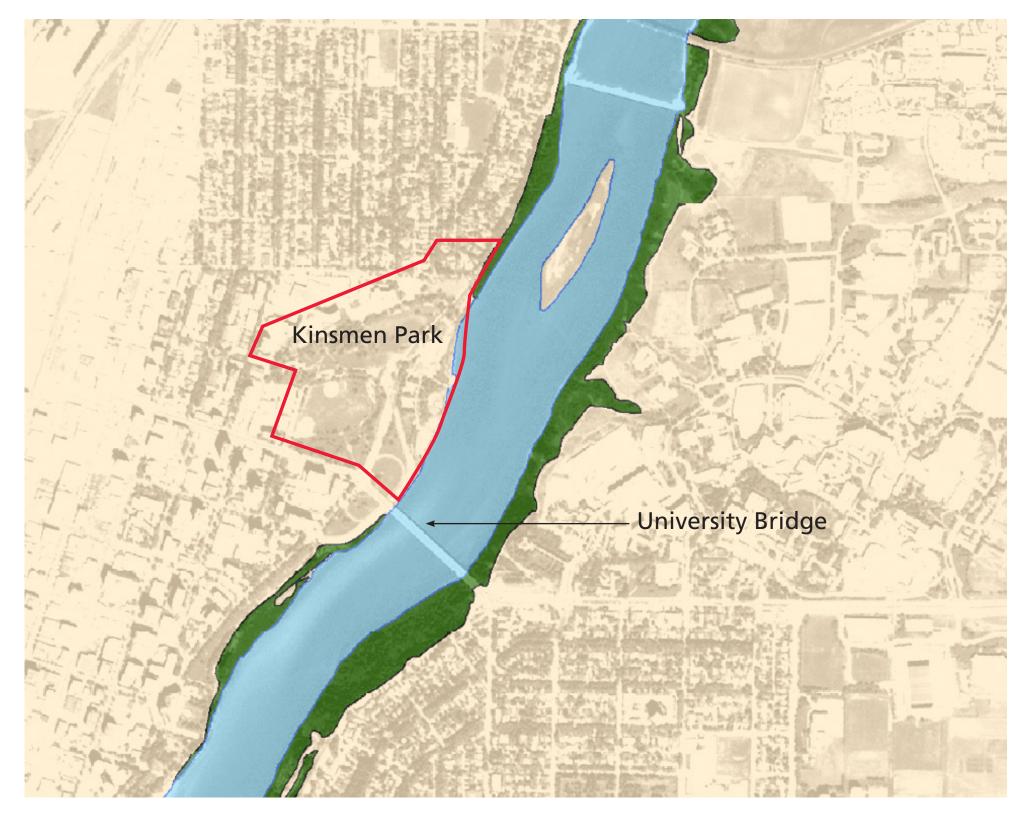
The Meewasin Valley Authority's "State of the Watershed" report (MVA 2008) characterized the ecological integrity of the entire valley. Their figures characterize the shoreline along Kinsmen Park as "disturbed or developed" (MVA 2008). This is in contrast to the native vegetation zones both north and south of Kinsmen Park.

Meewasin Valley Authority Ecological Integrity map for Kinsmen Park area (MVA 2008)

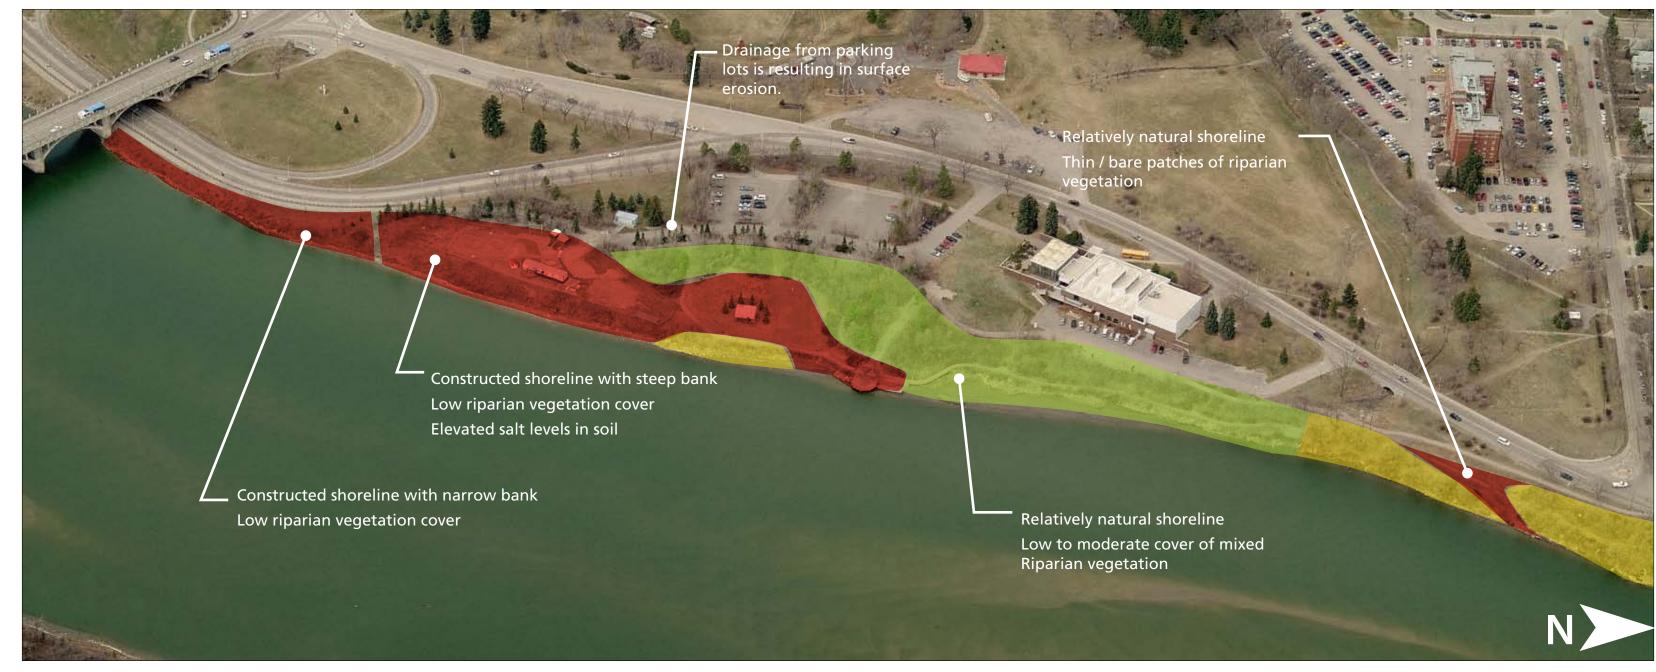
OVERVIEW OF RIVERBANK CONDITIONS ALONG KINSMEN PARK

Construction of the Spadina Interchange (1967) and later re-development of the Shakespeare on the Saskatchewan area (1987) resulted in substantial shoreline alterations along the south portion of the Kinsmen Park. The shoreline in this area has steep slopes, fill material, and riprap shoreline armoring. A snow dump was located in the Shakespeare on the Saskatchewan site until 1997, and soils here still have high salt content. Paths and dock development have altered the shoreline conditions along the rest of the Kinsmen Park shoreline. These general conditions are described in the graphic below.
