**The “Small Swale” Resource
Overview**

Prepared for:
City of Saskatoon
Community Services Department
City Planning Branch

November 2003
File: 132-52599.01
Copyright © Stantec Consulting Ltd.,
2003

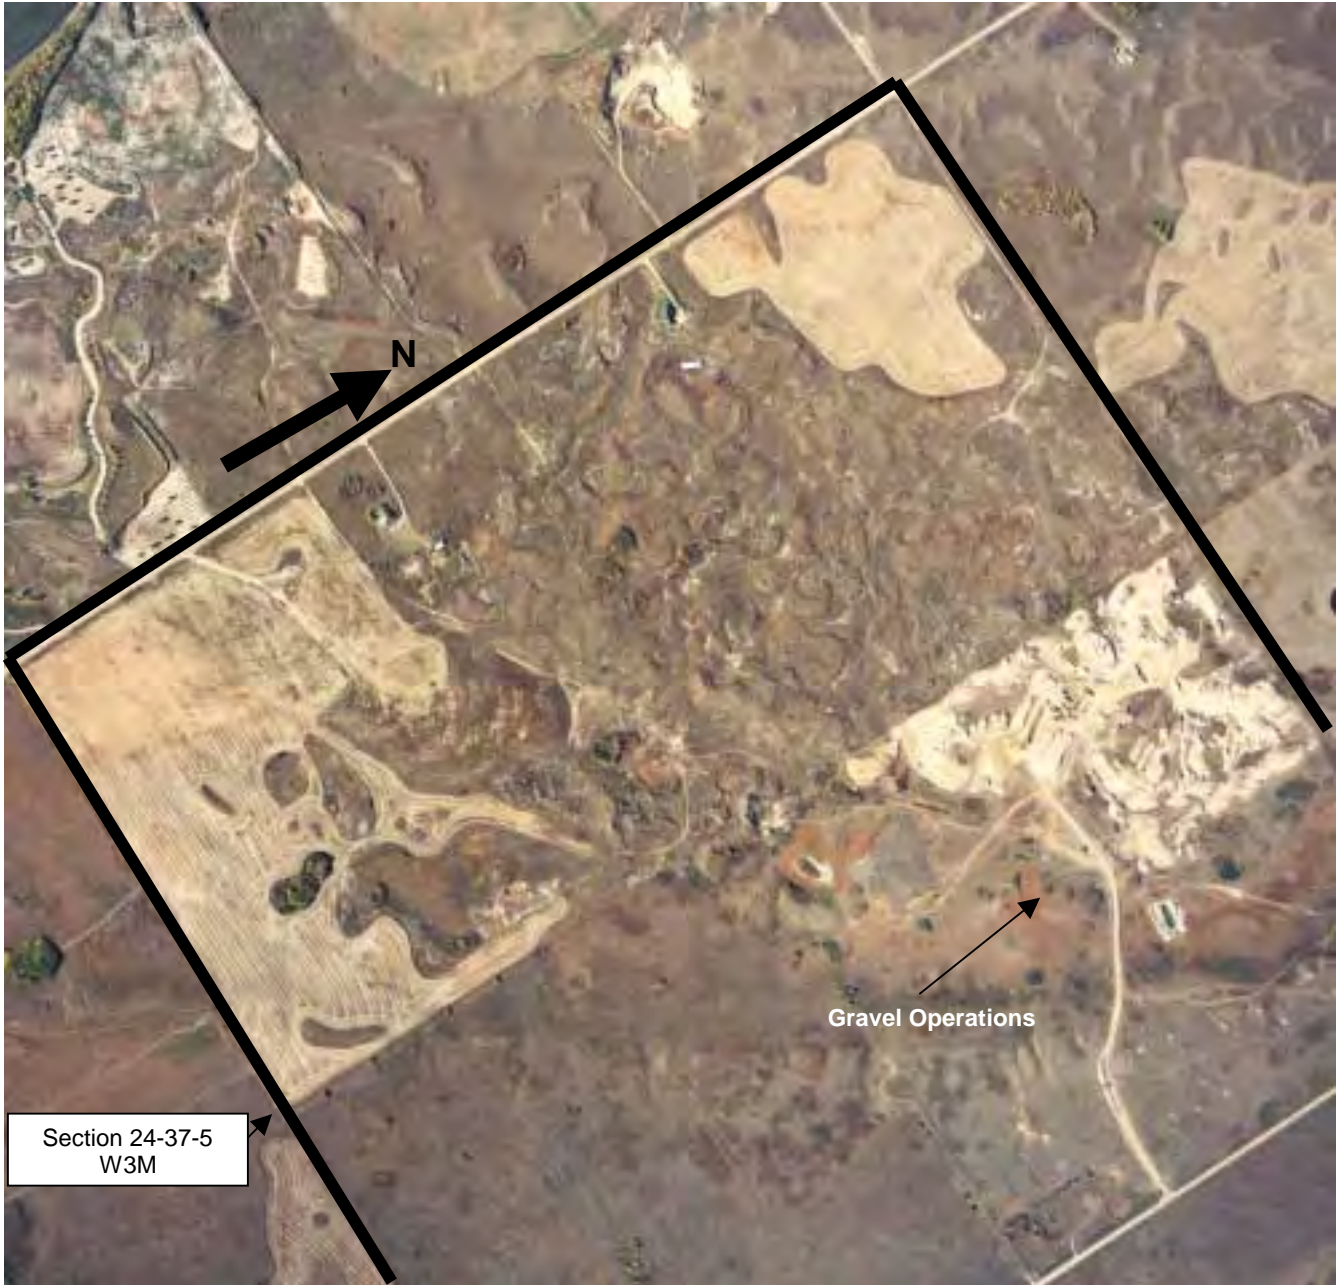
Figure No.
2

2003 Aerial Photograph
(scale: 1:11,000)

Currently, land use is a combination of gravel extraction, pasture, idle lands, and residential (Refer to Figures 2 and 3). Much of the N 1/2 of Section 24 is currently used for gravel extraction and the natural character of the landscape has been completely modified. The SE of Section 25 is an overgrazed pasture that has also had some historic excavation and there are numerous large rock piles along the eastern boundary of this section. The SW of Section 25 contains a mixture of cultivated land and pasture. The W 1/2 of Section 30 contains a combination of a relatively natural grassland/shrub environment, and some disturbed lands that are used by the RM of Corman Park. A farmstead is located within the SE of Section 25.

Aerial photographs (Figures 2 and 3) illustrate how disturbed the study area has become. Much of Section 24 is now actively farmed or has large-scale gravel extraction activities. Much of the SW of Section 25 is cultivated and the SE of 25 has been heavily grazed. Only portions of Section 30 remain relatively undisturbed, although as noted in Hudson's remarks, the more northern portions are in the most natural state.

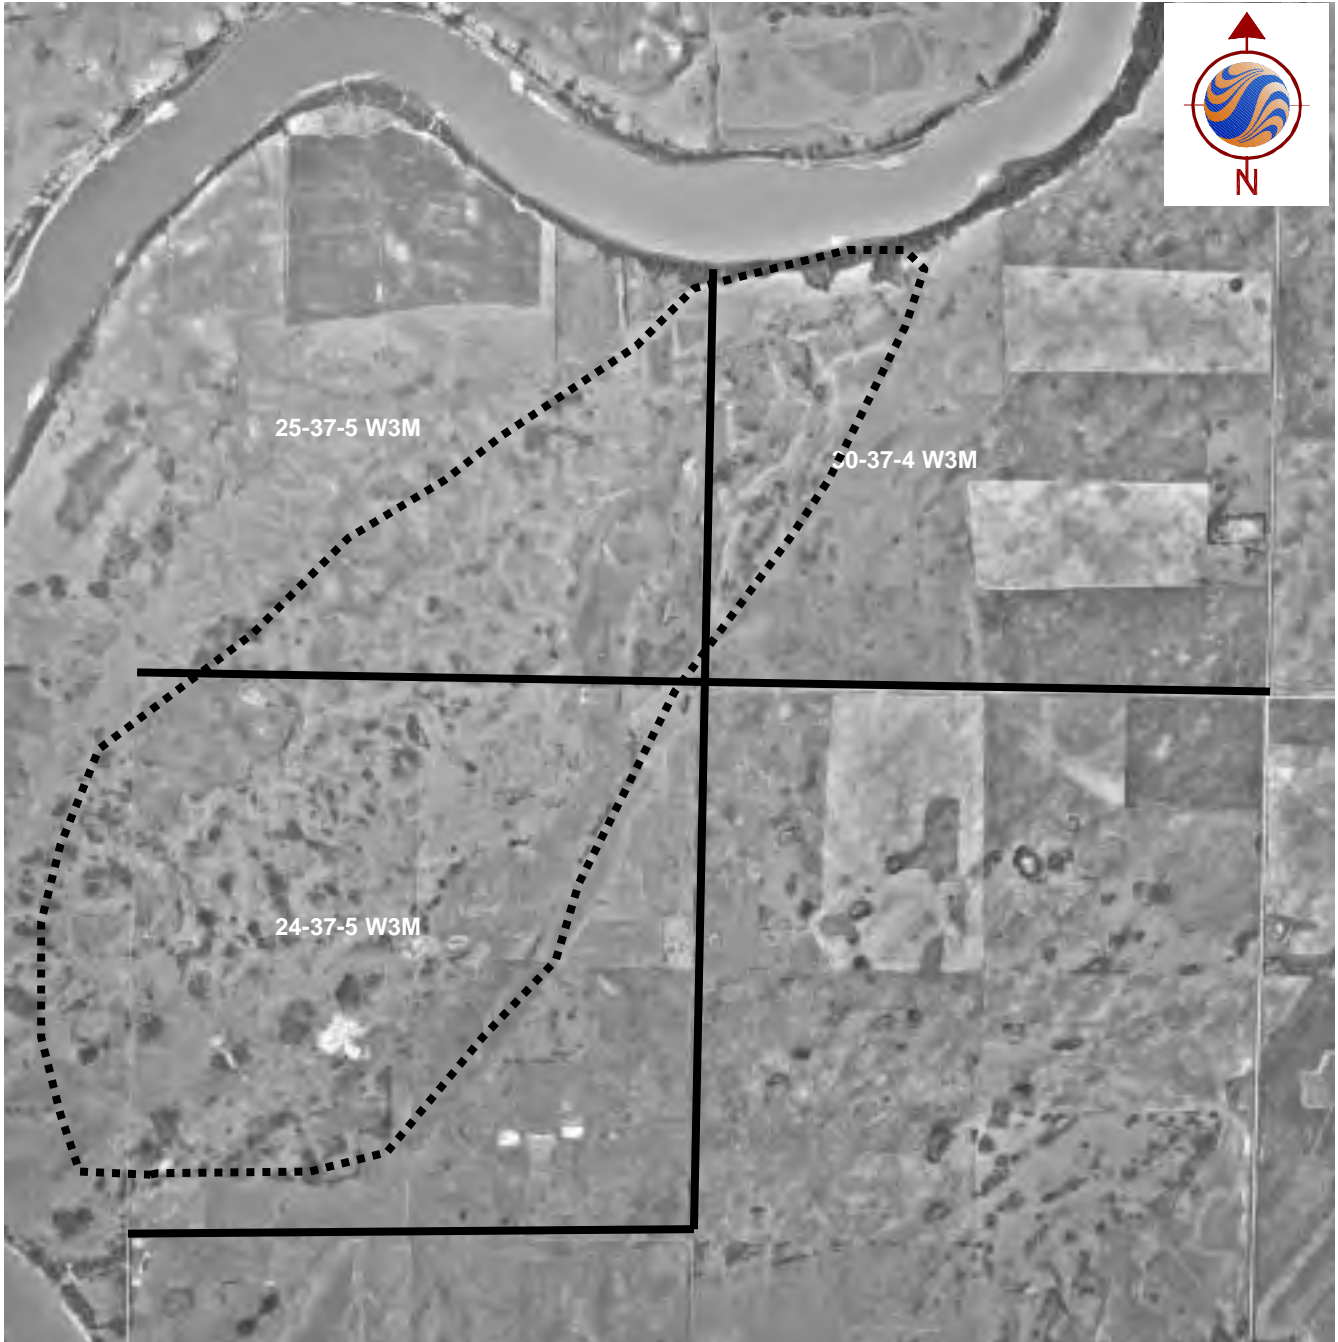
4

Small Swale study area (approx.)

1961 Aerial Photograph
(scale: 1:21,000 approx.)

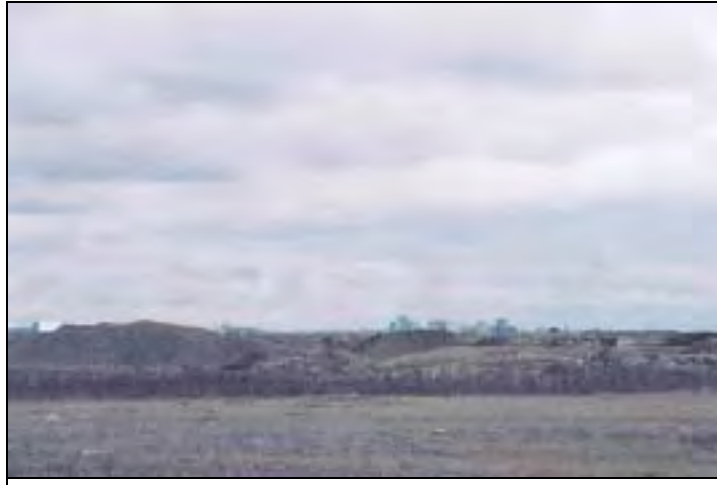
PHOTO 1 Looking west to the gravel operations in NE 24

- The northern half of 24-37-5 W3M once contained some interesting natural vegetation, as reported by Hudson (1993). A rare plant species was found here in 1965. However, this area is now highly disturbed by gravel operations and very little natural environment remains. The highly disturbed and fragmented nature of this area suggests that it has little ecological value and future developments could occur with no concern.

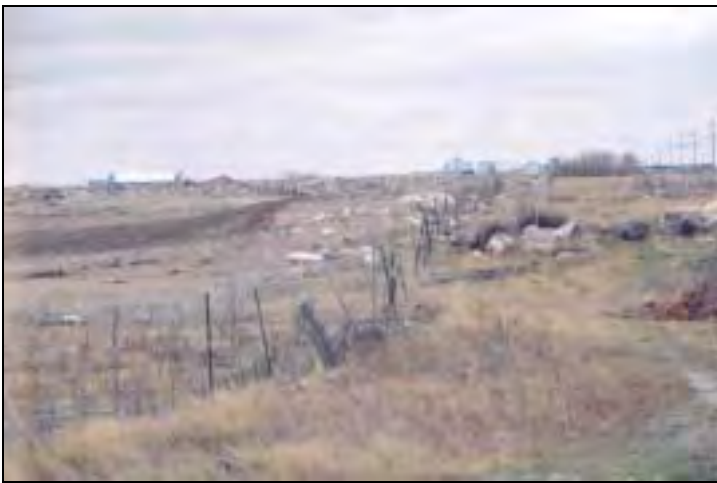
PHOTO 2 Looking west along abandoned road allowance between Sections 24 and 25

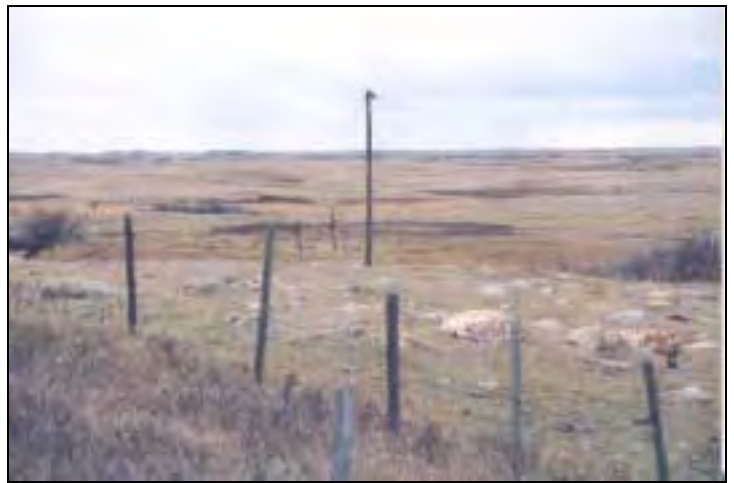
PHOTO 3 Looking northwest into the SE of Section 25

- The southern half of 25-37-5 W3M has been used for a variety of purposes. The SE quarter contains a small saline, seasonal slough but the quarter has been overgrazed and portions were used for small scale gravel or rock extraction activities. The SW quarter is more natural, although it too has seen small scale gravel/rock extraction activities, grazing, and cultivation. Generally, the fragmented and disturbed nature of the southern half of 25 suggests that it has minimal ecological value and future developments could occur with no concern.

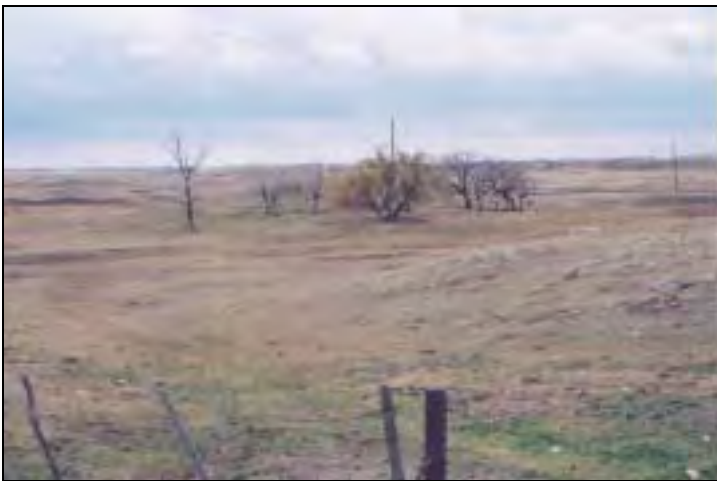
A windshield survey of the study area was completed and 2003 aerial photographs of the site were examined. This review suggested that the heritage resource potential for the majority of the Small Swale region is low. However, there are two exceptions. Lands near the river (e.g., within 500 m) may have some potential for surface finds such as stone circles (tepee rings), particularly within Section 30, which is the most undisturbed component of the study area. Additionally, a review of historic aerial photographs reveals that there were buildings located within the pasture in the SE of Section 25 (Refer to Figures 3 and 4 and Photo 4). Hudson (1993) also commented that he saw evidence of old buildings at this location. There is a high probability that this was an old homestead site.

PHOTO 4 Potential old farmstead site in the SE of Section 25

- The potential heritage site (old building/farmstead) with the SE 25-37-5 W3M should be visited and site information collected, if available. The presence of this site does not prevent future development, but the information should be collected and reported to the Heritage Branch prior to development.

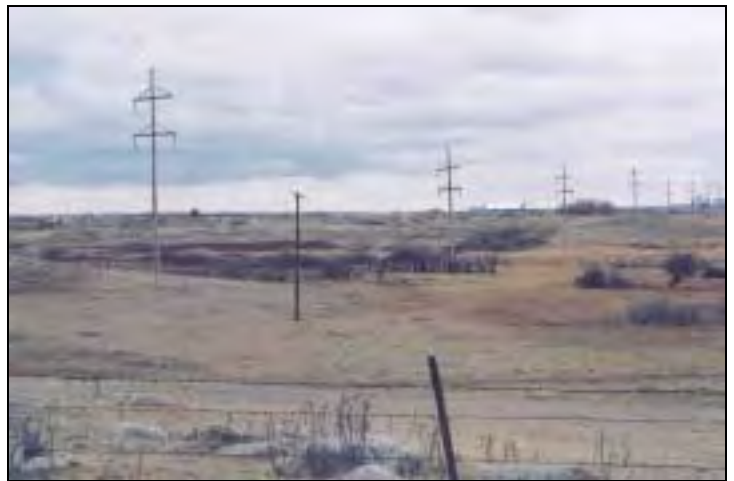
He noted that the saline areas were related to groundwater seepage and the slopes around the depressions were "sometimes subsaline dominated by *Crepis runcinata*, *Distichlis stricta*, or more often mainly with *Lilium*, *Zygadenus elegans*, and *Potentilla flabelliformis*." It should be noted that much of the NE ¼ of 24 has now been disturbed by active gravel operations and the natural character described by Hudson has been destroyed.

PHOTO 5 Looking west into the saline depression along the border of Sections 24 and 25.

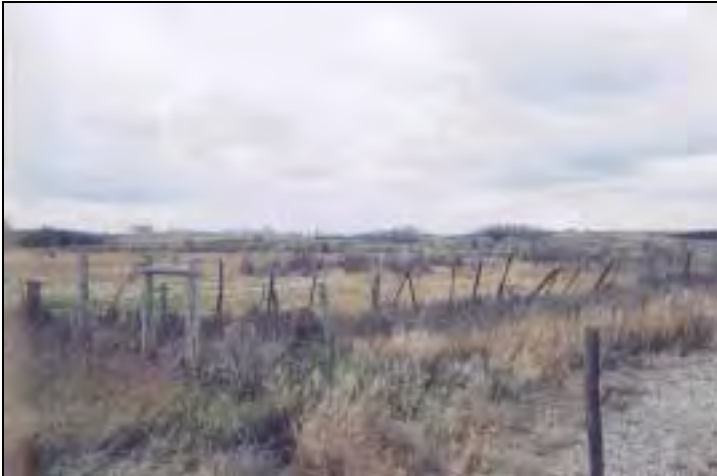
PHOTO 6 West half of Section 30

- A heritage resource impact assessment (HRIA) should be completed on lands within the W ½ of 30-37-4 W3M, particularly near the northern portion and the river. There may be some potential for tepee rings to be found here. Again, the presence of these would not affect future development but should be recorded if present. If no development is planned for this area, no HRIA will be required.

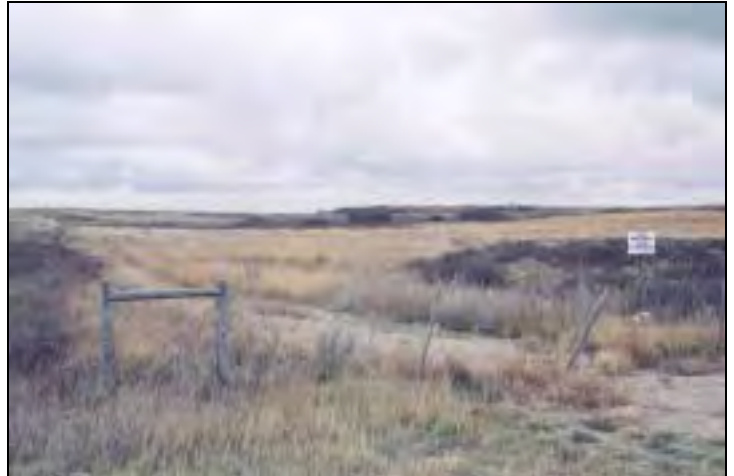
PHOTO 7 Section 30. Lands used by the RM of Corman Park. This site is disturbed.

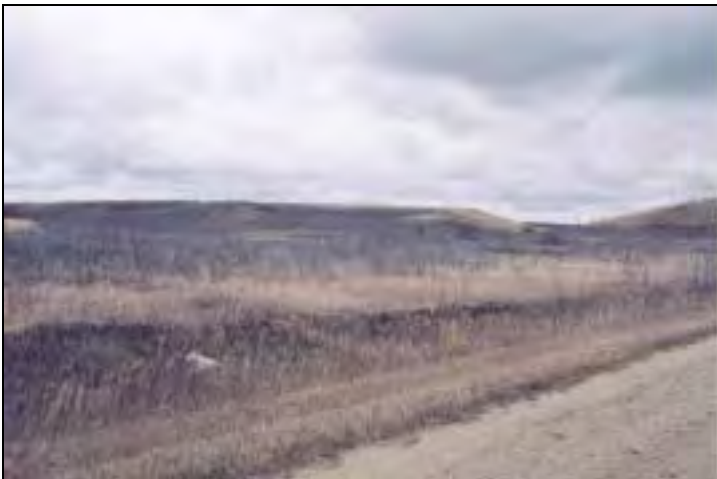
He describes portions of Section 30 as being a gently rolling till surface not as eroded as the other tracts were. The southern half was initially fescue prairie but has been invaded by brome and quack grasses, now making up about 60% of the cover. The northern half, on more clay soils, is a *Stipa-Agropyron* grassland with some fescue in the low spots and on the north slopes. Introduced species are less on the more northern portions.

PHOTO 8 Looking southeast into the SW of Section 30. A relatively undisturbed rolling landscape, although brome grass is common.

The study area is now a fragmented mosaic of gravel operations, abandoned roadways, old rock/gravel quarries, cultivated lands, and pasture. No large, relatively undisturbed natural ecological units remain, although lands within Section 30 remain ecologically well connected to the river valley. Future development activity with Sections 24 and 25 will likely not affect any important ecological units. However, it is recommended that disturbance within Section 30, particularly near the river, be avoided. This area remains in the most natural state, although grazed, and could serve as a potential environmental reserve, although small in size.

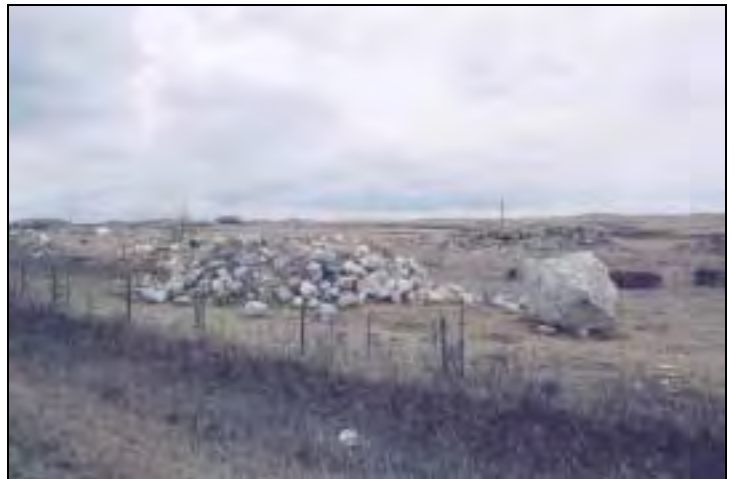
PHOTO 9 Old rock piles in the overgrazed pasture within the SE of Section 25
