Building Better Bridges: An Asset Management Plan for Bridges & Structures

Bridges & Structures

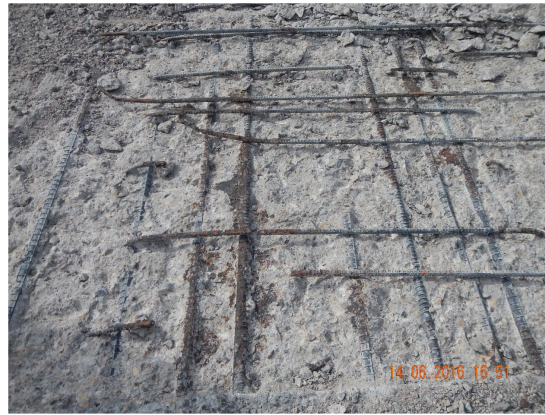
An example of a "Poor" condition structure was Idylwyld Drive over Ruth Street Overpass illustrated in the pictures below. While monitored, the overpass was still safe to the general public, however, advanced deterioration was identified and to ensure the structure could remain in service a rehabilitation was required. Defects were discovered through deck testing and were not visible until rehabilitation occurs. The program allowed the City to plan and rehabilitate the structure in 2016 and ensured the overpass will remain safe and serviceable into the future.

Severe corrosion on the reinforcing steel.

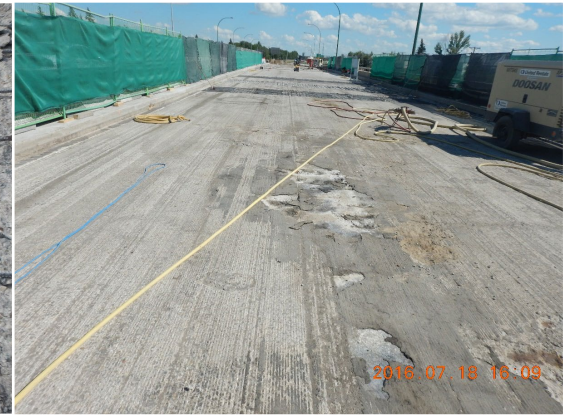
Disintegrated concrete and delaminations that became apparent once asphalt was removed.

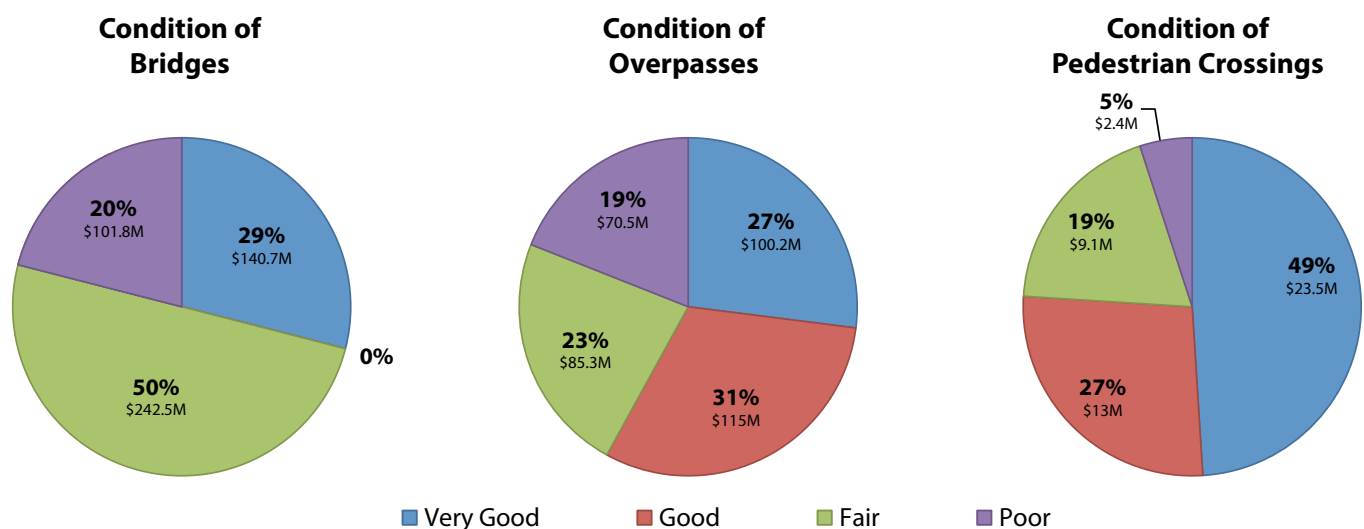
The following charts show the current physical condition of the bridge and structure inventory by replacement value.

| Asset | Physical Condition Actual | Physical Condition Desired | Desired Expenditure Level | Required 10 year funding (to meet Expenditure Level) | 10 year Budgeted Funding | 10 year Funding Gap (to meet Expenditure Level) |
|---|---|---|---|--|---|---|
| Bridges | <i>Remaining:</i> <ul style="list-style-type: none"> • 29% Very Good • 50% Fair • 20% Poor | Good | Level B | 64.93 | 35.20 | 29.73 |
| Overpasses | <ul style="list-style-type: none"> • 27% Very Good • 31% Good • 23% Fair • 19% Poor | Good | Level B | 40.29 | 25.37 | 14.92 |
| Pedestrian Crossing | <ul style="list-style-type: none"> • 48% Very Good • 27% Good • 19% Fair • 5% Poor | Good | Level B | 0.35 | 0.00 | 0.35 |
