CITY OF SASKATOON

Asbestos-Containing Building Materials Assessment Report - Avenue C Substation

Report Number: 1667963

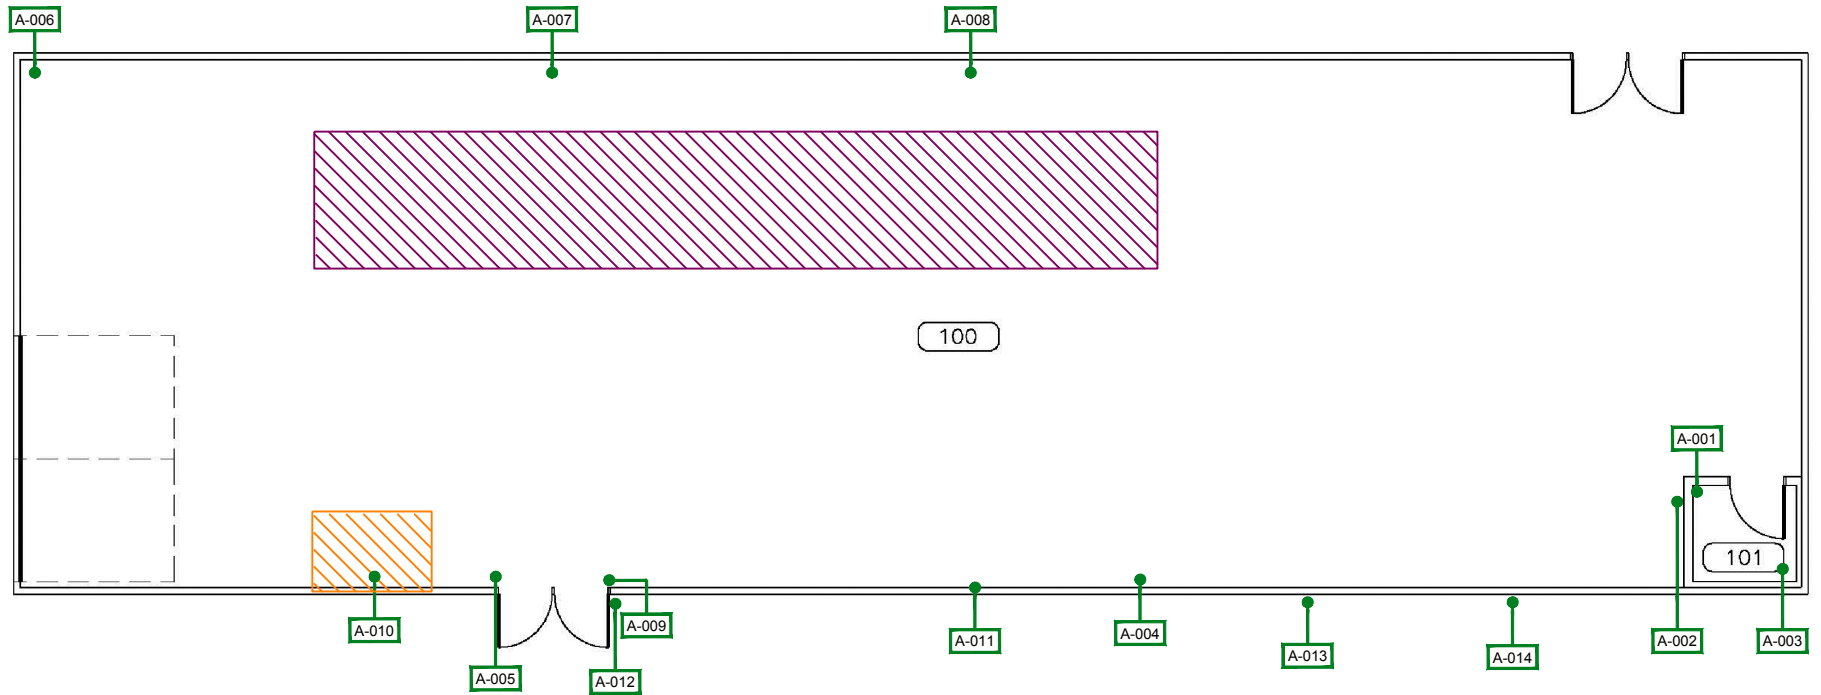
Floor Plan

1. ASBESTOS IS A CARCINOGEN. DO NOT BREATHE ASBESTOS DUST.
2. ADDITIONAL ASBESTOS-CONTAINING GREY FIRESTOP MAY BE LOCATED WITHIN THE CRAWLSPACE AND OTHER COVERED FLOOR PENETRATIONS THROUGHOUT THE SITE.
