July 14, 2017

CITY OF SASKATOON

Asbestos-Containing Building Materials Assessment Report - City Yards V&E Storage Building 15

Report Number: 1667963

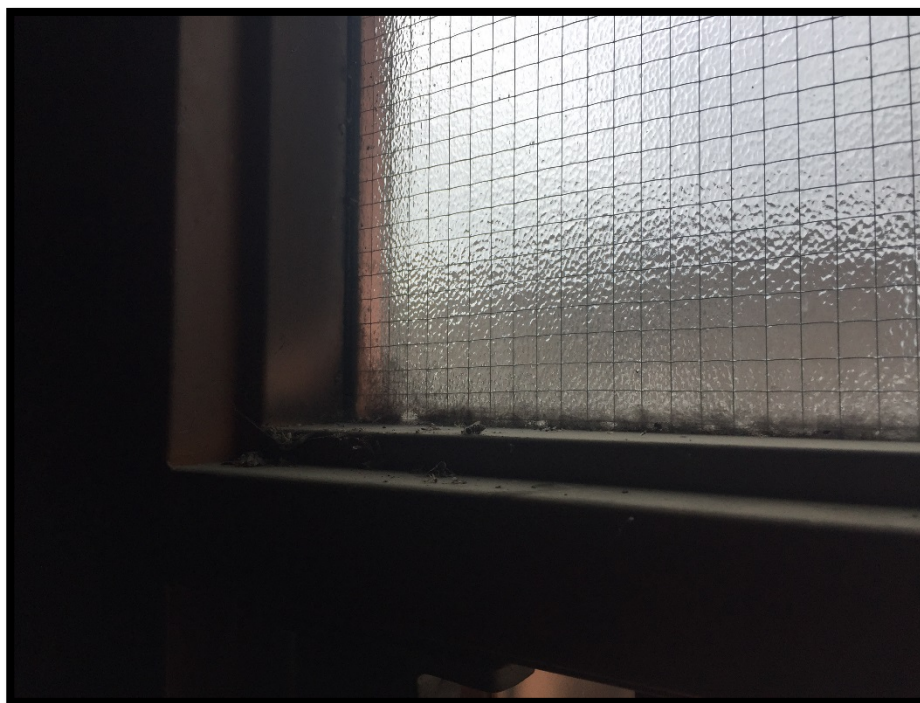
Photograph 1: Asbestos-Containing Black Window Caulking.

One (1) sample of black window caulking was collected during the assessment. The sample collected was found to contain 15% Chrysotile asbestos. Asbestos-containing black window caulking (see Photograph 1 in Appendix B) was observed in the following locations:

- Door Windows (approximately 32 linear ft).

If scheduled for impact, asbestos-containing black window caulking should be abated following low-risk abatement work procedures as outlined in the *Saskatchewan Asbestos Abatement Manual* (2017). Alternatively, as the black window caulking was observed in good condition, and with a priority rating of 5 (please see the room by room spreadsheet provided in Appendix C for a description of the priority ratings), it can be managed in place if not scheduled for impact.

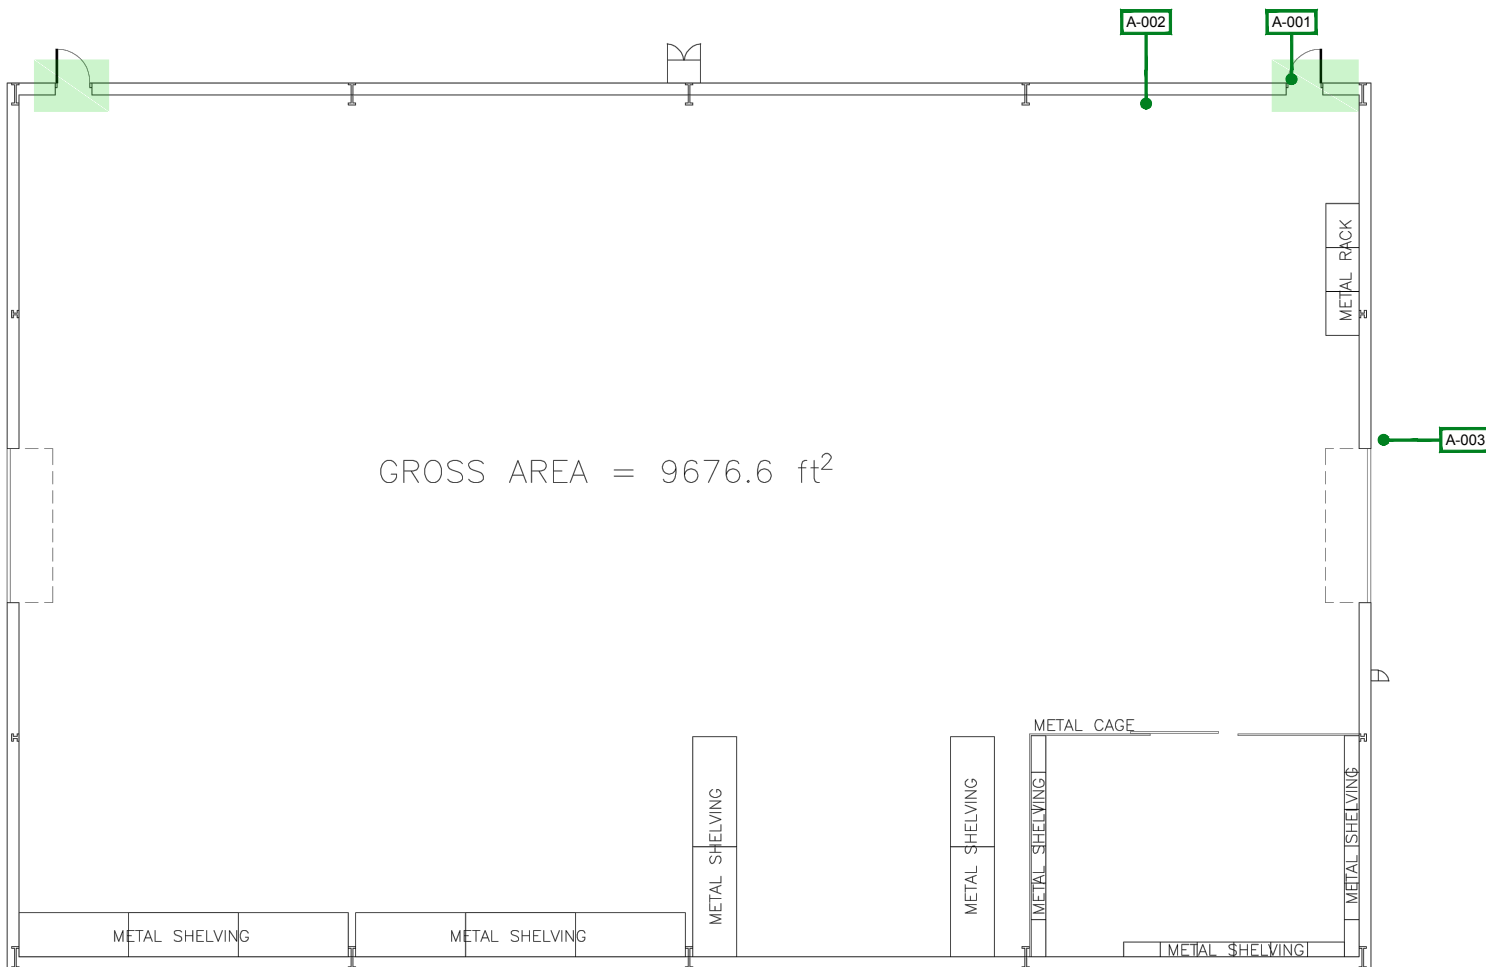
FIGURE
1

- # ASBESTOS SAMPLE LOCATION
- ASBESTOS - CONTAINING WINDOW CAULKING

TITLE
MAIN FLOOR
