CITY OF SASKATOON

# Asbestos-Containing Building Materials Assessment Report - Kiwanis Memorial Park Belvedere Building

**Report Number: 1667963**

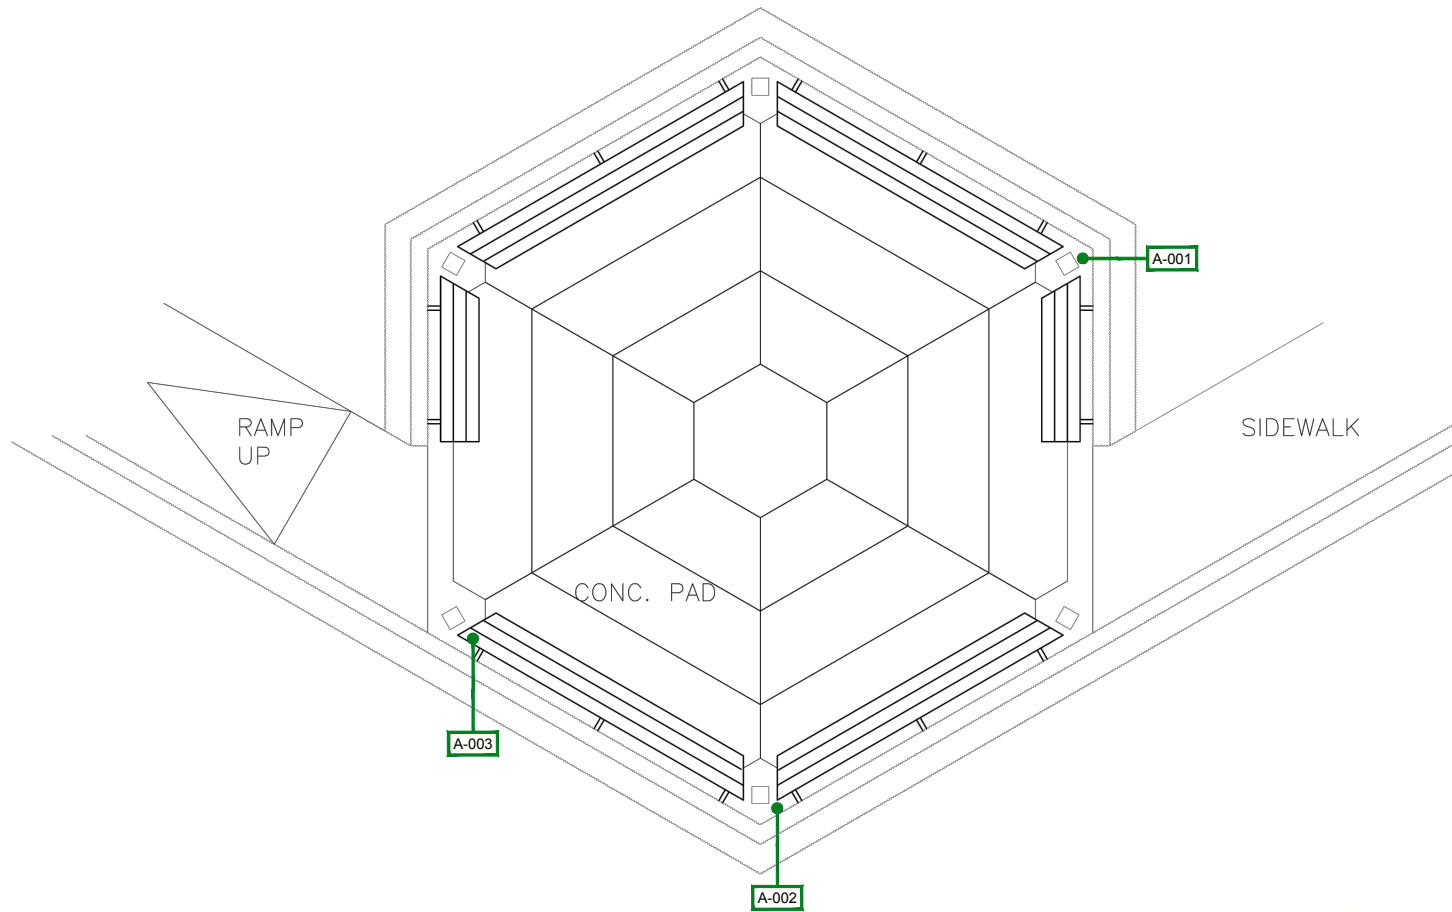
FIGURE  
 1

● # ASBESTOS SAMPLE LOCATION

1. ASBESTOS IS A CARCINOGEN. DO NOT BREATHE ASBESTOS DUST.
2. ASBESTOS-CONTAINING MATERIALS WERE NOT OBSERVED WITHIN THE BUILDING AT THE TIME OF THE ASSESSMENT.

TITLE  
**MAIN FLOOR**
