CITY OF SASKATOON

Asbestos-Containing Building Materials Assessment Report - Lakewood Civic Centre Storage Shed

Report Number: 1667963

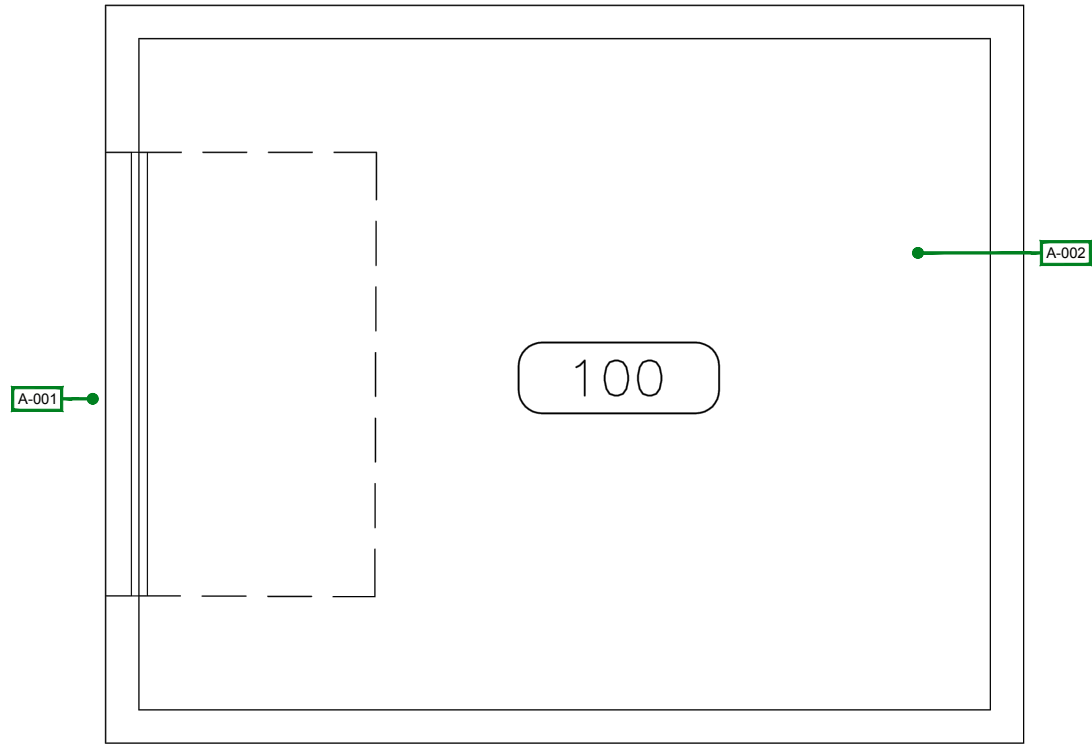
FIGURE
 1

1. ASBESTOS IS A CARCINOGEN. DO NOT BREATHE ASBESTOS DUST.
2. ASBESTOS-CONTAINING MATERIALS WERE NOT OBSERVED WITHIN THE SHED AT THE TIME OF THE ASSESSMENT

STORAGE SHED
