CITY OF SASKATOON

Asbestos-Containing Building Materials Assessment Report - Landfill Quonset Storage Building

Report Number: 1667963

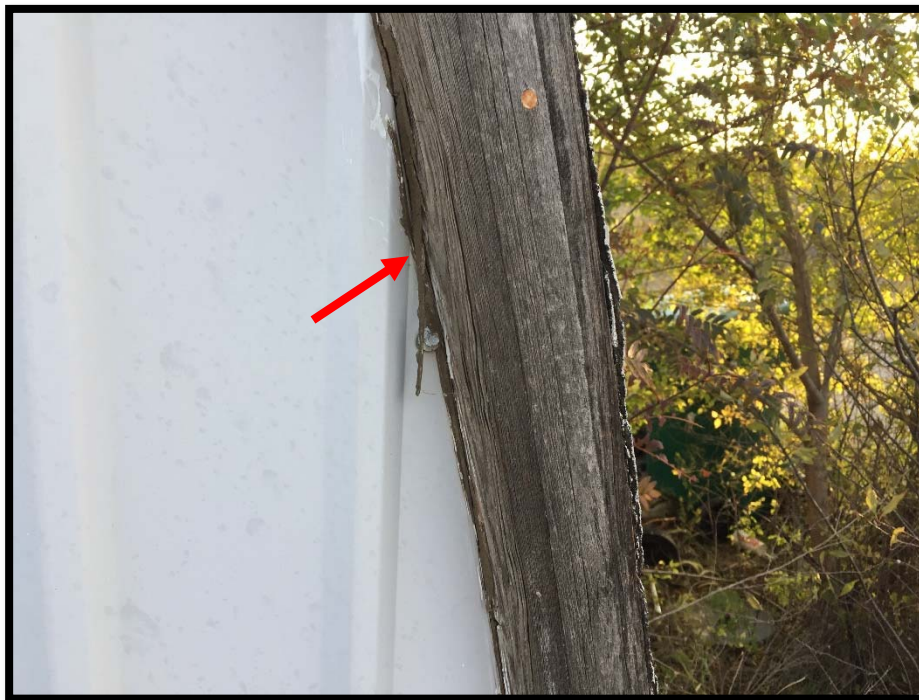
One (1) sample of brown building caulking was collected during the assessment. The sample collected was found to contain 2.3% Chrysotile asbestos. Asbestos-containing brown building caulking (see Photograph 1 in Appendix B) was observed in the following location:

- Exterior (approximately 100 linear ft).

Photograph 1: Asbestos-Containing Brown Building Caulking.

If scheduled for impact, asbestos-containing brown building caulking should be abated following low-risk abatement work procedures as outlined in the *Saskatchewan Asbestos Abatement Manual* (2017). Alternatively, as the brown building caulking was observed in good condition, and with a priority rating of 5 (please see the room by room spreadsheet provided in Appendix C for a description of the priority ratings), it can be managed in place if not scheduled for impact.
