CITY OF SASKATOON

Asbestos-Containing Building Materials Assessment Report - Main Street Substation

Report Number: 1667963

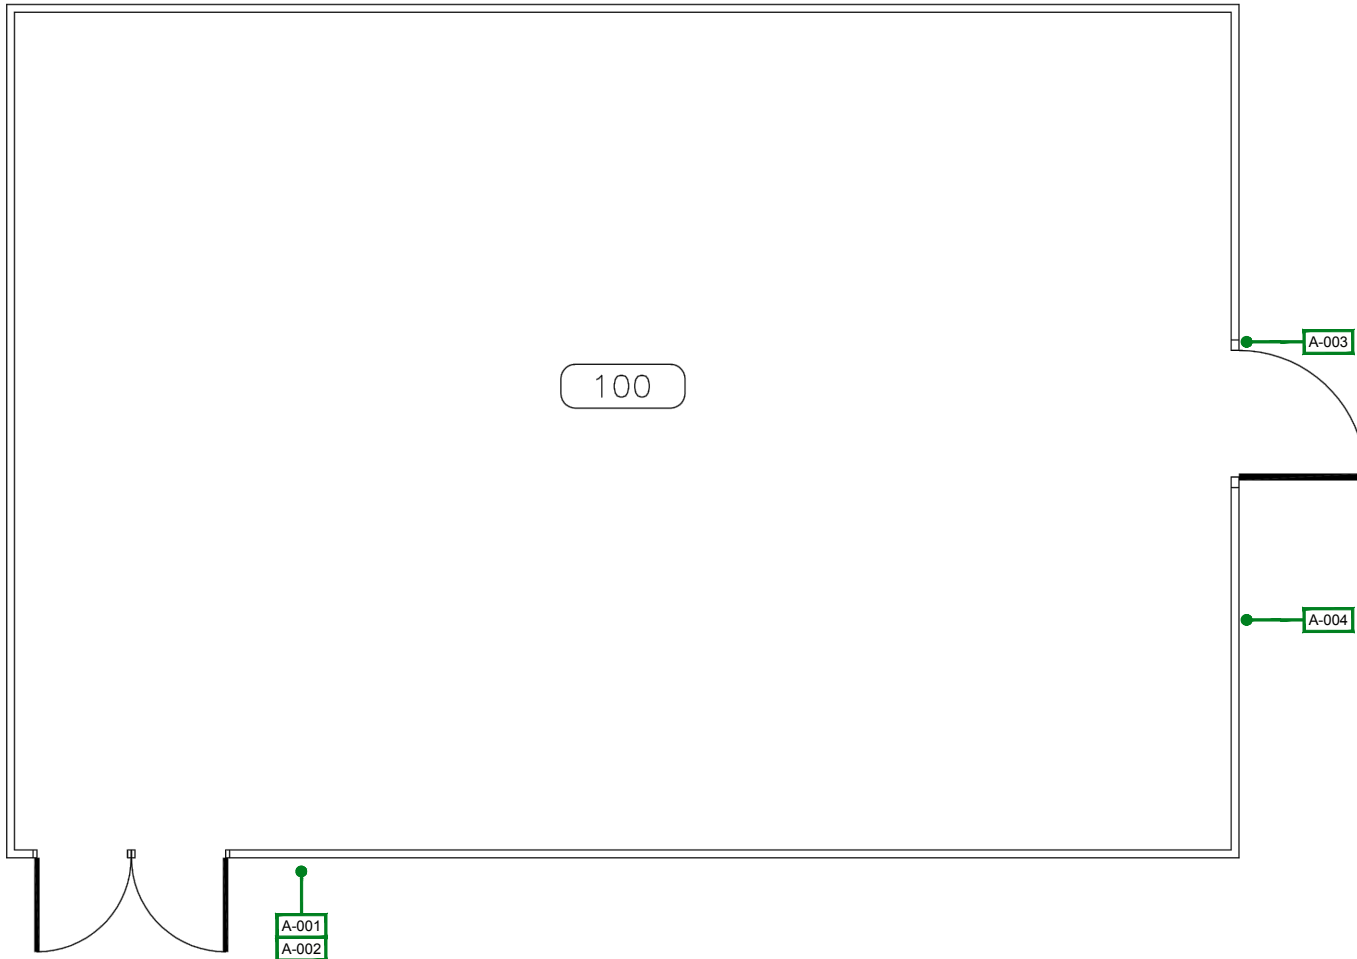
FIGURE
 1

NOTE(S)
 1. ASBESTOS IS A CARCINOGEN. DO NOT BREATHE ASBESTOS DUST.
 2. ASBESTOS-CONTAINING MATERIALS WERE NOT OBSERVED WITHIN THE BUILDING AT THE TIME OF THE ASSESSMENT.
