November 3, 2017

CITY OF SASKATOON

Asbestos-Containing Building Materials Assessment Report - Senator Sidney L. Buckwold Park Tennis Courts and Paddling Pool

Report Number: 1667963

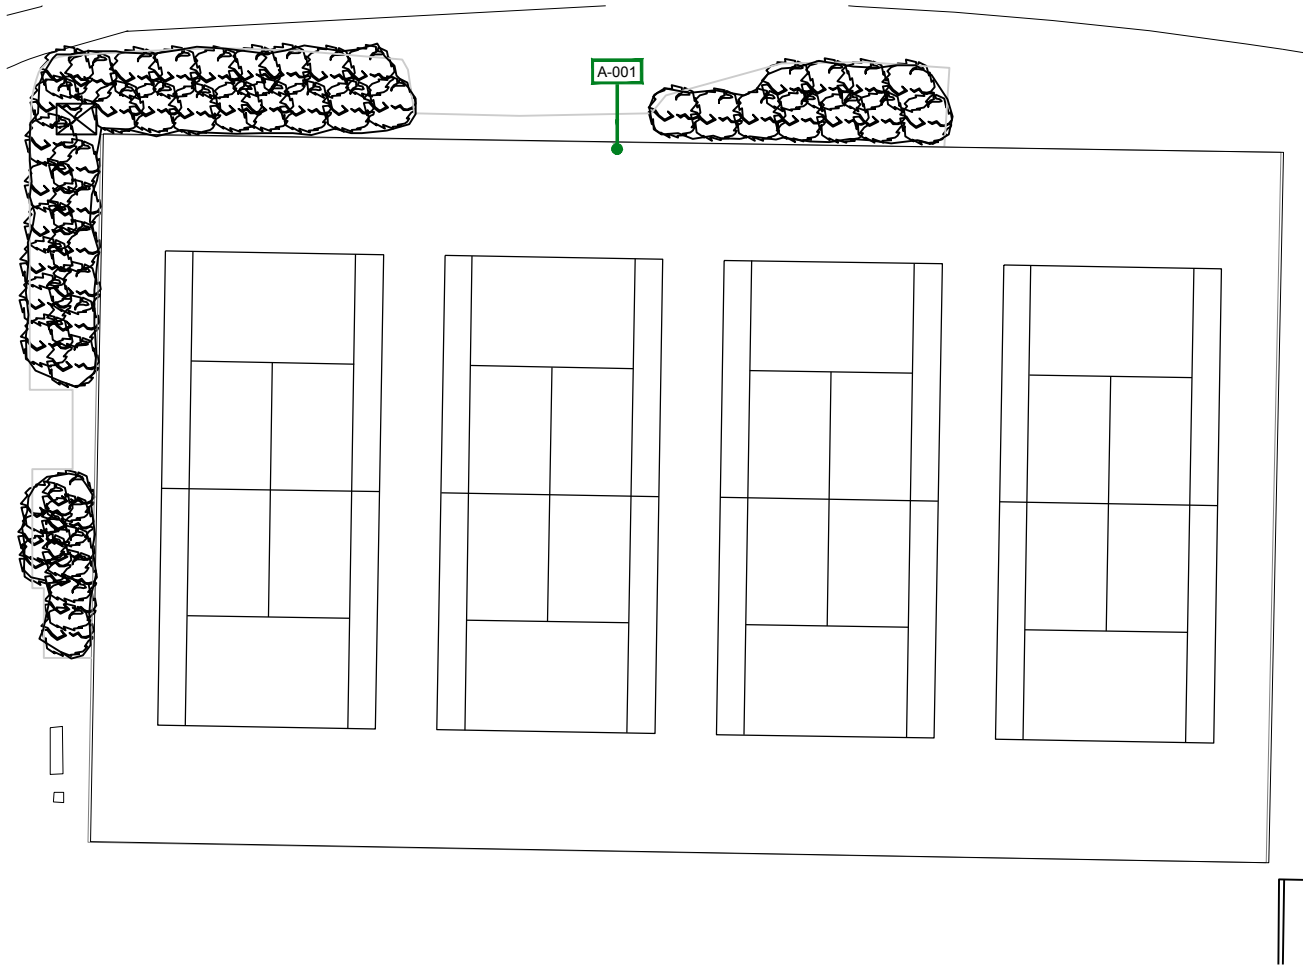
FIGURE
 1

Lab No.: 6368307 Client No.: A-001	Analyst Observation: Black/Red Cementitious Client Description: Court Asphalt	Location: Exterior, Tennis Court Facility:
<u>Percent Asbestos:</u> <i>None Detected</i>	<u>Percent Non-Asbestos Fibrous Material:</u> None Detected	<u>Percent Non-Fibrous Material:</u> 100

1. ASBESTOS IS A CARCINOGEN. DO NOT BREATHE ASBESTOS DUST.
2. ASBESTOS-CONTAINING MATERIALS WERE NOT OBSERVED ON SITE DURING THE ASSESSMENT.

TENNIS COURT

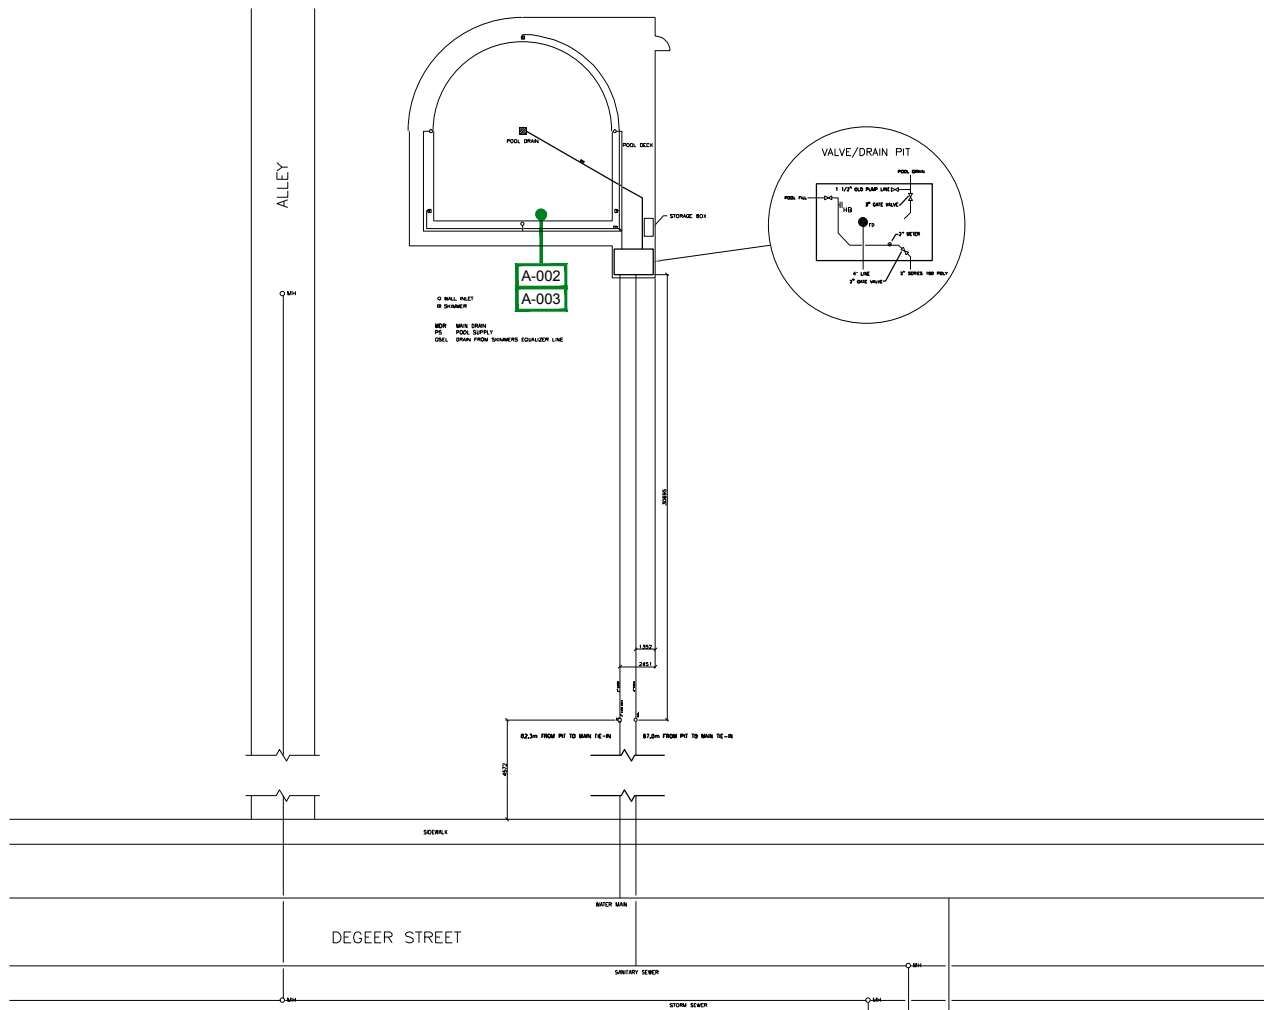
FIGURE
 2

Lab No.: 6368308 Client No.: A-002	Analyst Observation: Grey Caulk Client Description: Grey Concrete Caulking	Location: Exterior, Paddling Pool Facility:
<u>Percent Asbestos:</u> <i>None Detected</i>	<u>Percent Non-Asbestos Fibrous Material:</u> 2 Cellulose	<u>Percent Non-Fibrous Material:</u> 98

Lab No.: 6368309 Client No.: A-003	Analyst Observation: Grey Caulk Client Description: White Concrete Caulking	Location: Exterior, Paddling Pool Facility:
<u>Percent Asbestos:</u> <i>None Detected</i>	<u>Percent Non-Asbestos Fibrous Material:</u> 1 Cellulose	<u>Percent Non-Fibrous Material:</u> 99

NOTE(S)
 1. ASBESTOS IS A CARCINOGEN. DO NOT BREATHE ASBESTOS DUST.
 2. ASBESTOS-CONTAINING MATERIALS WERE NOT OBSERVED ON SITE DURING THE ASSESSMENT.

TITLE
PADDLING POOL
