July 14, 2017

## CITY OF SASKATOON

# Asbestos-Containing Building Materials Assessment Report - Nicholson Yards Weigh Shed

**Report Number: 1667963**

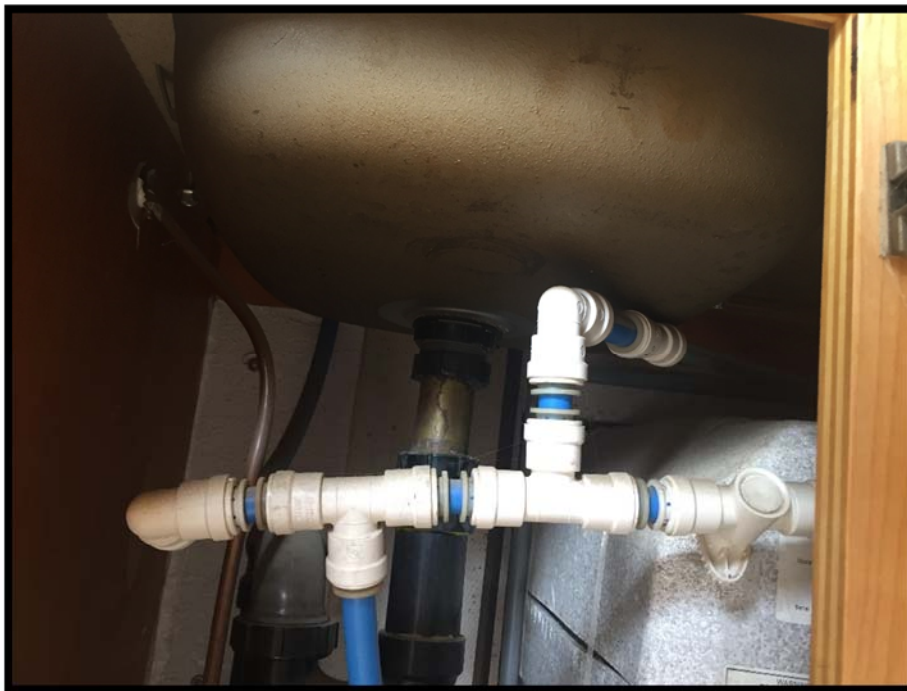
One (1) sample of gold sink undercoat was collected during the assessment. The sample collected was found to contain 3.4% Chrysotile asbestos. Asbestos-containing gold sink undercoat (see Photograph 1 in Appendix B) was observed in the following location:

- Room 100 (approximately 1 sink).

**Photograph 1: Asbestos-Containing Gold Sink Undercoat.**

| Included/Excluded | Floor | Room # | Area Description | Elements | Subelements | Material Description | Accessibility | Suspect? | Sampled? | Asbestos Containing Material? | Condition | Field Notes | Sample Type | Sample ID | Sample Date | Asbestos Type | ACM Product | % of asbestos | Friable | Sprayed-on | Maintenance | Inspection | Priority | Potential for Disturbance | Recommended Action | Quantity | Photograph ID | Labelling Type |
|---|---|---|---|---|---|---|---|---|---|---|---|---|---|---|---|---|---|---|---|---|---|---|---|---|---|---|---|---|
| Included | M | 100 | General Room | Plumbing | Sink | Gold Sink Undercoat | High | Yes | Yes | Yes | Good | | Bulk | A-003 | 16-Jun-17 | Chrysotile | Sink Undercoat | 3.4% | No | No | No | Annually | 5 | Moderate | Manage in place. | 1 Sink | Photograph 1 | Door Jamb |

If scheduled for impact, the sink with asbestos-containing gold sink undercoat should be abated following low-risk abatement work procedures as outlined in the *Saskatchewan Asbestos Abatement Manual* (2017). Alternatively, as the gold sink undercoat was observed in good condition, and with a priority rating of 5 (please see the room by room spreadsheet provided in Appendix C for a description of the priority ratings), it can be managed in place if not scheduled for impact.

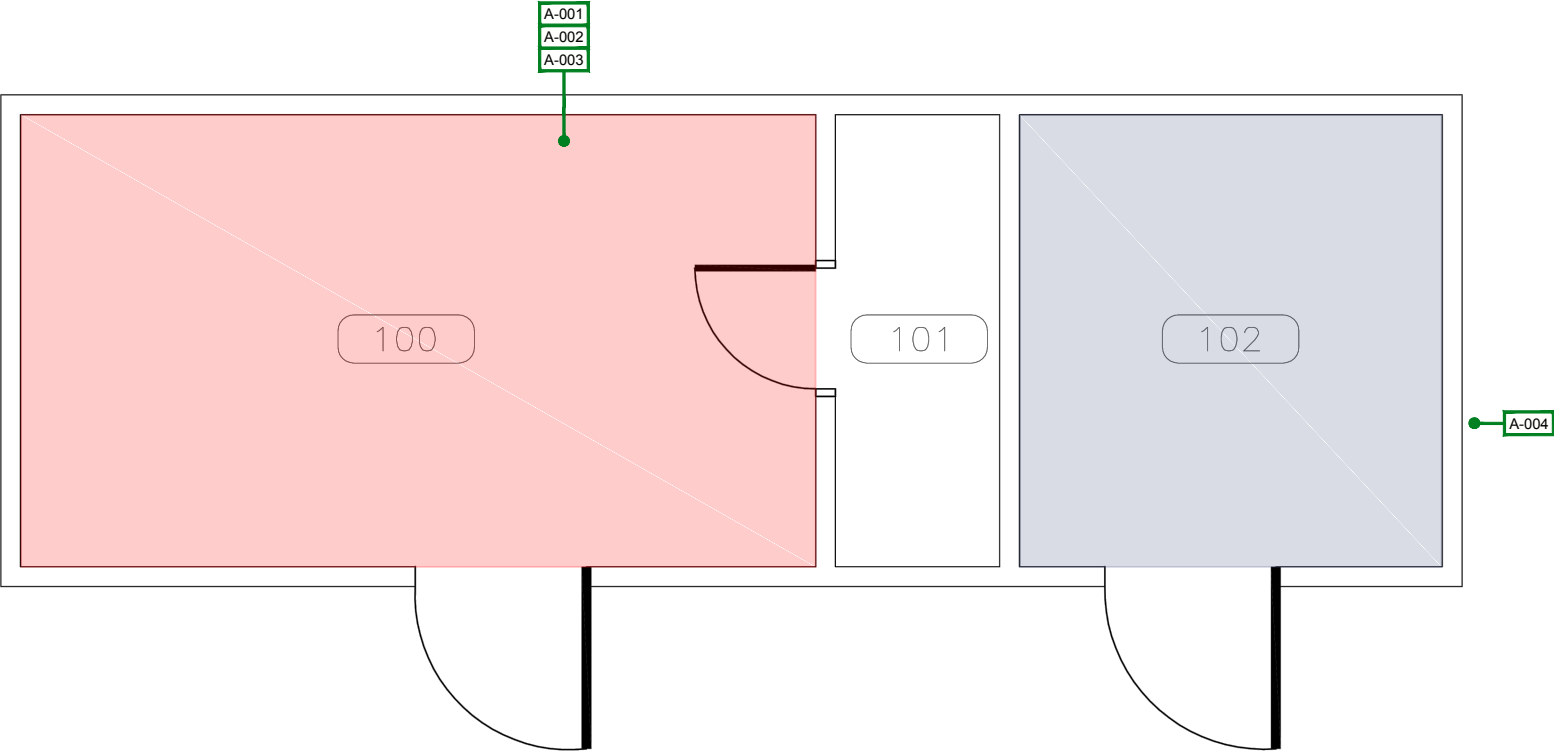
TITLE  
**MAIN FLOOR**

- ASBESTOS SAMPLE LOCATION
- ASBESTOS - CONTAINING SINK UNDERCOAT
- NO ACCESS
