CITY OF SASKATOON

Asbestos-Containing Building Materials Assessment Report - W J Bunn Substation

Report Number: 1667963

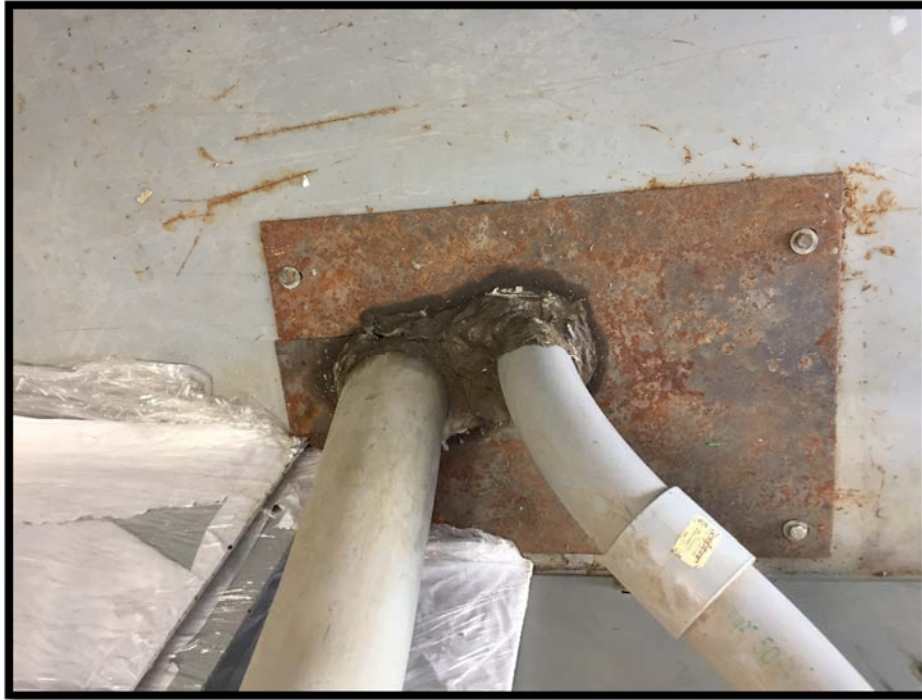
One (1) sample of grey firestop was collected during the assessment. The sample collected was found to contain 10% Chrysotile asbestos. Asbestos-containing grey firestop (see Photograph 1 in Appendix B) was observed in the following locations:

- Room 100 (approximately 2 ft²).

Photograph 1: Asbestos-Containing Grey Firestop.

If scheduled for impact, asbestos-containing grey firestop should be abated following the low-risk abatement work procedures as outlined in the *Saskatchewan Asbestos Abatement Manual (2017)*. Alternatively, as the grey firestop was observed in good condition, and with a priority rating of 5 (please see the room by room spreadsheet provided in Appendix C for a description of the priority ratings), it can be managed in place if not scheduled for impact.
