CITY OF SASKATOON

# Asbestos-Containing Building Materials Assessment Report - Waste Water Grit Tanks Building

**Report Number: 1667963**

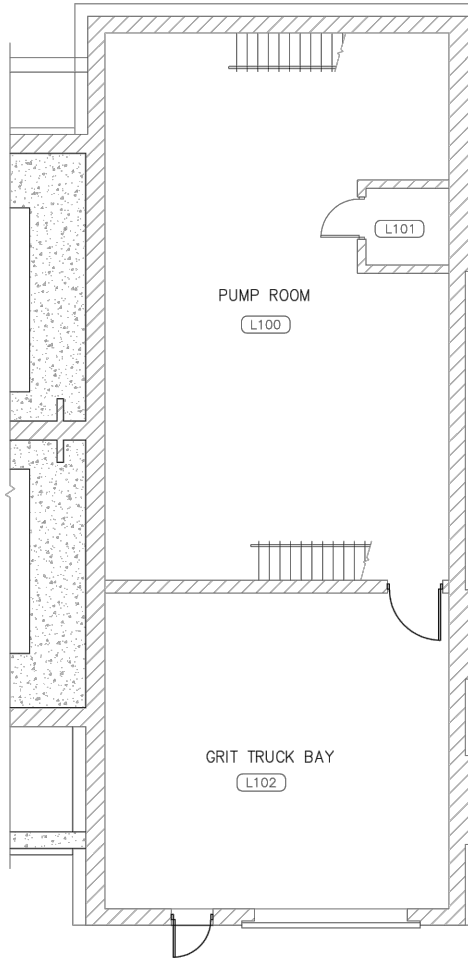
**NOTE(S)**  
 1. ASBESTOS IS A CARCINOGEN. DO NOT BREATHE ASBESTOS DUST.  
 2. ASBESTOS-CONTAINING MATERIALS WERE NOT OBSERVED ON SITE DURING THE ASSESSMENT.

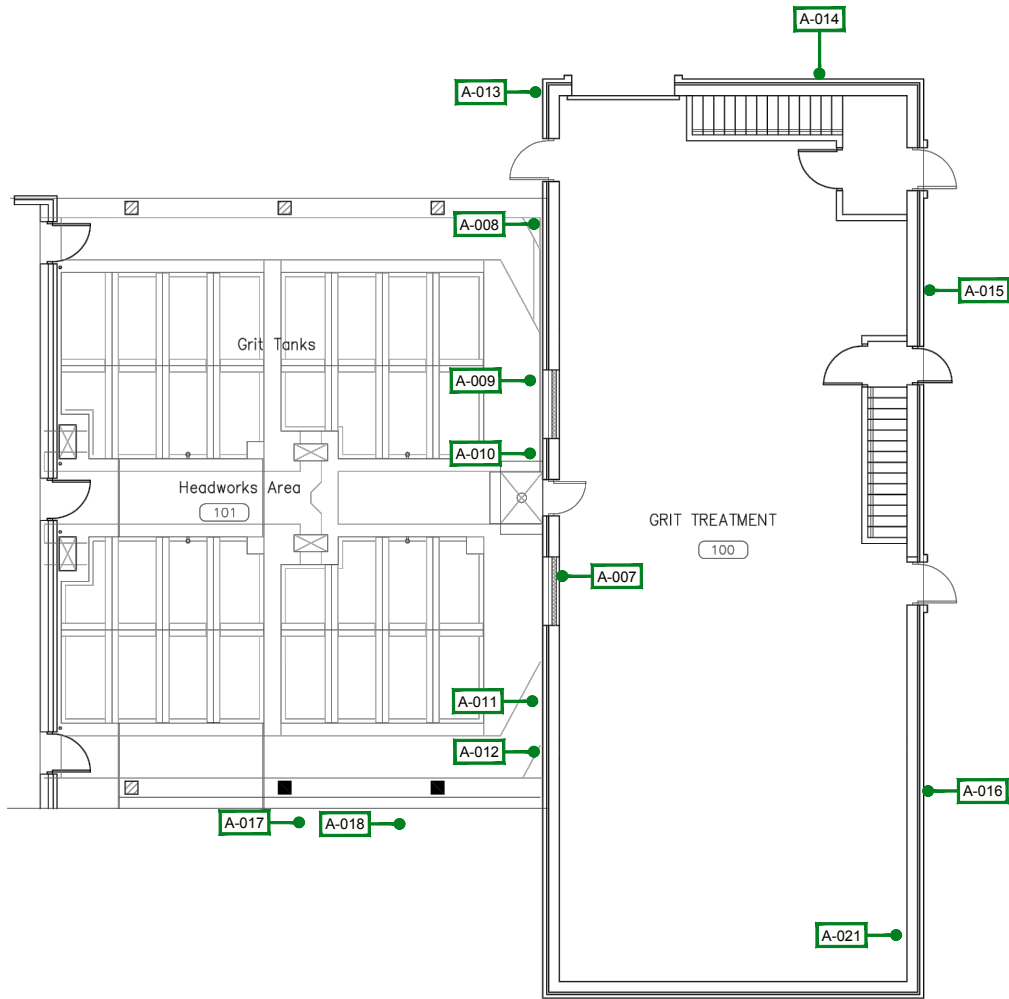
**NOTE(S)**  
 1. ASBESTOS IS A CARCINOGEN. DO NOT BREATHE ASBESTOS DUST.  
 2. ASBESTOS-CONTAINING MATERIALS WERE NOT OBSERVED ON SITE DURING THE ASSESSMENT.

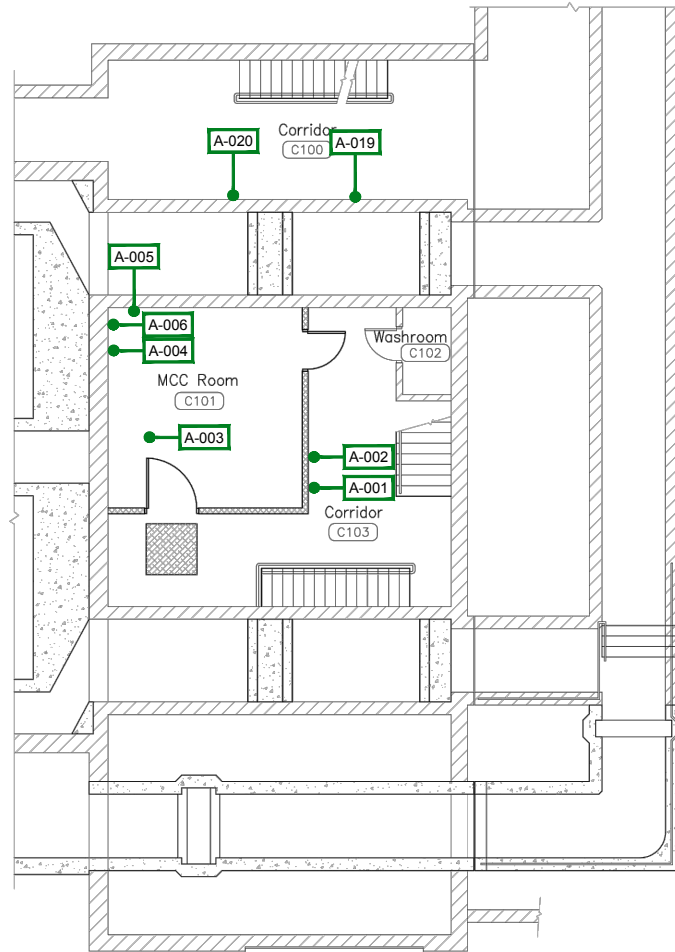
**NOTE(S)**  
 1. ASBESTOS IS A CARCINOGEN. DO NOT BREATHE ASBESTOS DUST.  
 2. ASBESTOS-CONTAINING MATERIALS WERE NOT OBSERVED ON SITE DURING THE ASSESSMENT.
